# W. EDWARD BALMER ELEMENTARY SCHOOL

NORTHBRIDGE PUBLIC SCHOOLS  
TOWN OF NORTHBRIDGE, MASSACHUSETTS

## PRELIMINARY DESIGN PROGRAM, SECTION 3.1.4

### EVALUATION OF EXISTING CONDITIONS

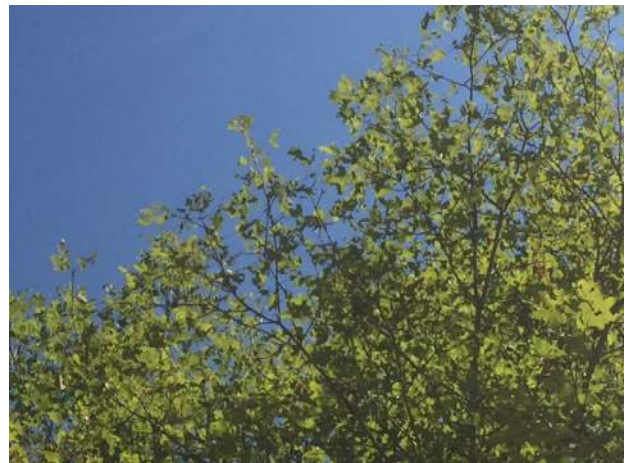
*Figure 6—Insect damage on shade trees*

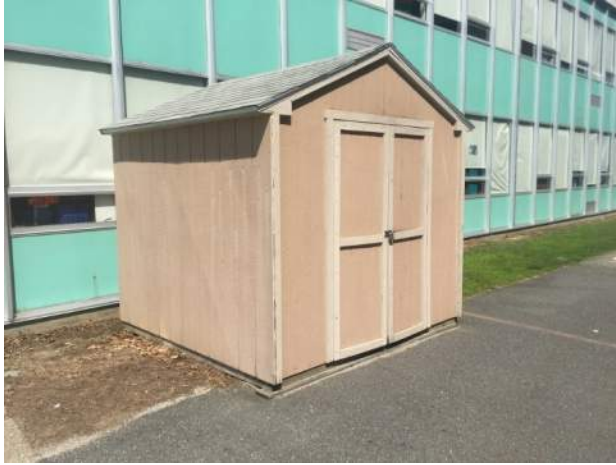
*Figure 7—Storage shed*

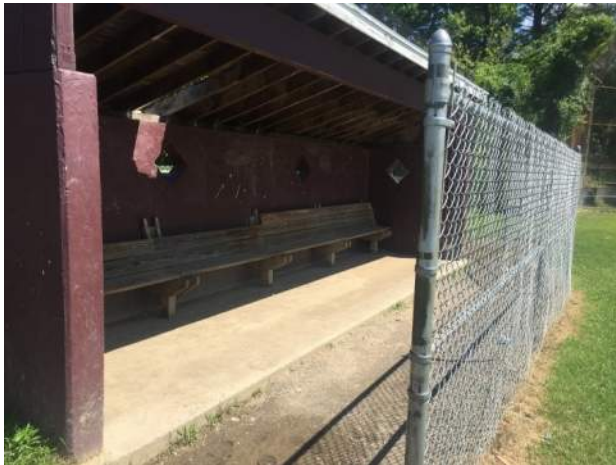
*Figure 9—Team dugouts in poor condition*

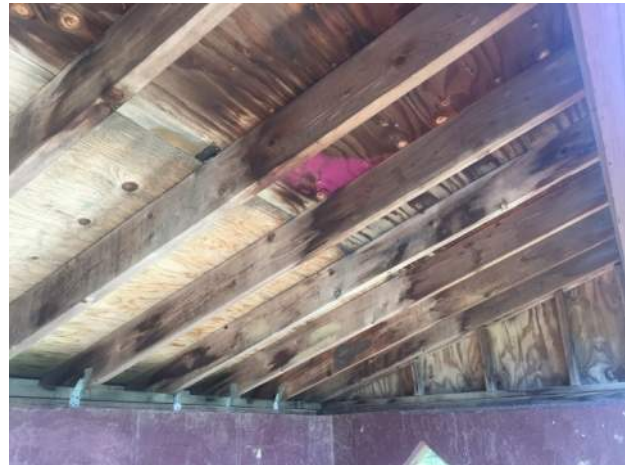
*Figure 10—Condition of dugout structure*

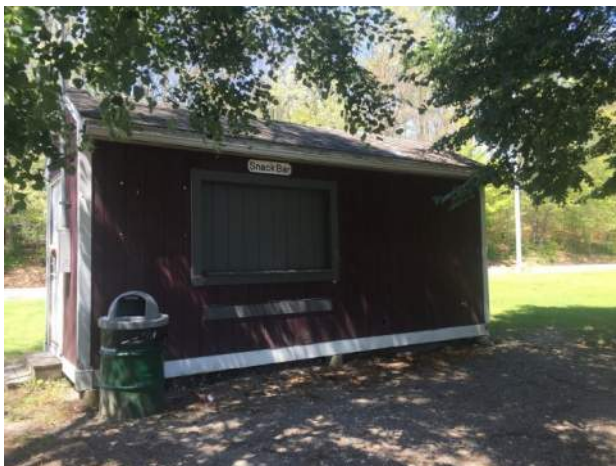
The concession booth at the athletic fields is in good condition and appears to be relatively new. The booth, if staffed by volunteers, is required to be accessible, and required to be accessible to the public making purchases. Neither appears to be the case, as there is a step leading into the booth, and the transaction window sill height is too high. (Figure 11)	Provide a ramp with landing at the entrance to the booth. Modify the transaction window and shutter to lower the sill to accessible height.

*Figure 11—Concession booth at ballfield*

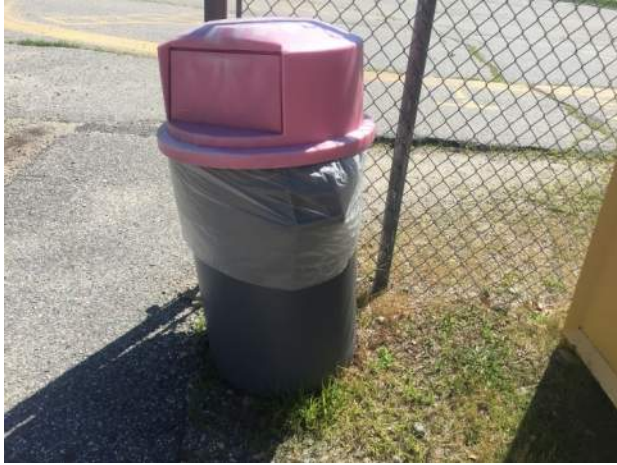
*Figure 13—Inadequate quality of exterior furnishings*

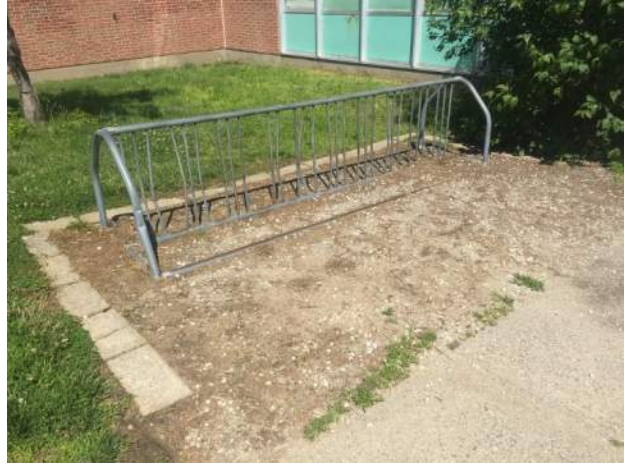
One bicycle rack was observed and was in fair condition, and was located on an unsuitable surface. The bicycle rack was bent and some areas were beginning to rust. No bicycle racks were observed at other entrances, playgrounds or ball fields. (Figure 14)	Provide more high quality bicycle racks to encourage student to bike to school and sports. Place bicycle racks on level, undamaged concrete pads for safety and accessibility. Provide bike racks at appropriate areas.

*Figure 14—Bicycle racks are in poor shape.*

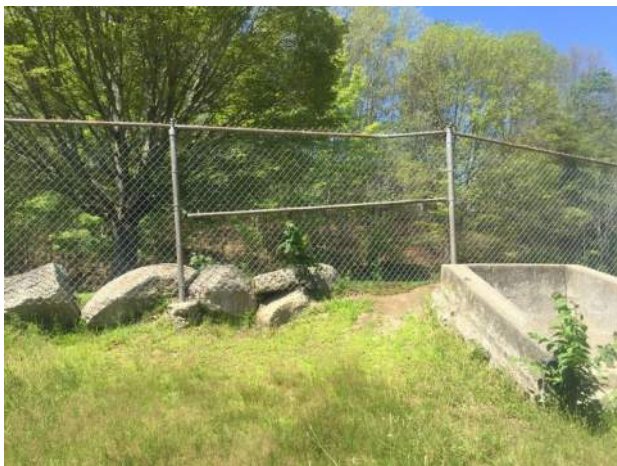
*Figure 17—Chain-link fencing in need of replacement*

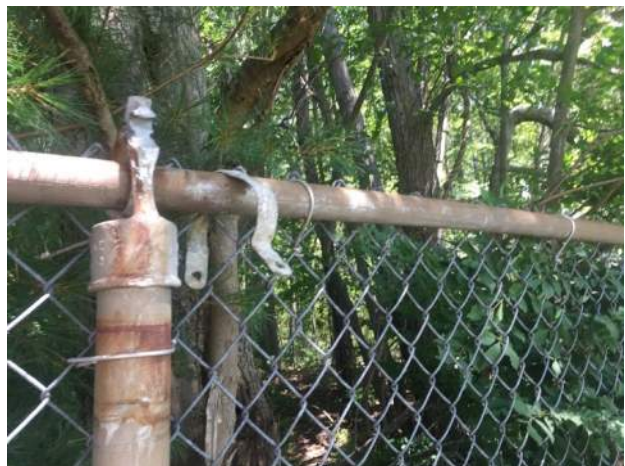
*Figure 18—Chain-link fencing in need of replacement*

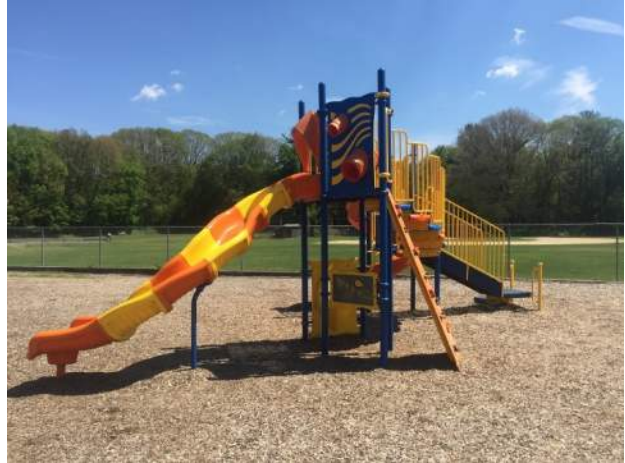
*Figure 20—Play equipment in fair to good shape.*

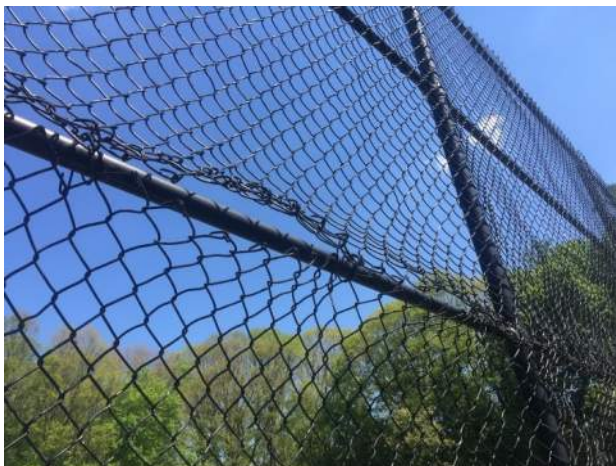
*Figure 23—Baseball backstop with damaged fabric.*

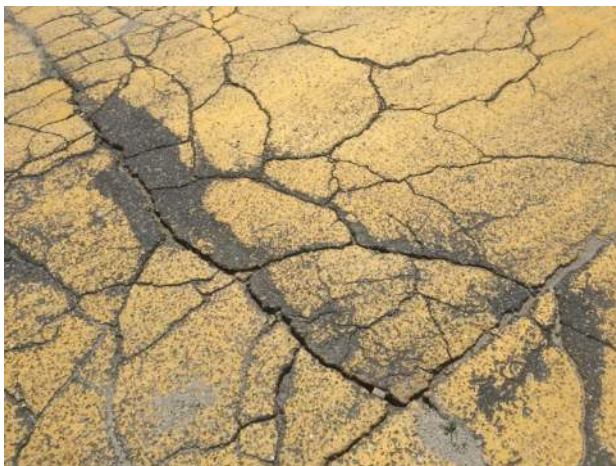
Bituminous pavement surfacing across the site is in poor condition and in need of replacement. Cracks, potholes, puddling, vegetative growth, and debris are prevalent. Painted markings, including crosswalks and handicapped aisles, are faded or worn away. These issues present safety and accessibility concerns. (Figures 25—30)	Provide new top coat at all bituminous pavement surfaces site-wide. Restripe and provide new painted markings for vehicular circulation.
--	--

*Figure 29—Cracks in pavement.*

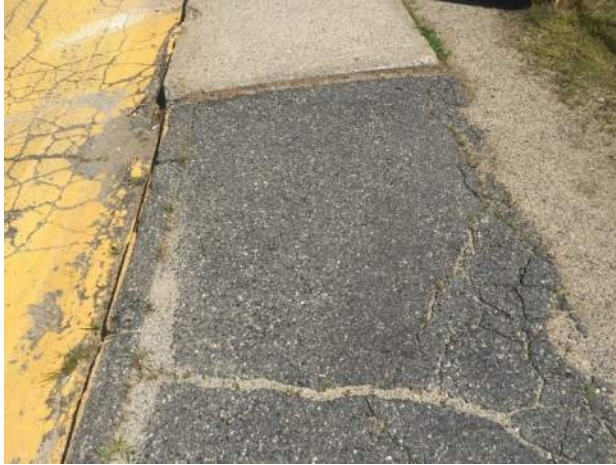
*Figure 31—Failure at joints of dissimilar surfaces*

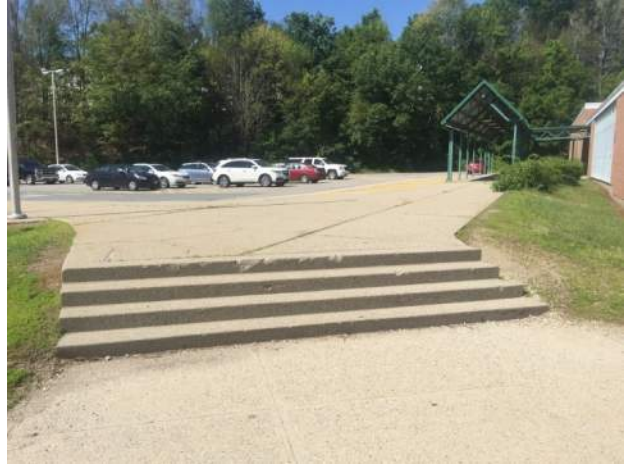
*Figure 32—Lack of accessible route at primary entrance*

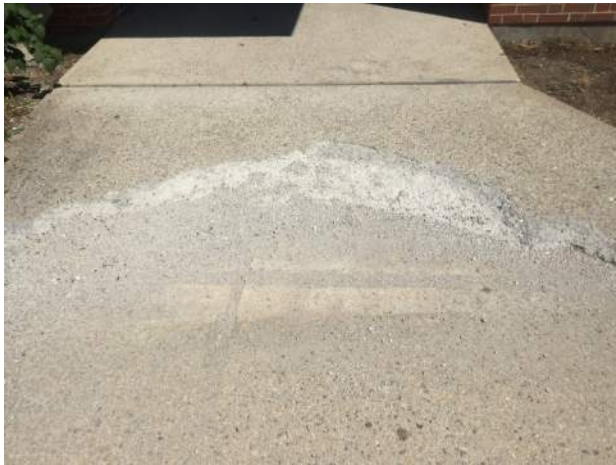
*Figure 33—Damaged concrete sidewalks*

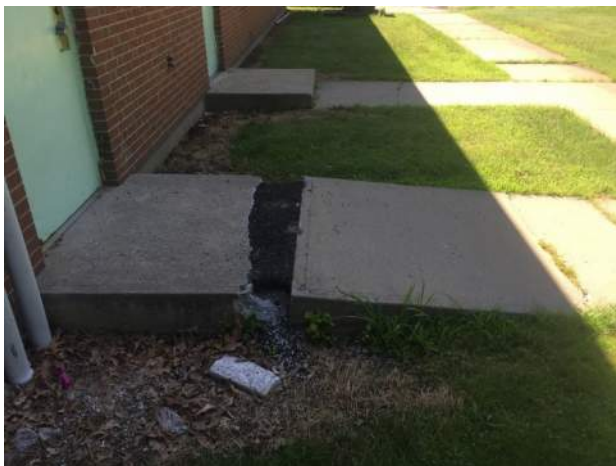
*Figure 35—Temporary repair at ramped entrance*

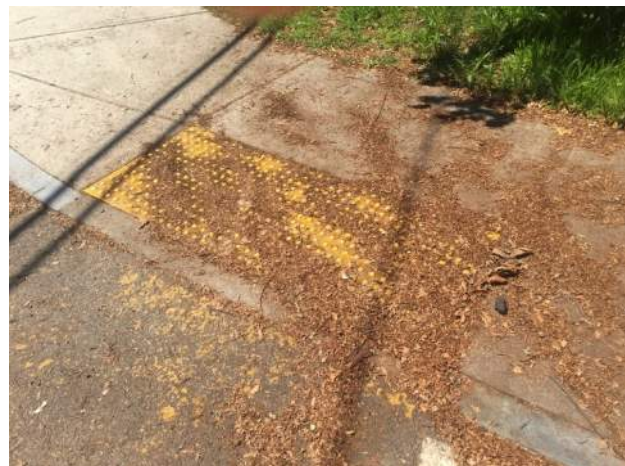
*Figure 36—Lack of maintenance impeding accessibility*

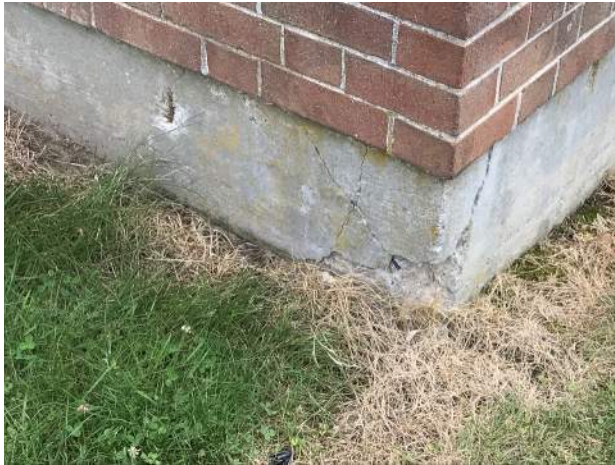
Various areas of cracking and in some cases exposed rebar was noted around the perimeter of the 1968 building. Cracks at the surface can allow water infiltration and additional damage during freeze-thaw cycles. (Figures 1-2).	Undertake a building-wide foundation concrete repair program, to remove all loose and unstable material, protect reinforcing with an applied coating, and patch all missing or cracked concrete. Consideration should also be given to applying a protective coating such as elastomeric paint to increase the service life of the patched walls.
Concrete frost pads / concrete sidewalk leading to the frost pads have issues of spalling with some having large areas of the concrete missing (Figures 3-4).	Repair all sidewalks and frost pads. Remove loose concrete from the sidewalks and frost pads, parge concrete to match existing planer surface.
Concrete loading dock is generally in fair condition, however there are a few areas of severe spalling of concrete. Dock bumpers are corroding, and staining concrete; rusted anchors can permit water to enter the concrete wall and cause additional deterioration. (Figures 5, 6).	Remove all loose concrete from loading dock walls and slab. Modify slab edge to include galvanized steel angle embedded in concrete to protect the edge of concrete. Seal all cracks in concrete. Parge concrete to match existing adjacent surfaces.  Replace dock bumpers.

*Figure 1—Foundation wall showing cracking*

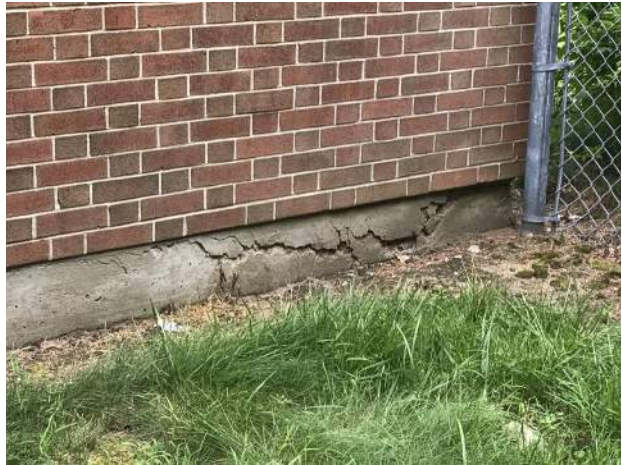
*Figure 2—Foundation wall showing cracking*

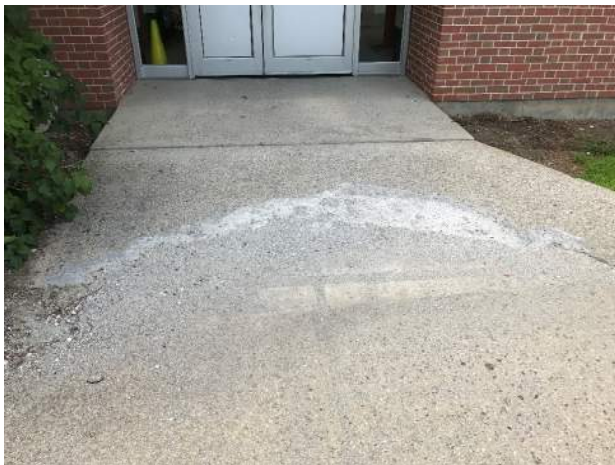
*Figure 3—Sidewalk at frost pad showing spalling*

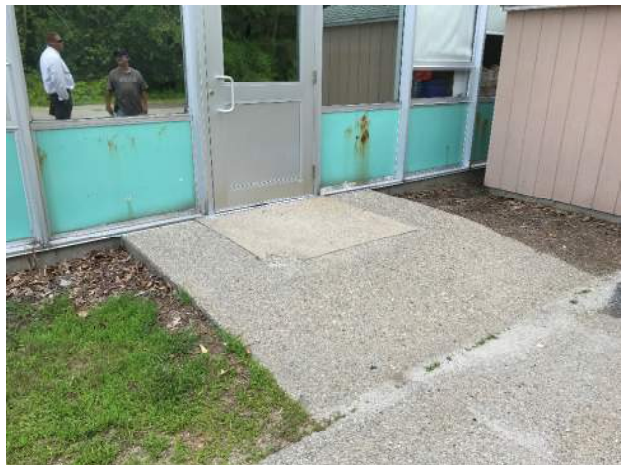
*Figure 4—Frost pad showing spalling missing corner*

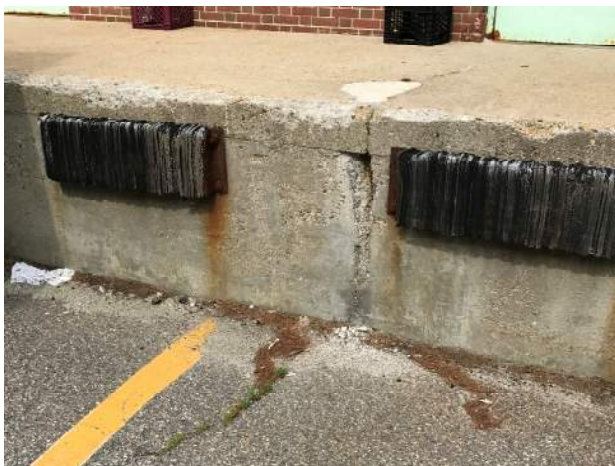
*Figure 5—Loading dock showing spalling concrete*

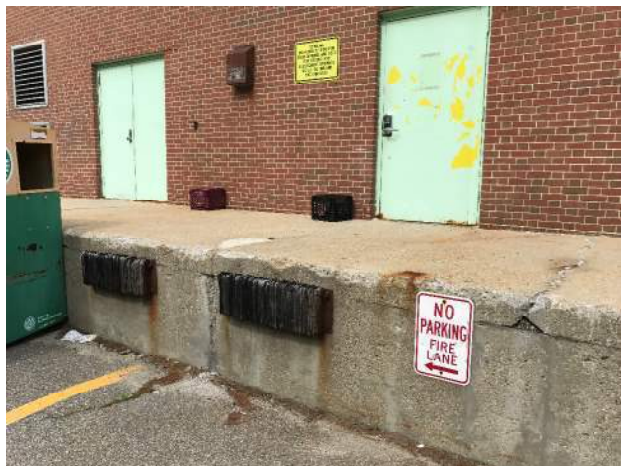
*Figure 6—Loading dock showing spalling concrete*

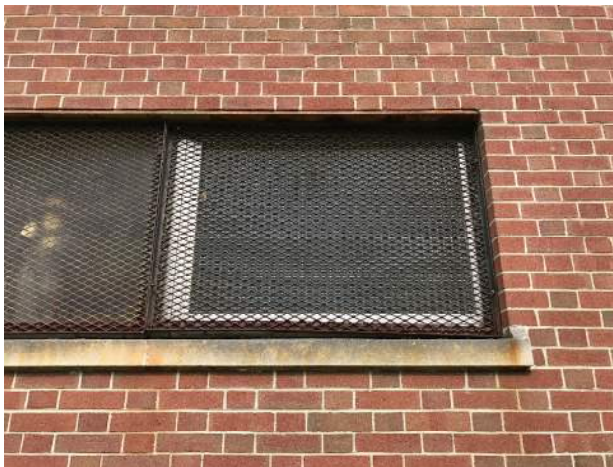
*Figure 15—Non thermally broken windows*

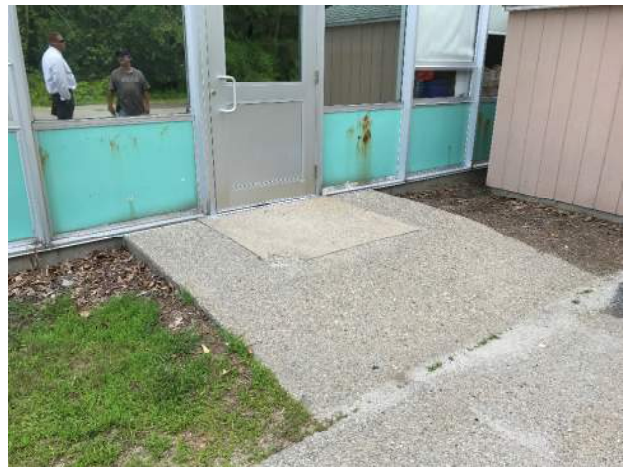
*Figure 16—Rusting enameled metal spandrel panels*

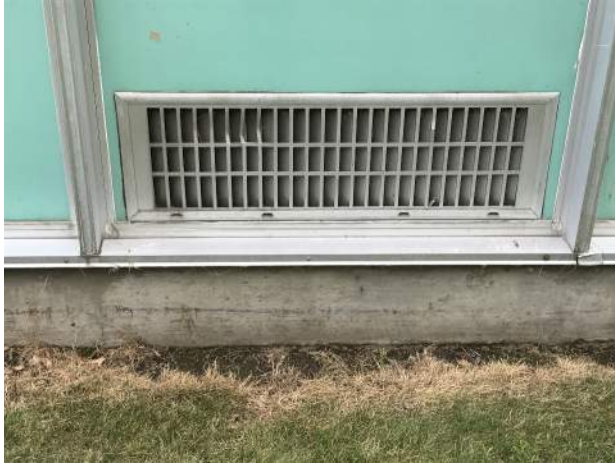
Louvers near grade feature some bent and split louver fins / grating at various locations on the curtain wall system (Figure 24).	With any building-wide curtainwall replacement, replace unit ventilator louvers with new horizontal-blade louvers.  Lacking replacement of curtainwall, replace damaged louvers with new.
Various locations the louver fins are very soiled with dirt or a black soot like substance. (Figures 25, 26, 27).	Clean all louvers. Verify that air handling system filters are changed regularly as part of a defined system maintenance plan.  Evaluate condition of adjacent site to eliminate sources of airborne dust and contamination.
Various louvers have degraded and cracking caulk around the perimeter of the louver frame (Figures 25, 27).	Undertake a building-wide caulking maintenance and replacement program, identifying and replacing all sealant joints that are deteriorated.

*Figure 24—Louver damage at curtain wall*

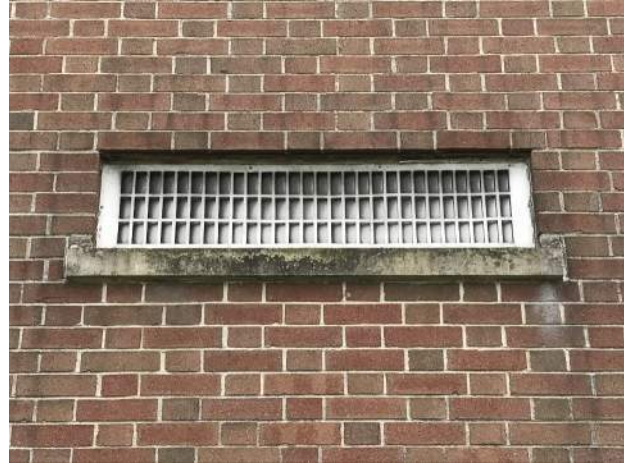
*Figure 25—Stained and dirty lower fins*

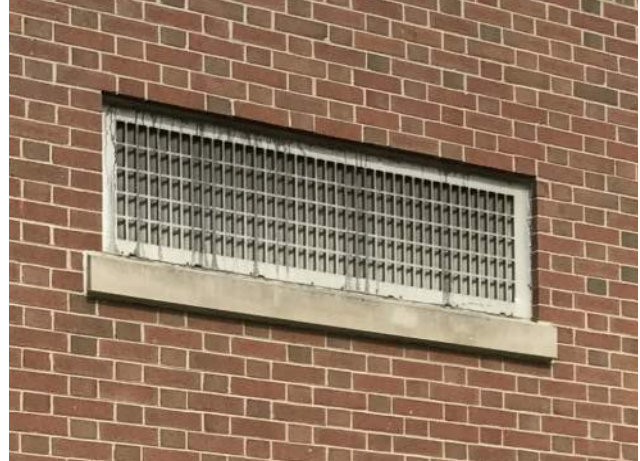
*Figure 27—Stained and dirty louver*

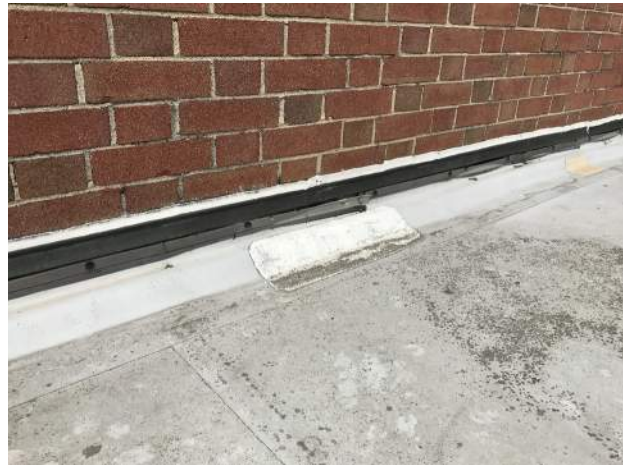
*Figure 31– Lifting and damaged termination bar*

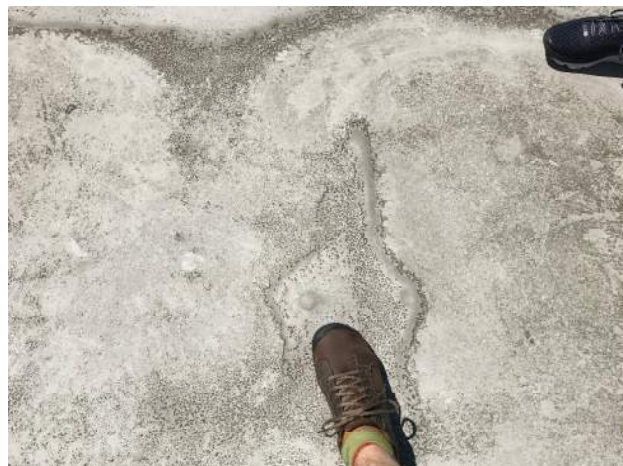
*Figure 33– Visible mech. fastener through membrane*

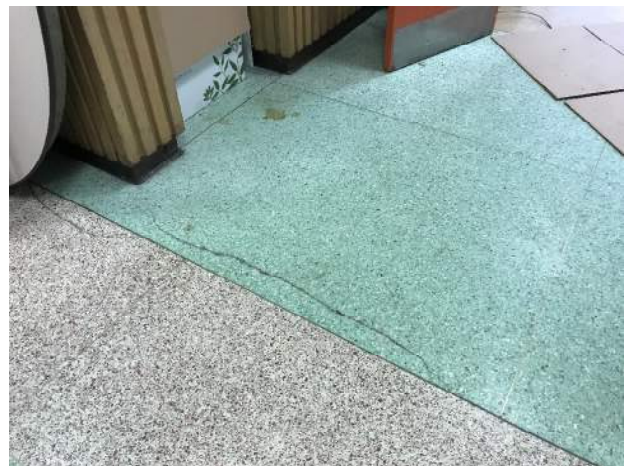
*Figure 41—Crack in terrazzo floor*

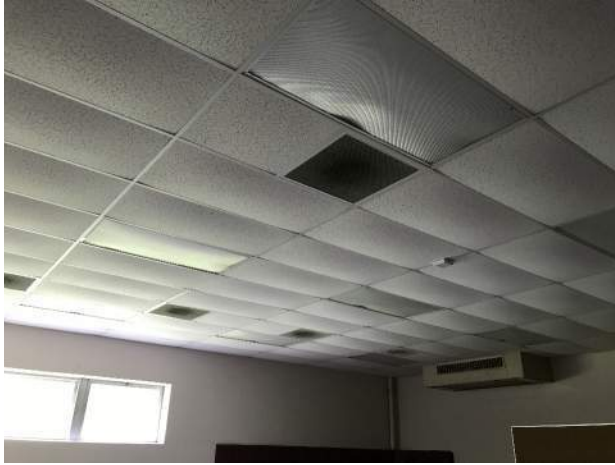
The ACP ceiling panels throughout the building are beyond their expected service life, and exhibit significant sagging from humidity. Some tiles are no longer supported by the grid members. Several tiles throughout are stained from water damage. (Figures 53, 54, 55, 56, 57).	Replace acoustic panel ceilings throughout the school with new humidity resistant panels in grids that are corrosion resistant.
In all the bathrooms and wet areas the ceiling tile and grid system is not humidity resistant (Figure 58).	Replace ceiling grid and tiles with a moisture resistant grid and ceiling tile system.
The acoustic ceiling panels in the kitchen are a mix of styles, including moisture susceptible fissured type panels that are not washable.	Replace acoustic ceiling panels throughout the kitchen with a system with washable panels in a grid system that is corrosion resistant and approved by the USDA for use in commercial kitchens.

*Figure 53—Sagging ACP ceiling*

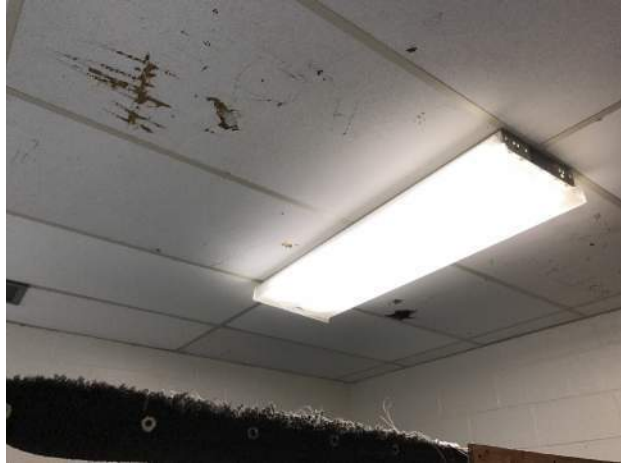
*Figure 54—Sagging and damaged ACP ceiling*

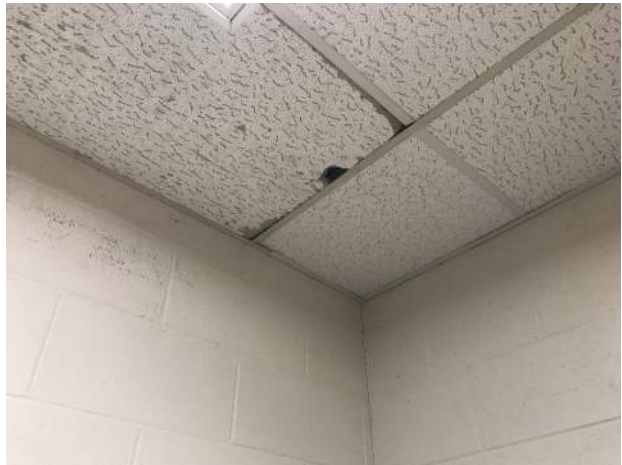
*Figure 56—Damaged ceiling tile typical*

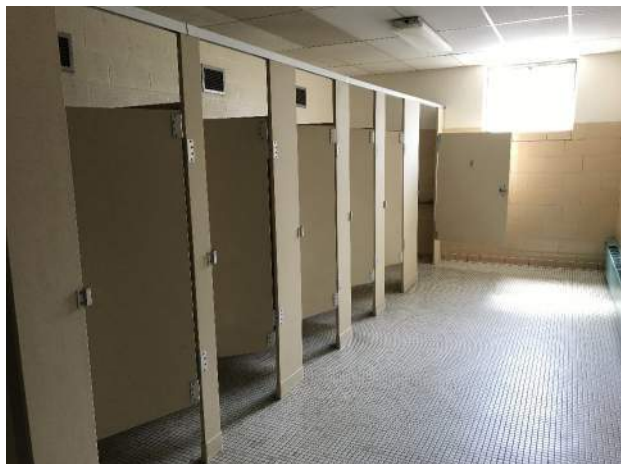
*Figure 58—Current non moisture resistant grid and tile*

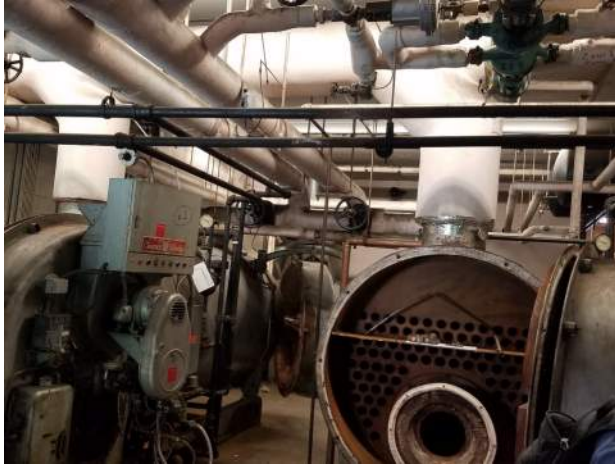
*Figure 1*

All insulation associated with the Heating Hot Water system may contain asbestos.	Test and abate all insulation as required.
Abandoned fuel-oil system may be a cause for pollution concerns beneath the ground.	Remove/ test fuel-oil system as required to alleviate all concerns of pollution.
The hot water heating plant and all associated components are antiquated and beyond their expected service life.	Provide new high efficiency hot water heating plant.

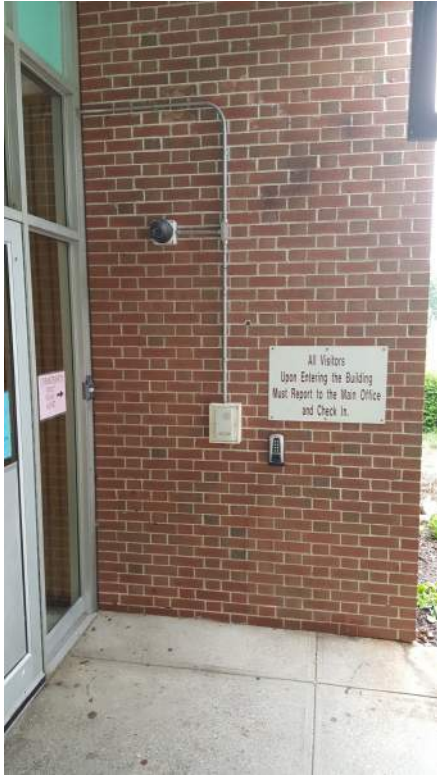
Possible lack of coverage by surveillance system cameras and alarm system motions sensors on the first floor.	Increase the number of cameras and areas of coverage as required or needed. Adjust and modify with additional motion sensors to first floor areas for greater intrusion detection. Maintain system software assurance for best return on investment.
---	--

*Figure 21— Entrance Security*

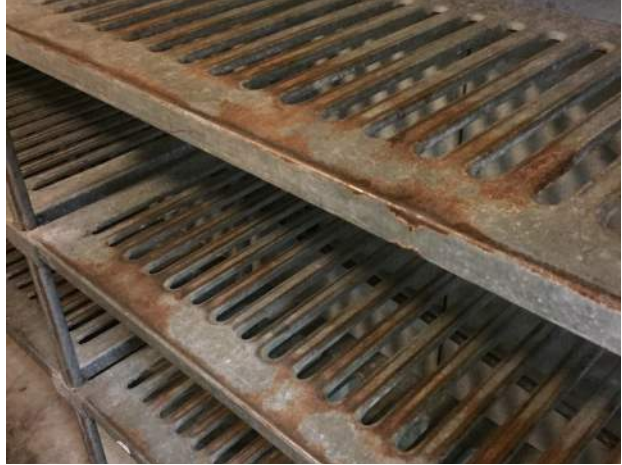
*Figure 2—Walk-in cooler corroded shelving*

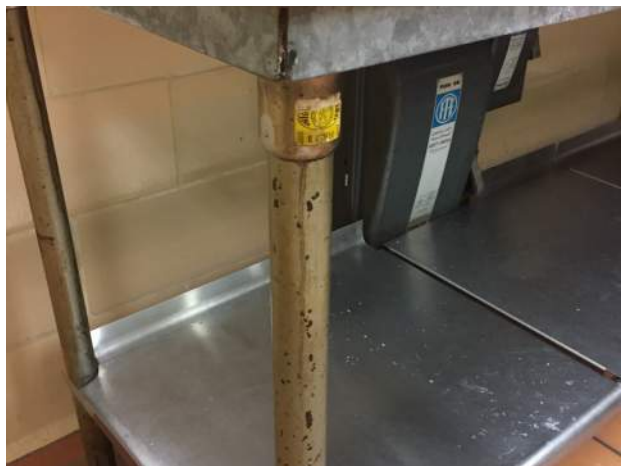
*Figure 6— Galvanized and corroding table bases*

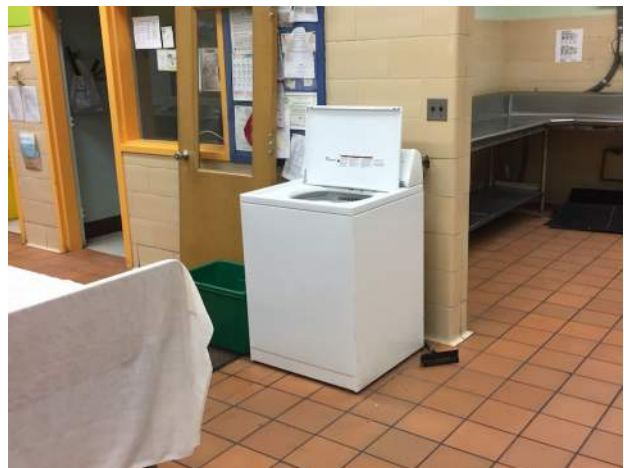
*Figure 12— Clothes washer in food preparation space*

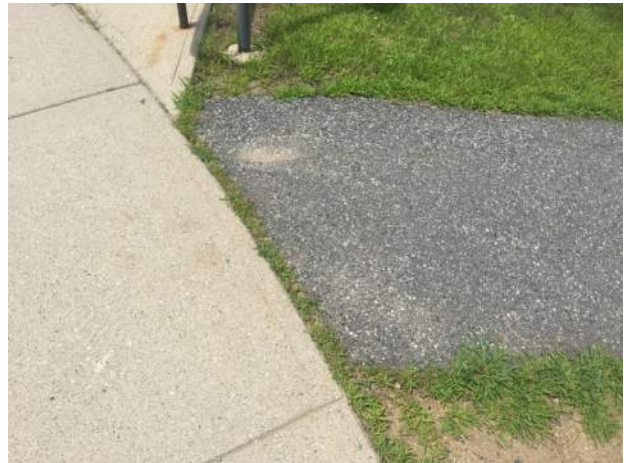
*Figure 34—Gap at union of sidewalk materials*

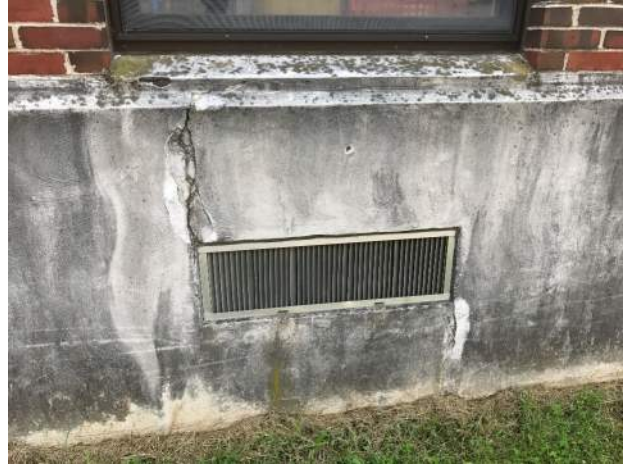
*Figure 2—Cracking at unit vent grille*

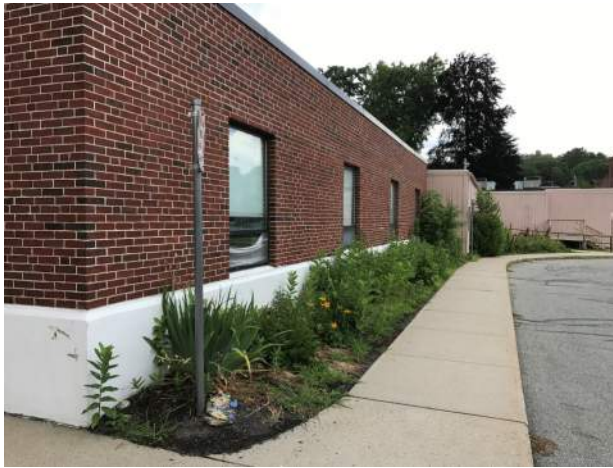
*Figure 18—Non thermally broken windows*

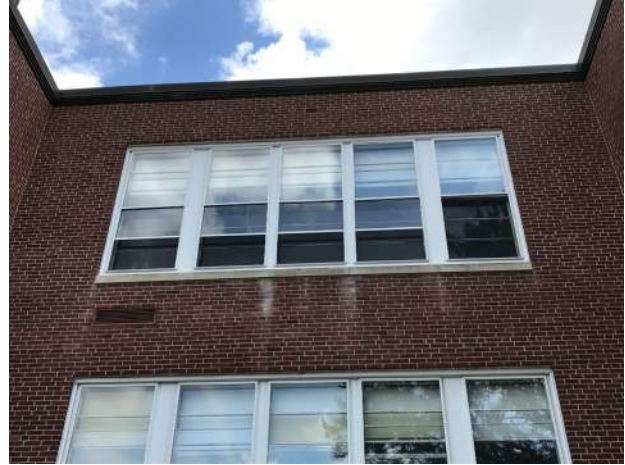
*Figure 28—Degraded paint on louvers @ '52 building*

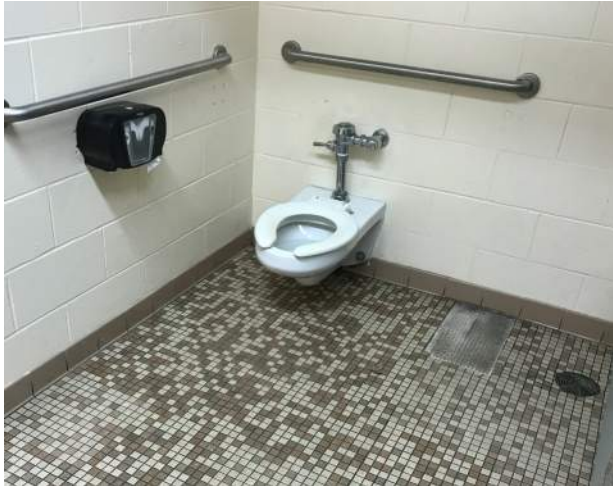
*Figure 42— Area of missing mosaic tile*

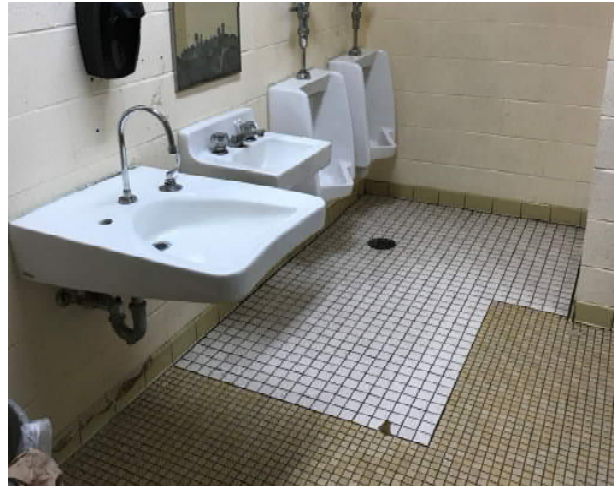
*Figure 43—Large area of mismatched tile*

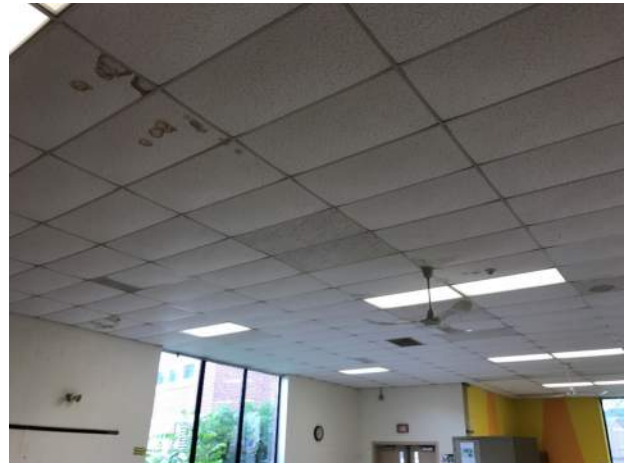
*Figure 57—Sagging & stained ceiling panels.*

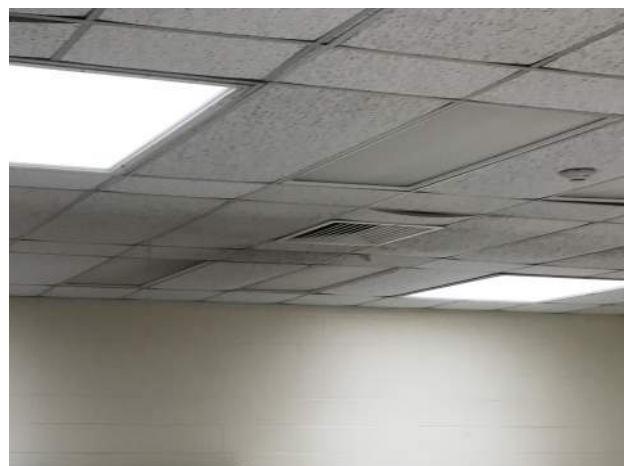
*Figure 59—Soiled ceiling panels at return grilles*

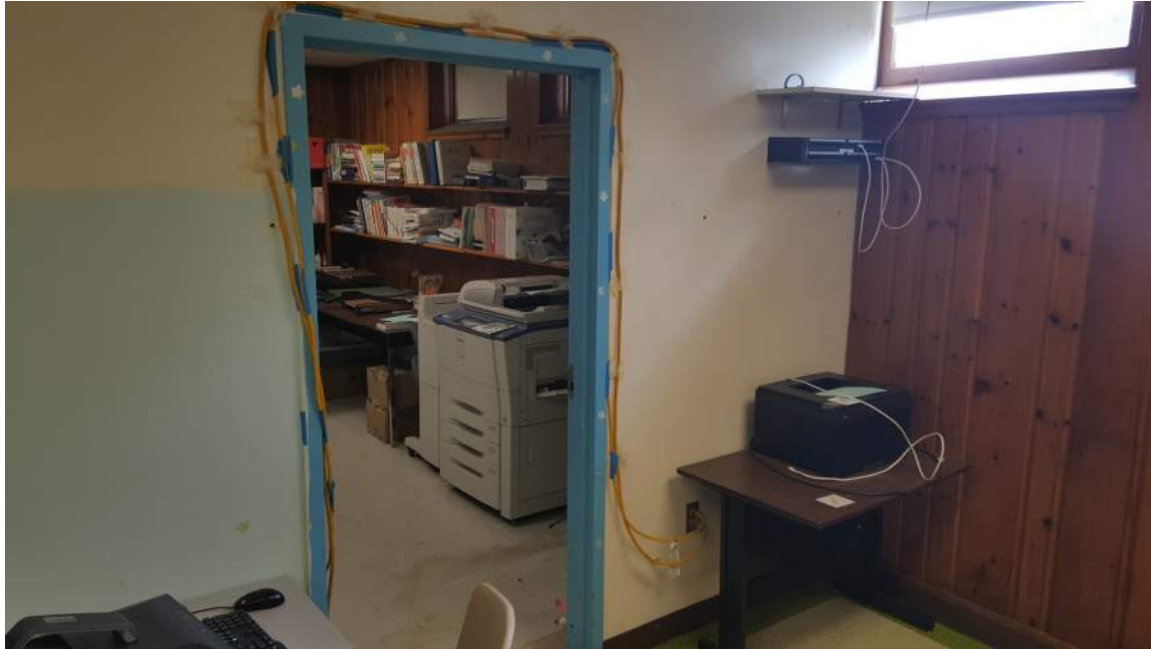
<i>Specific Issues</i>	<i>Recommendations</i>
The 5400zl series chassis have reached end of life with HP as of December of 2015.	Upgrade and replace the 5400zl series with the newer 5400R series of chassis switches. Existing Switches can be redeployed elsewhere as long as they are working condition. Chassis switches should be equipped with SFP+ fiber optic modules, GbE and Gb PoE network ports and management modules. Minimum backbone optics between MDF and IDF should be based on 20GbE.

*Figure 1-IDF showing insufficient power distribution for equipment*
