COMMUNITY FORUM 1 AUGUST 1, 2017

Northbridge Public Schools

- 1. What is a Feasibility Study? Who is the MSBA?
- 2. Schedule and Process
- 3. Educational Planning & Visioning...so far
- 4. Existing Conditions at Balmer and Northbridge Elementary
- 5. Preliminary Assessments of Possible Sites
- 6. Questions, Comments, Feedback

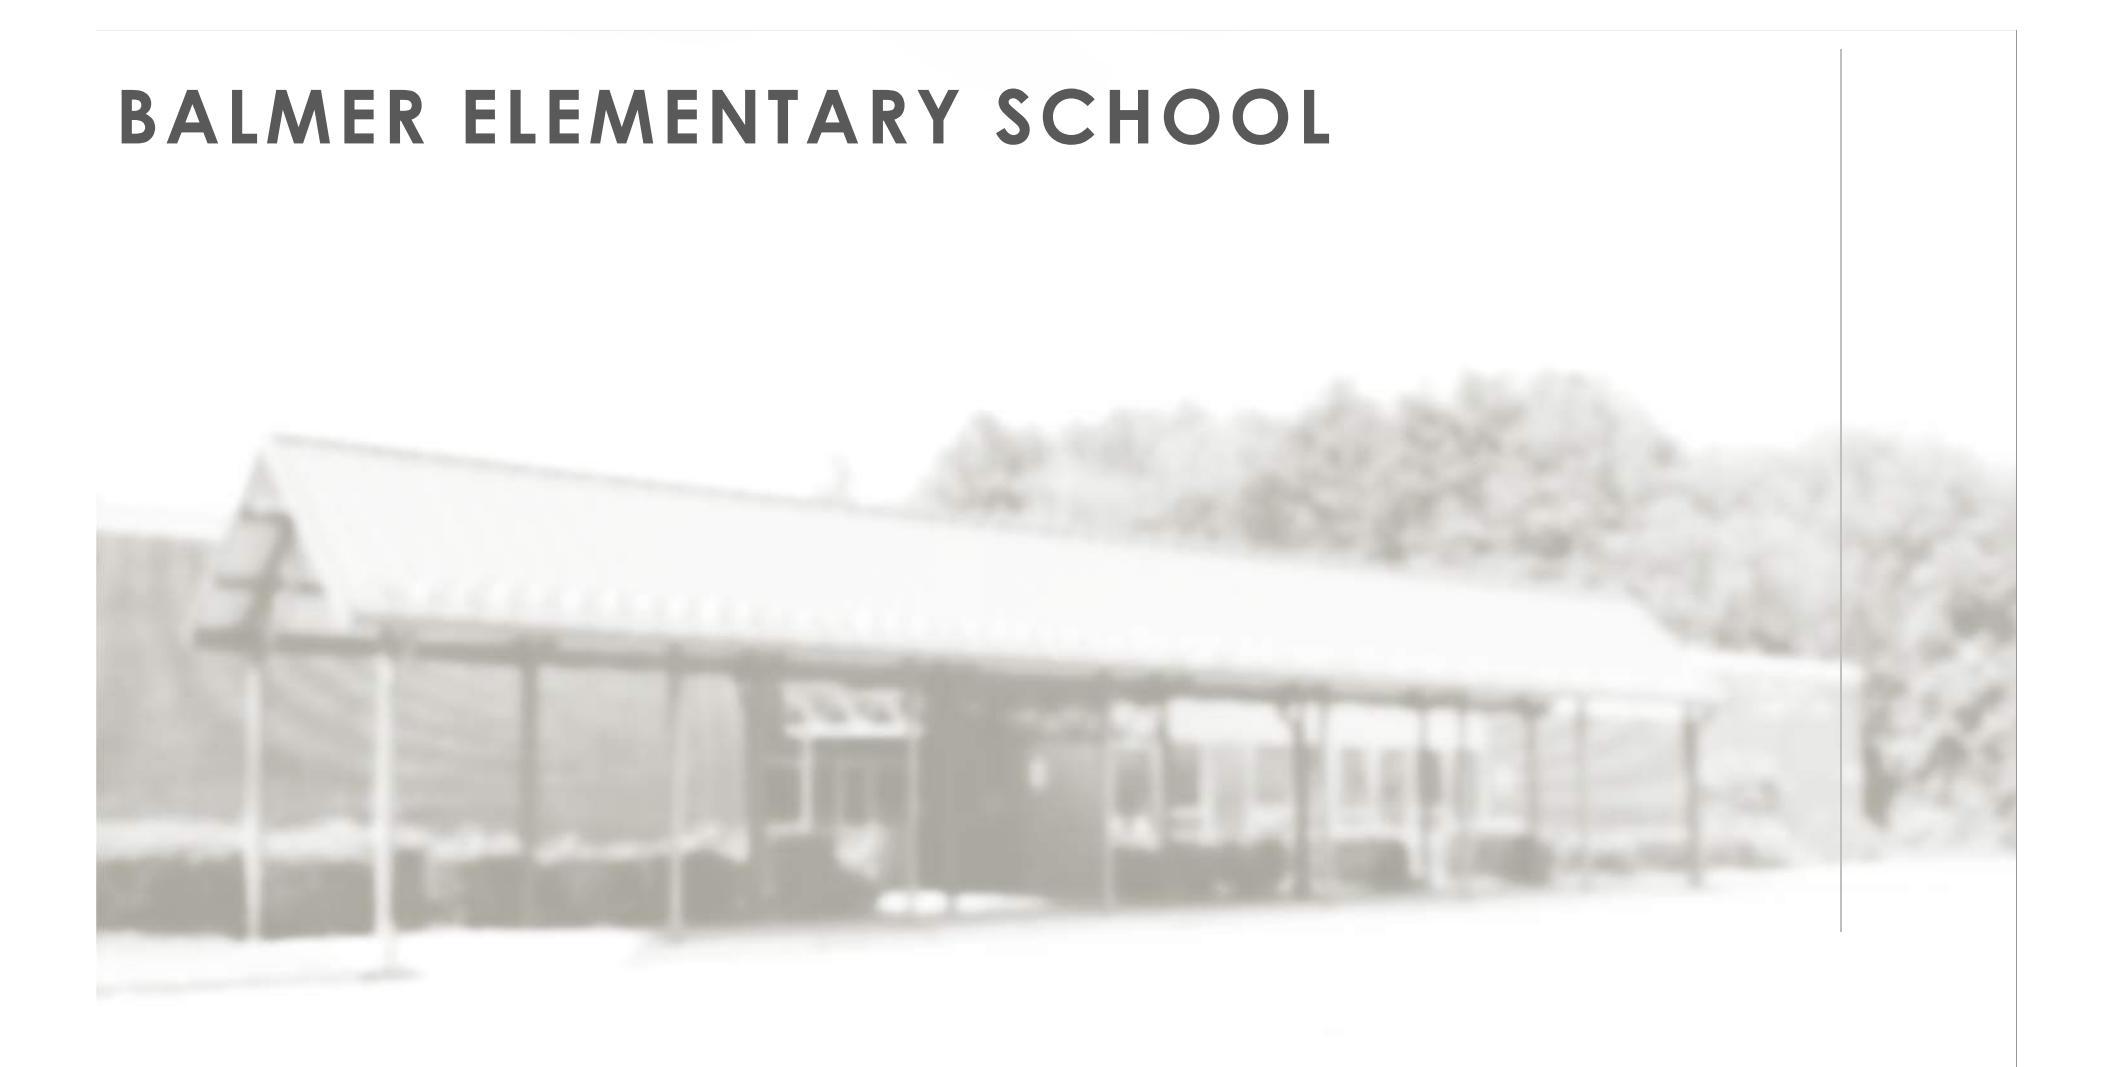
Site Issues

- One entry/exit
- Traffic
- Circulation
- Parking
- Paving
- Accessibility

Civil/Drainage

- Poor drainage
- Stormwater standards
- Erosion

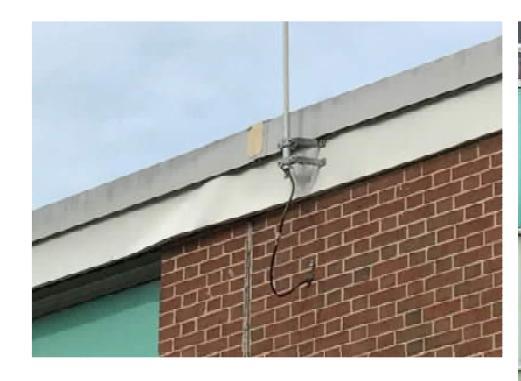
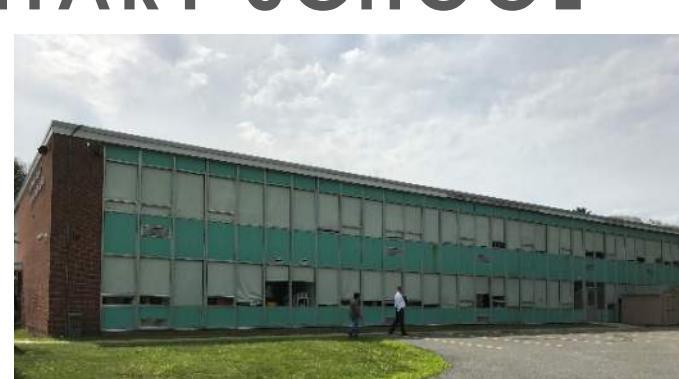
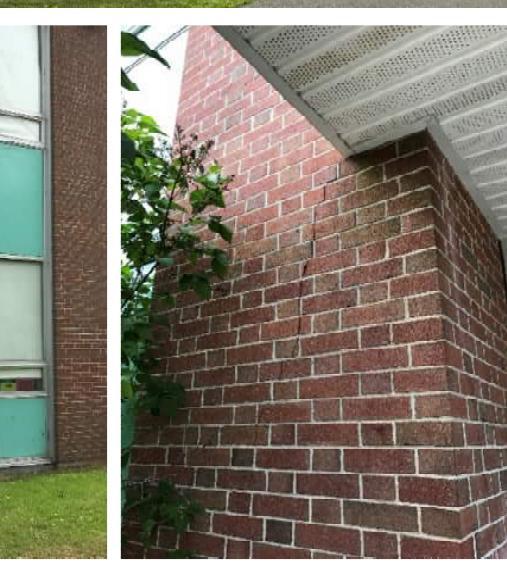
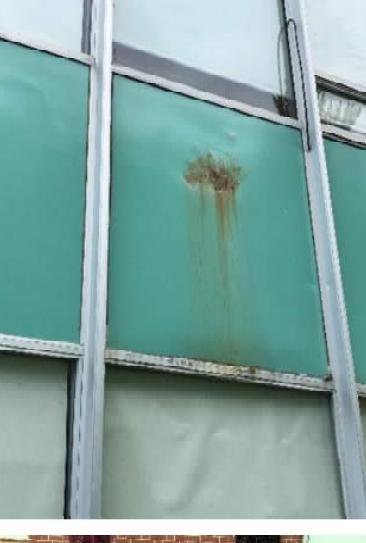
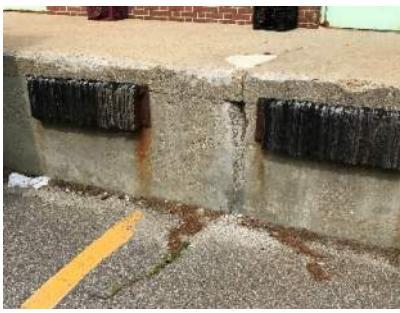
Architectural Issues

Built 1968

- Windows/ Curtain Wall
- Exterior Walls
- Foundation Walls

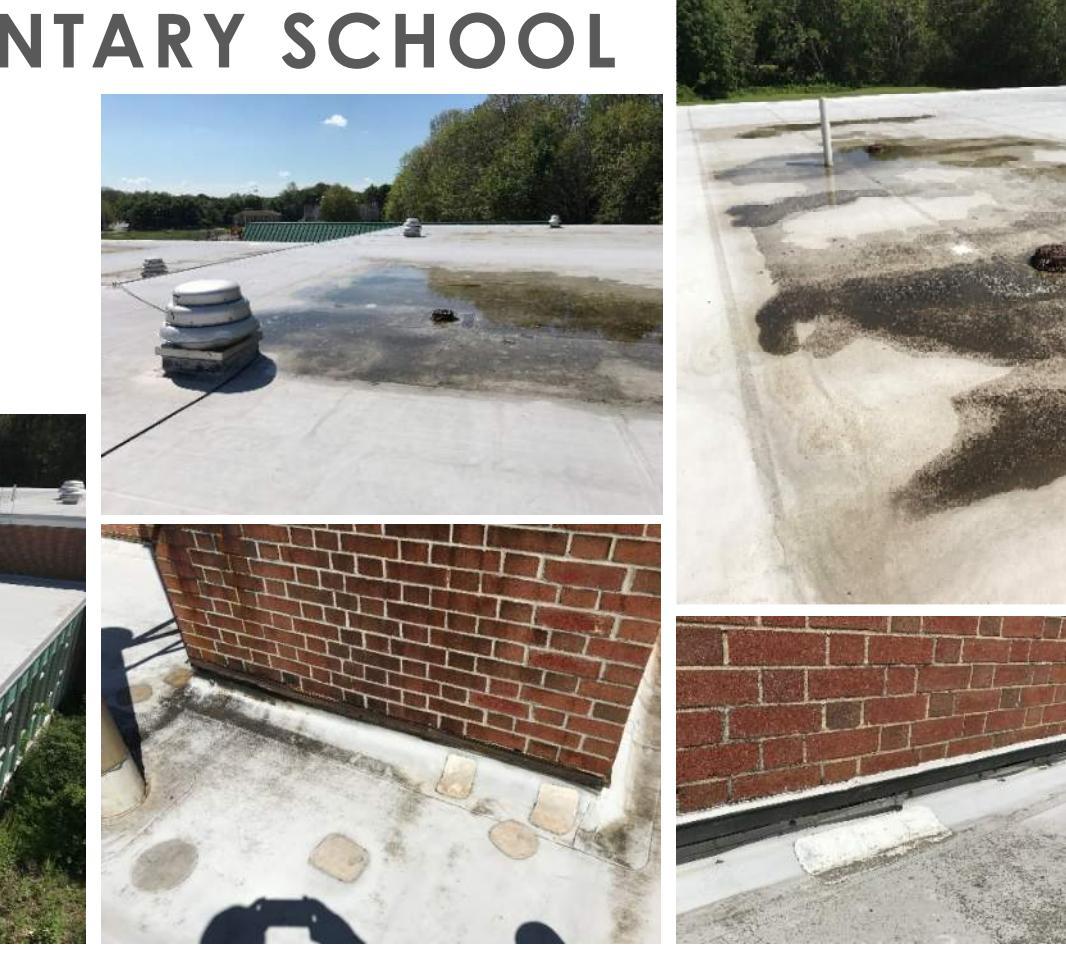
Architectural Issues:

• Roof

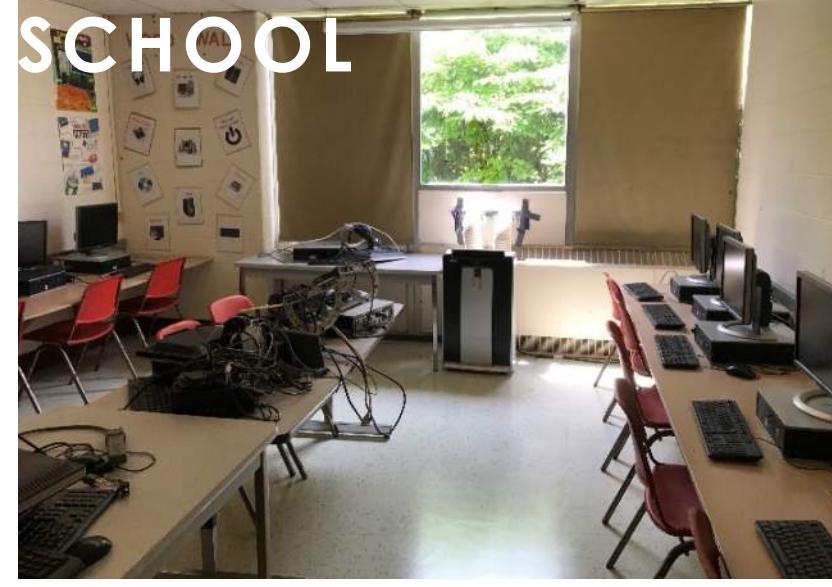
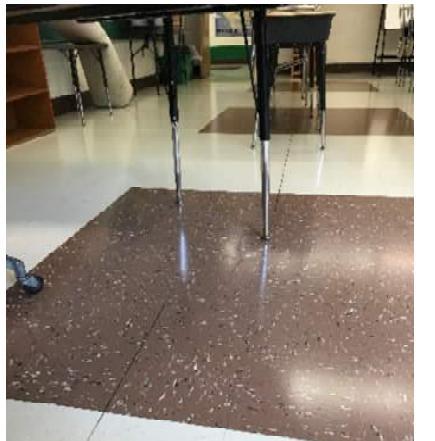
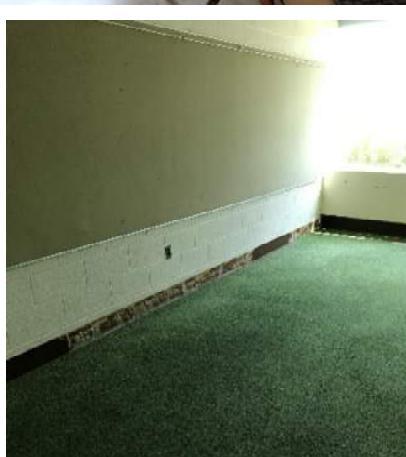
BALMER ELEMENTARY

Architectural Issues:
Interior Environment:

- Summer condensation
- Mold/mildew
- General lack of temperature control
- Drafty, leaky envelope
- Single-glazed window:

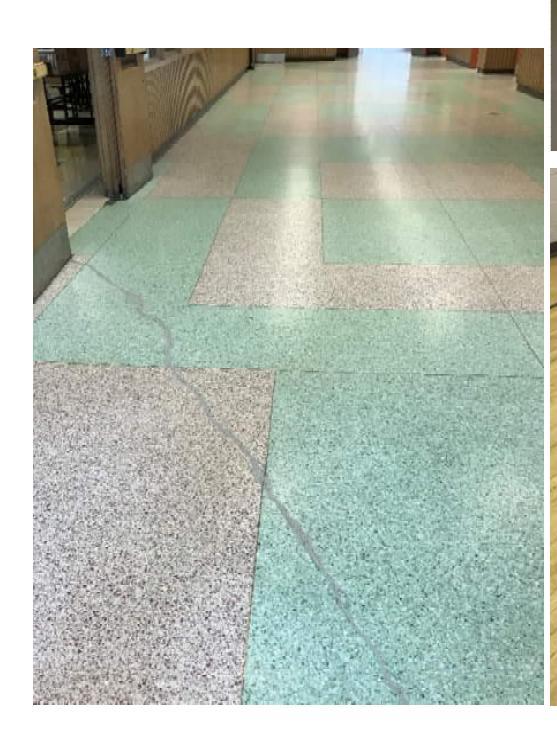
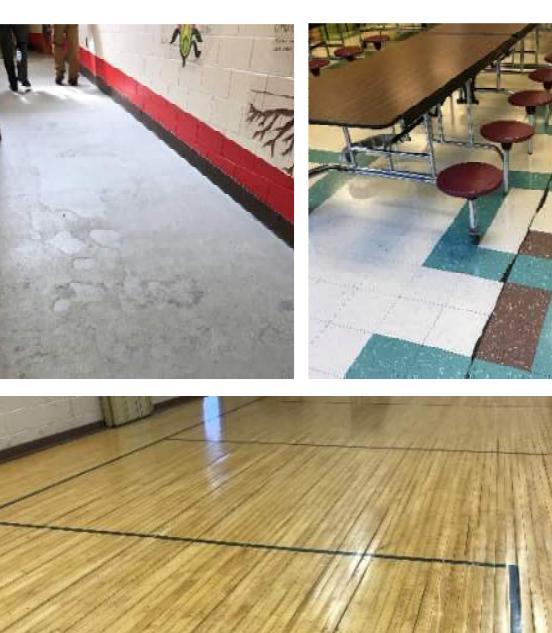
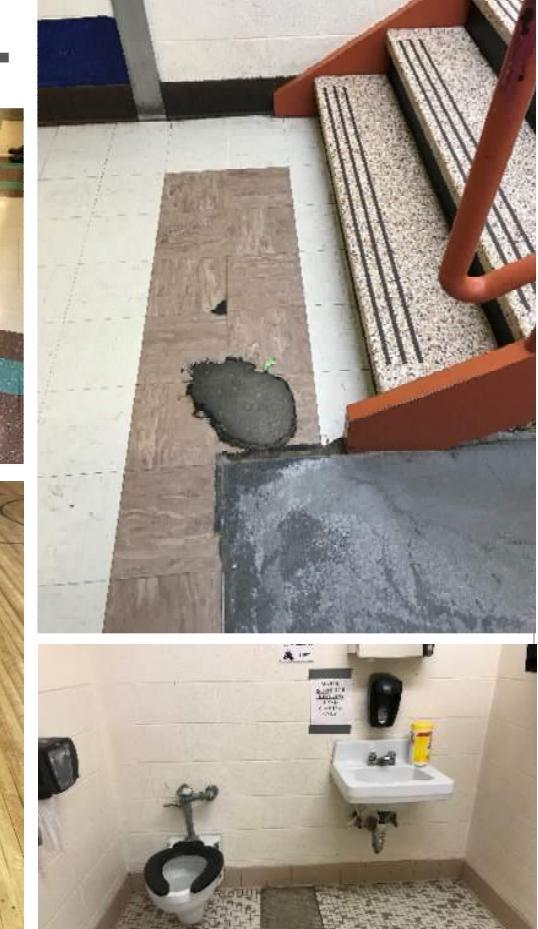
Architectural Issues:

• Floors

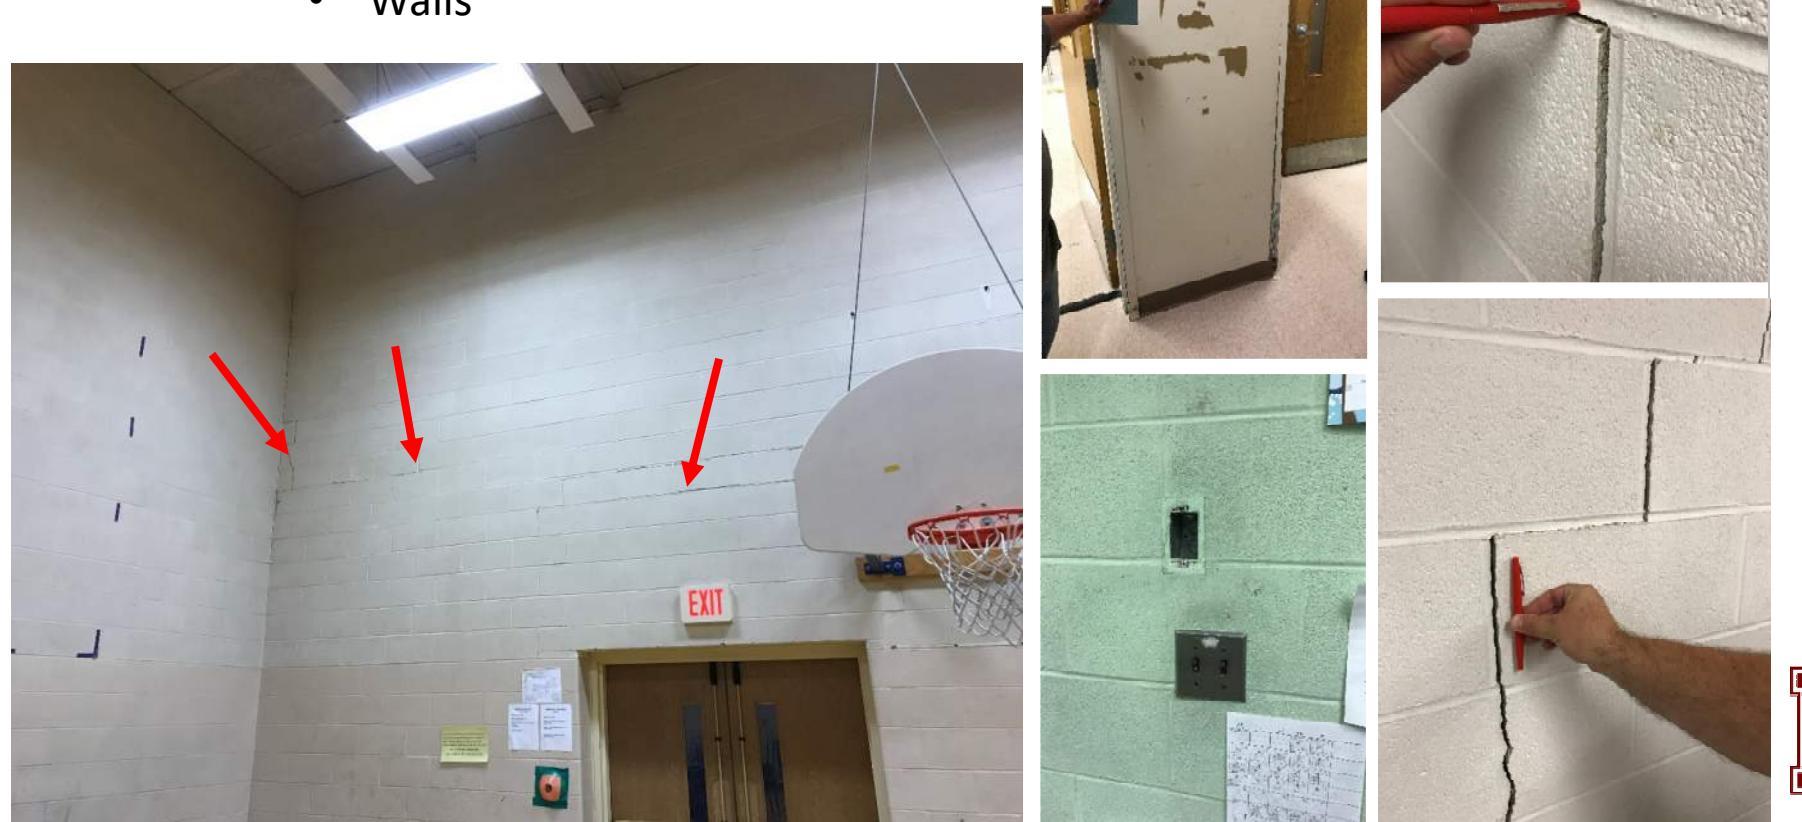
Architectural Issues:

• Walls

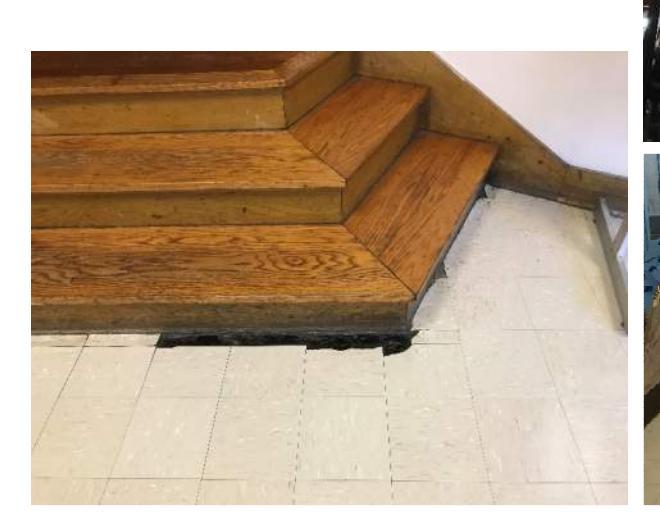
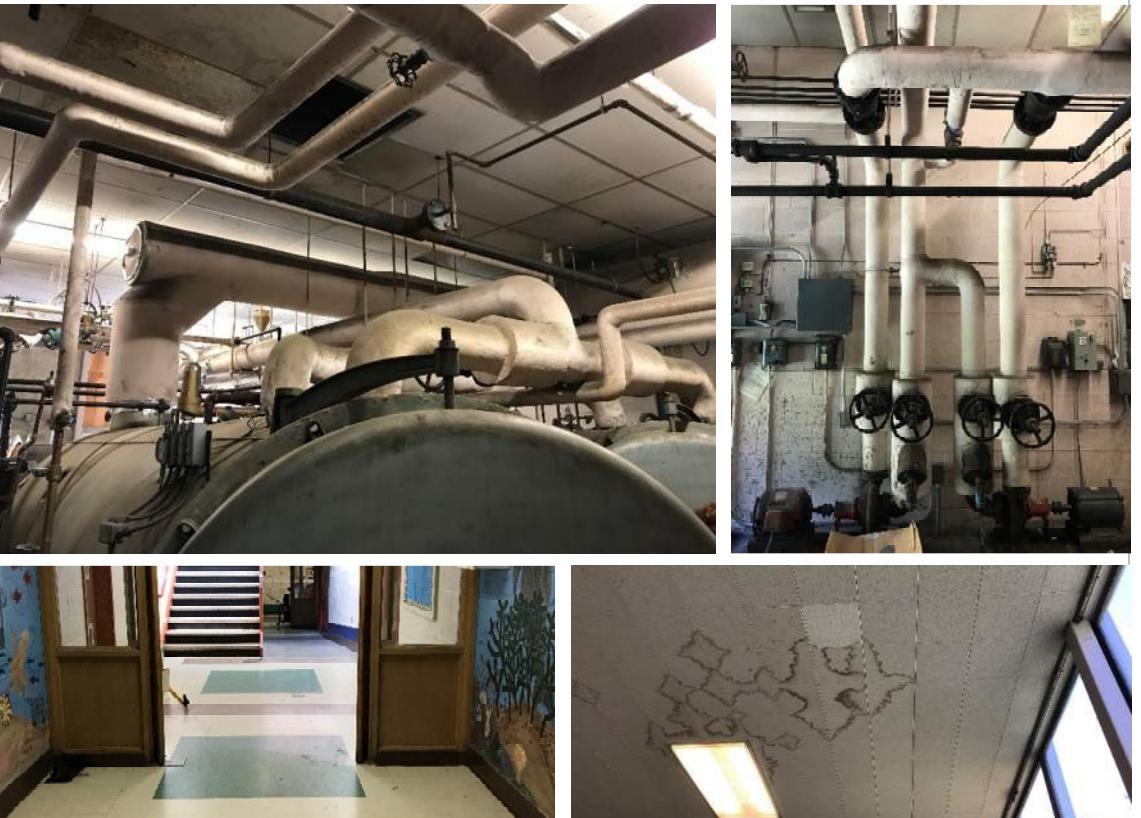
Hazmat Issues

- *VAT*
- Pipe insulation
- Some ceiling tiles
- Adhesives Lab results pending

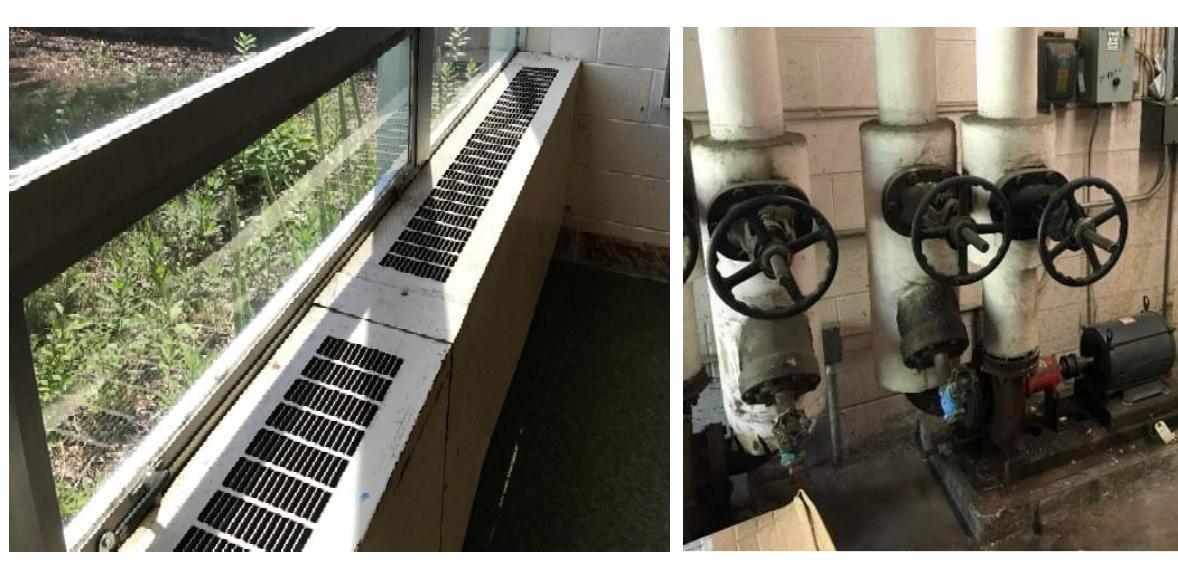
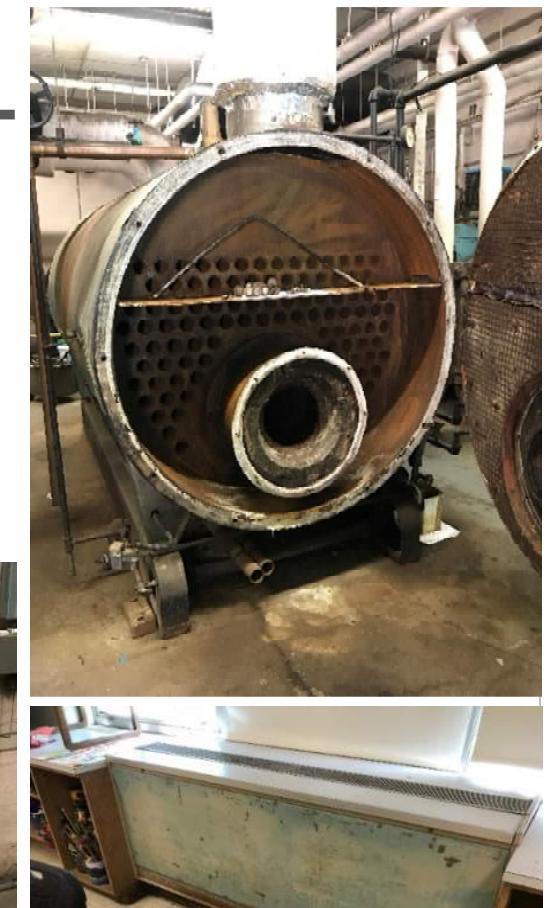
Mechanical Issues:

- HVAC systems far beyond expected life
- Need better efficiency and control
- Noisy, inefficient, hard to get parts
- Inadequate ventilation
- Poor temperature control

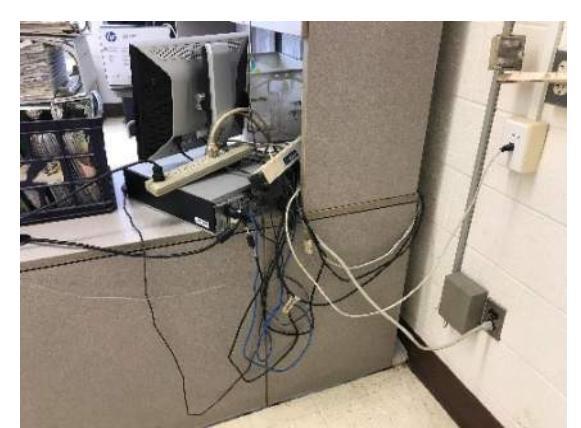
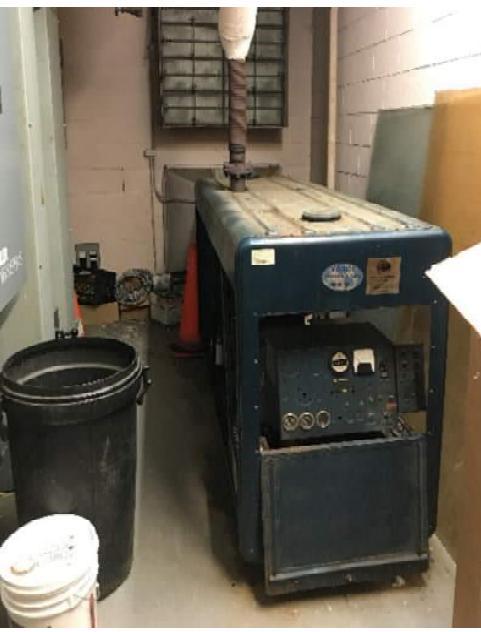
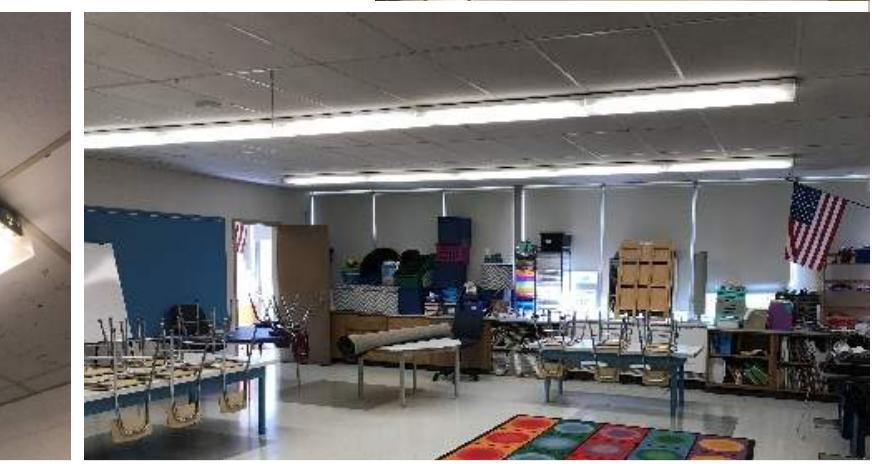
Electrical Issues:

Systems **far beyond** expected life, should replace:

- Fire alarm
- Generator
- Life Safety lighting
- Switch gear, wiring, panels
- GFI outlets
- Paging system
- Lighting
- Telephone

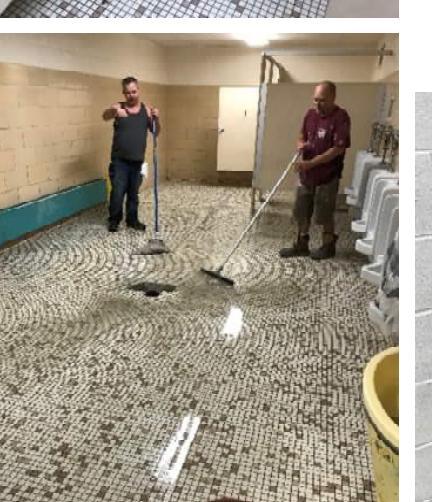
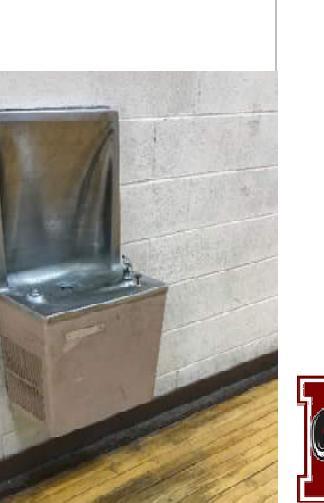
Plumbing Issues:

- Tap water
- Fixtures
- Accessibility
- Water Pressure
- Floor drains
- Roof drains

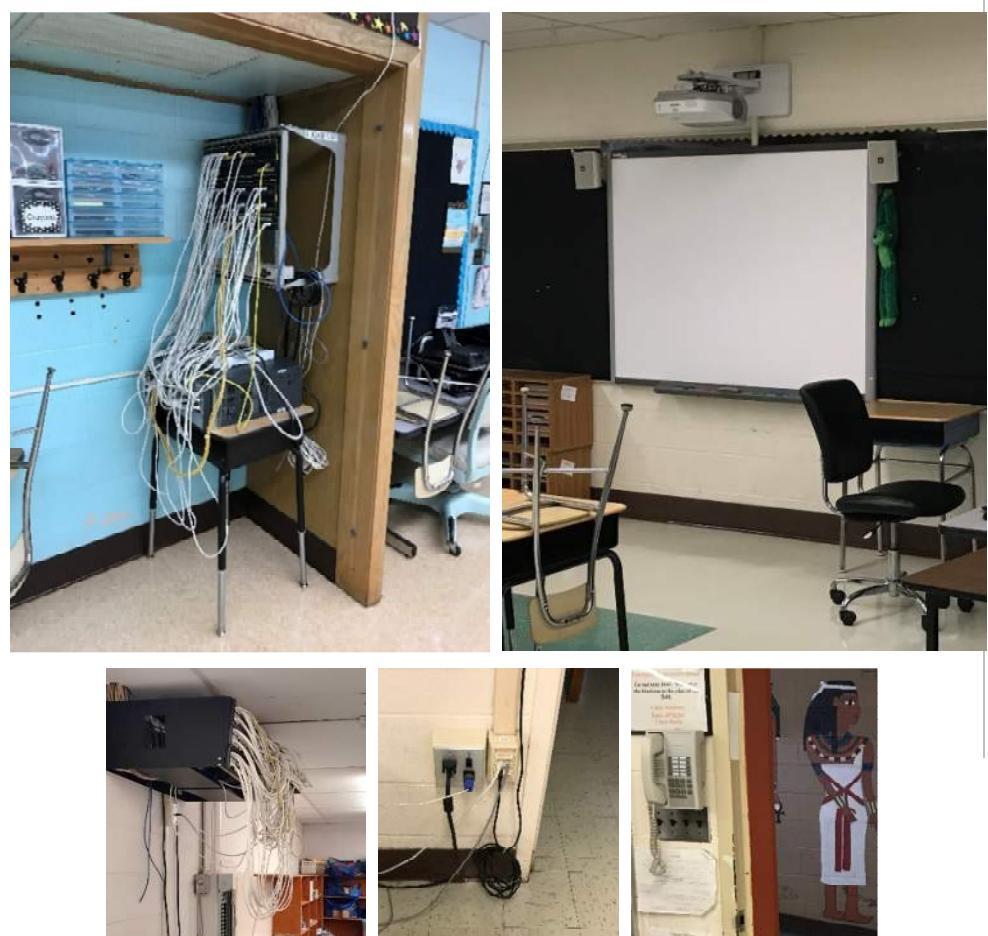
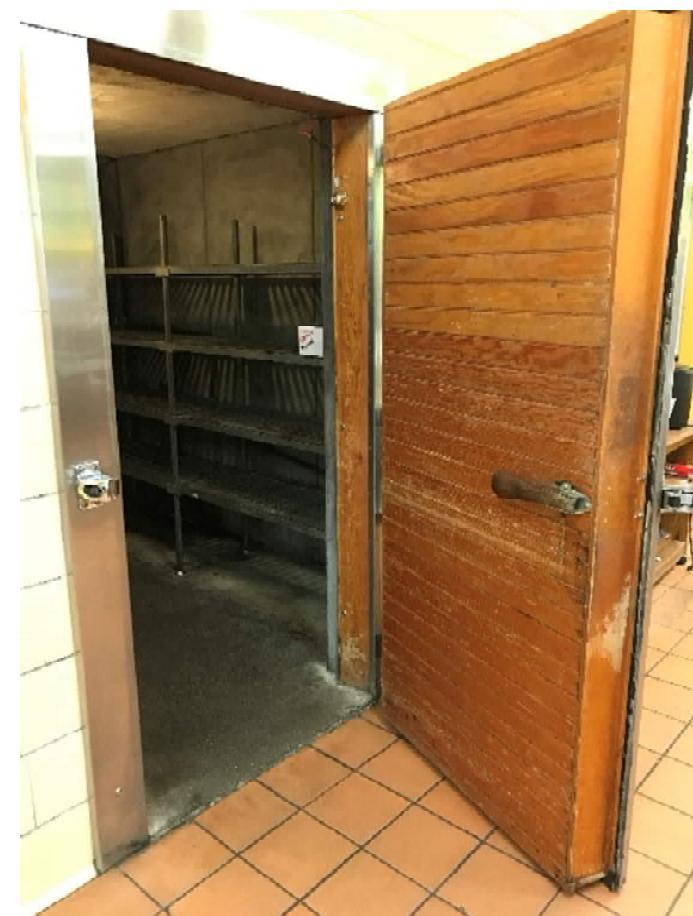
Technology Issues:

District tech initiatives moving in the right direction; however need to upgrade:

- IT Room, racks
- Network hardware
- Cabling to Cat 6E
- Interactive boards
- Security systems
- Laptop carts

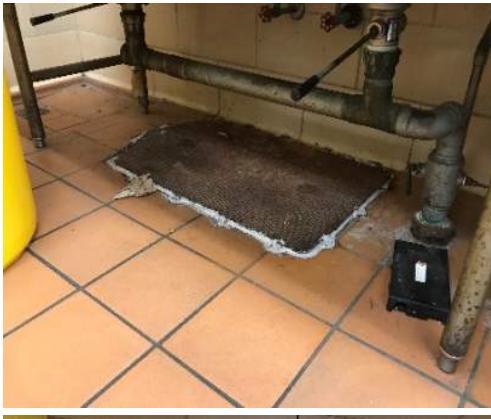
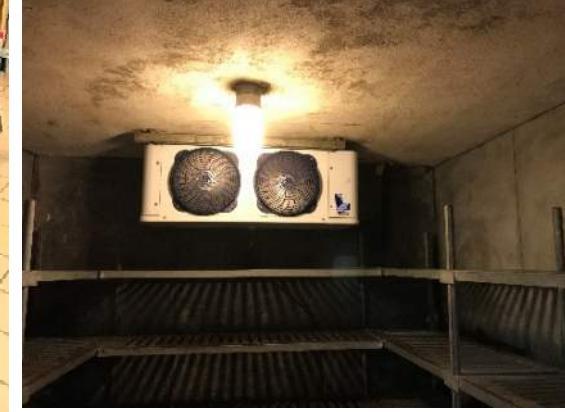
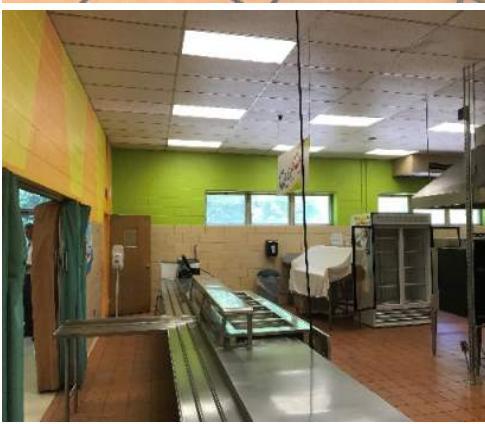
Kitchen Issues:

- Code violations
- Aging, inefficient equipment
- Service concept

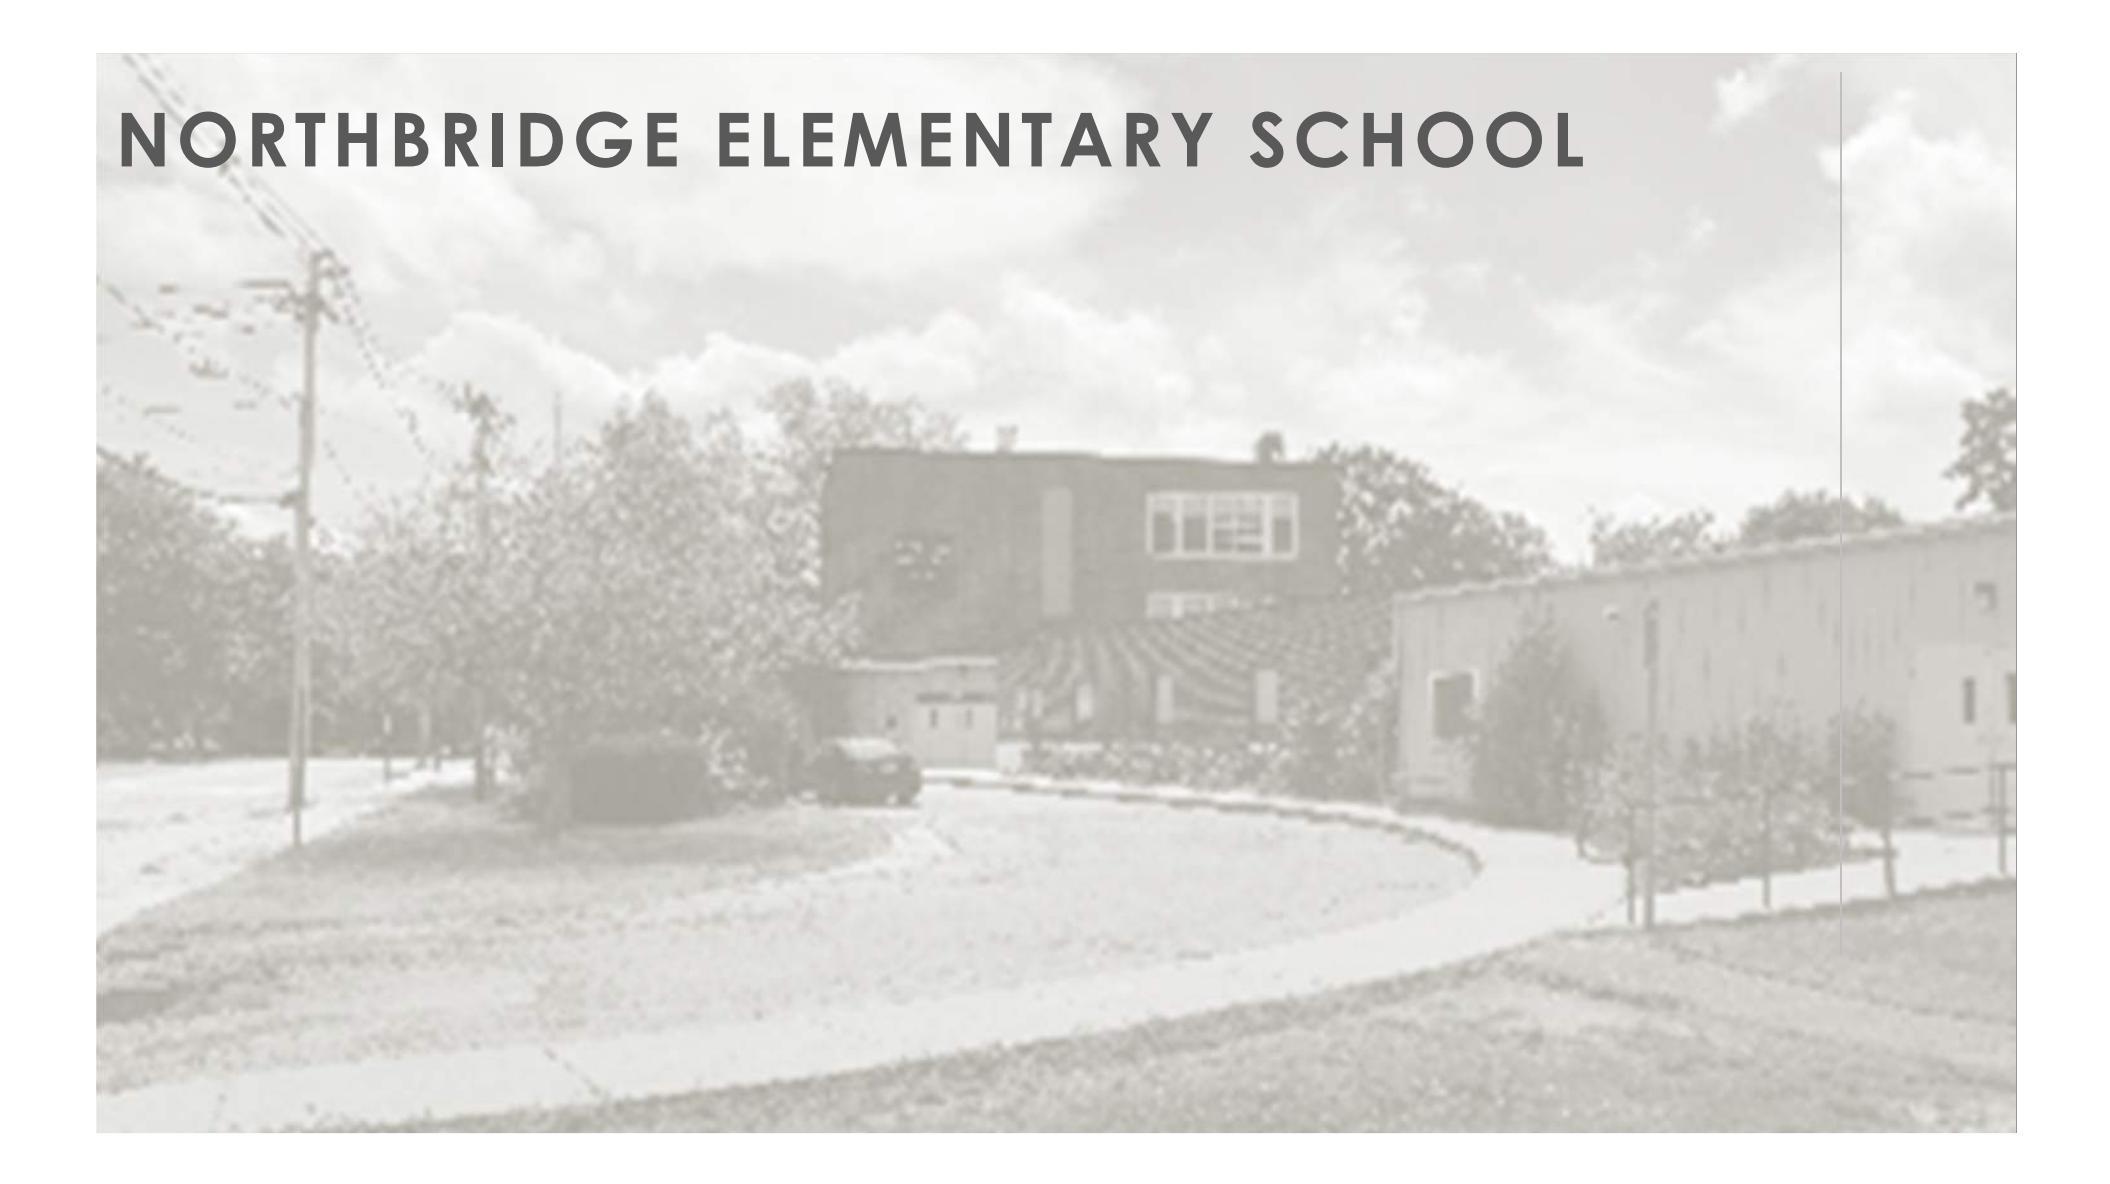
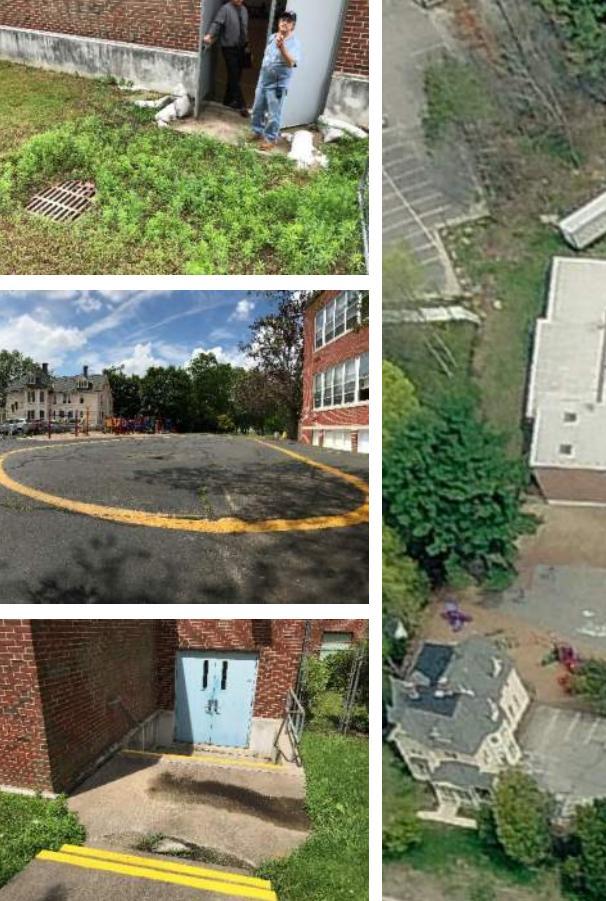
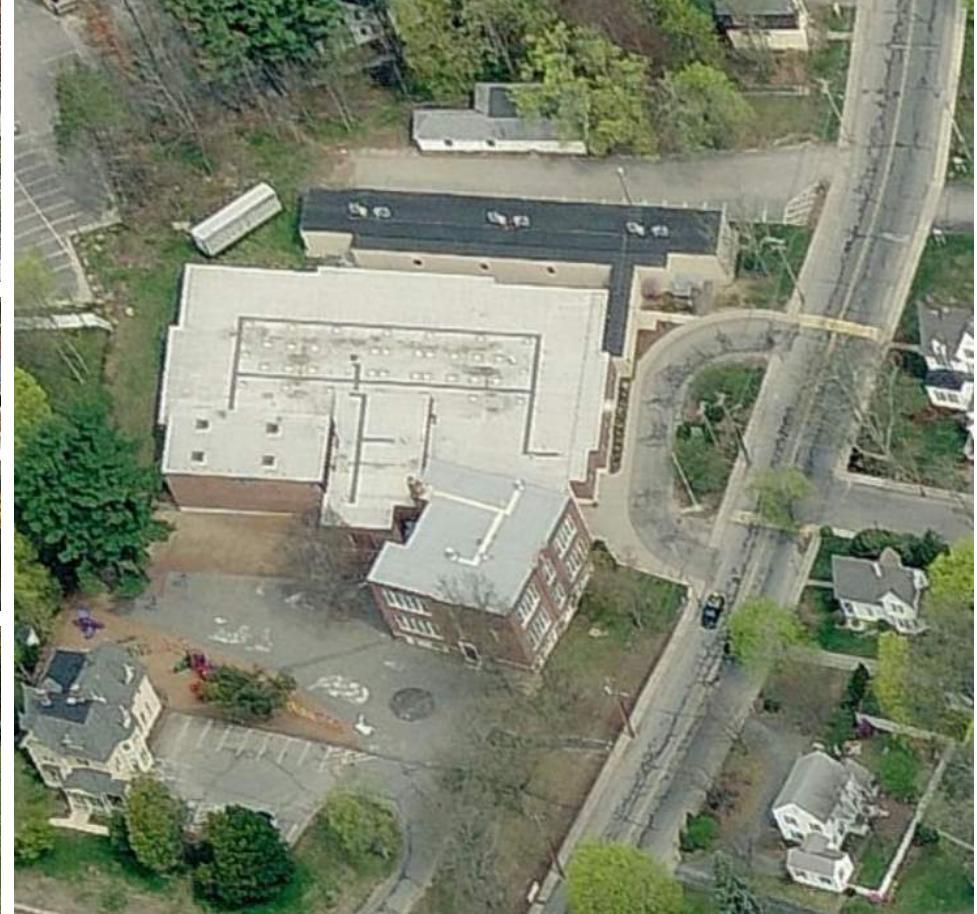
Site Issues

- Tiny loop
- Traffic
- Circulation
- Parking
- Paving
- Accessibility
- Leased Land
- No play fields

Civil/Drainage

- Poor drainage
- SW standards
- Erosion

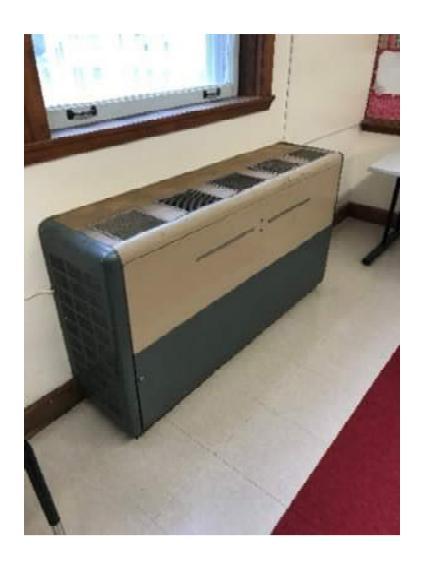
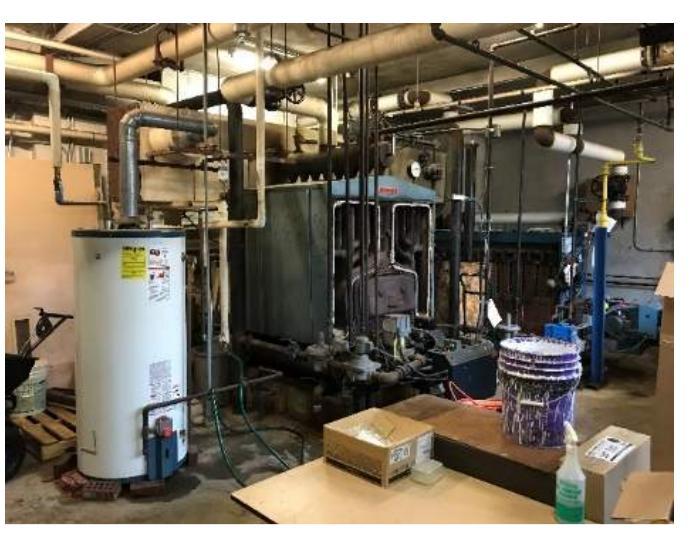
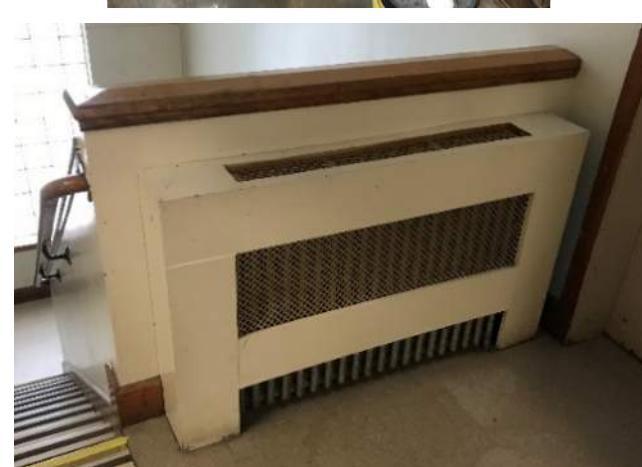
Mechanical Issues:

- HVAC systems far beyond expected life
- Need better efficiency and control
- Noisy, inefficient, hard to get parts
- Inadequate ventilation
- Poor temperature control

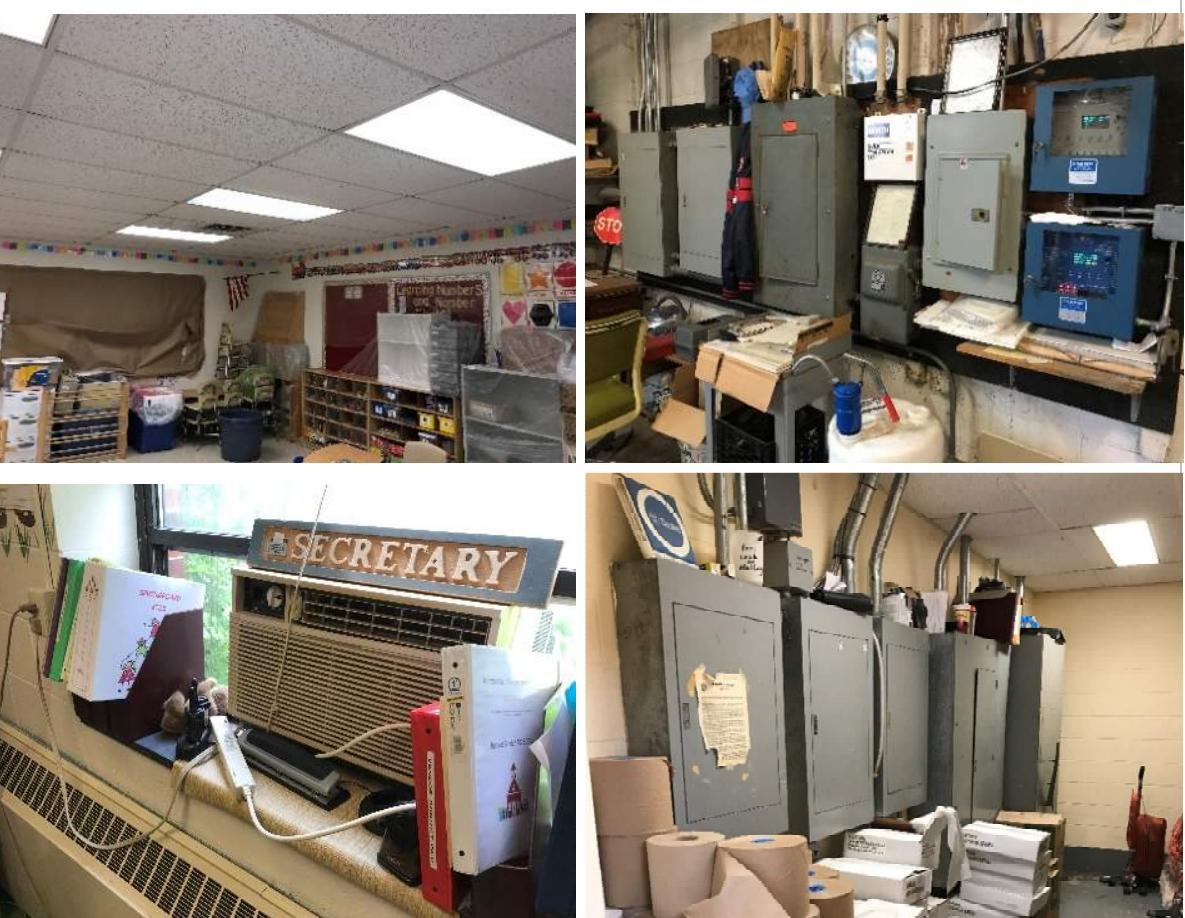
Electrical Issues: *Systems far beyond expected life, should replace:*

- Fire alarm
- Generator
- Life Safety lighting
- Switch gear, wiring, panels
- GFI outlets
- Paging system
- Lighting
- Telephone

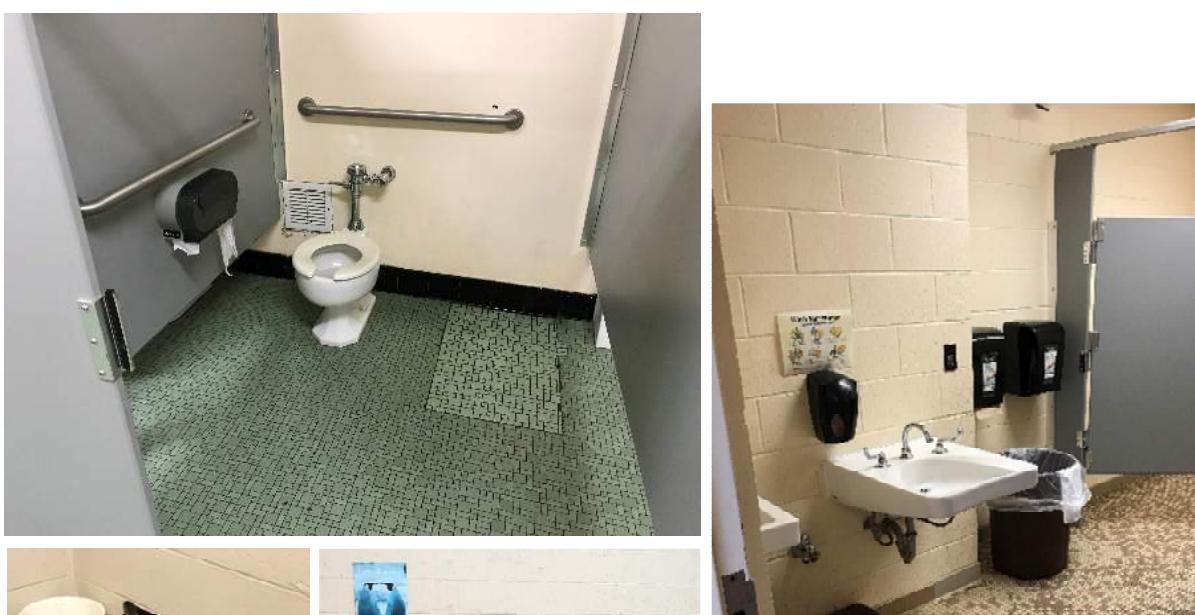
Plumbing Issues:

- Tap water
- Fixtures
- Accessibility
- Water Pressure
- Child Size Fixtures
- Backflow
- Leaks

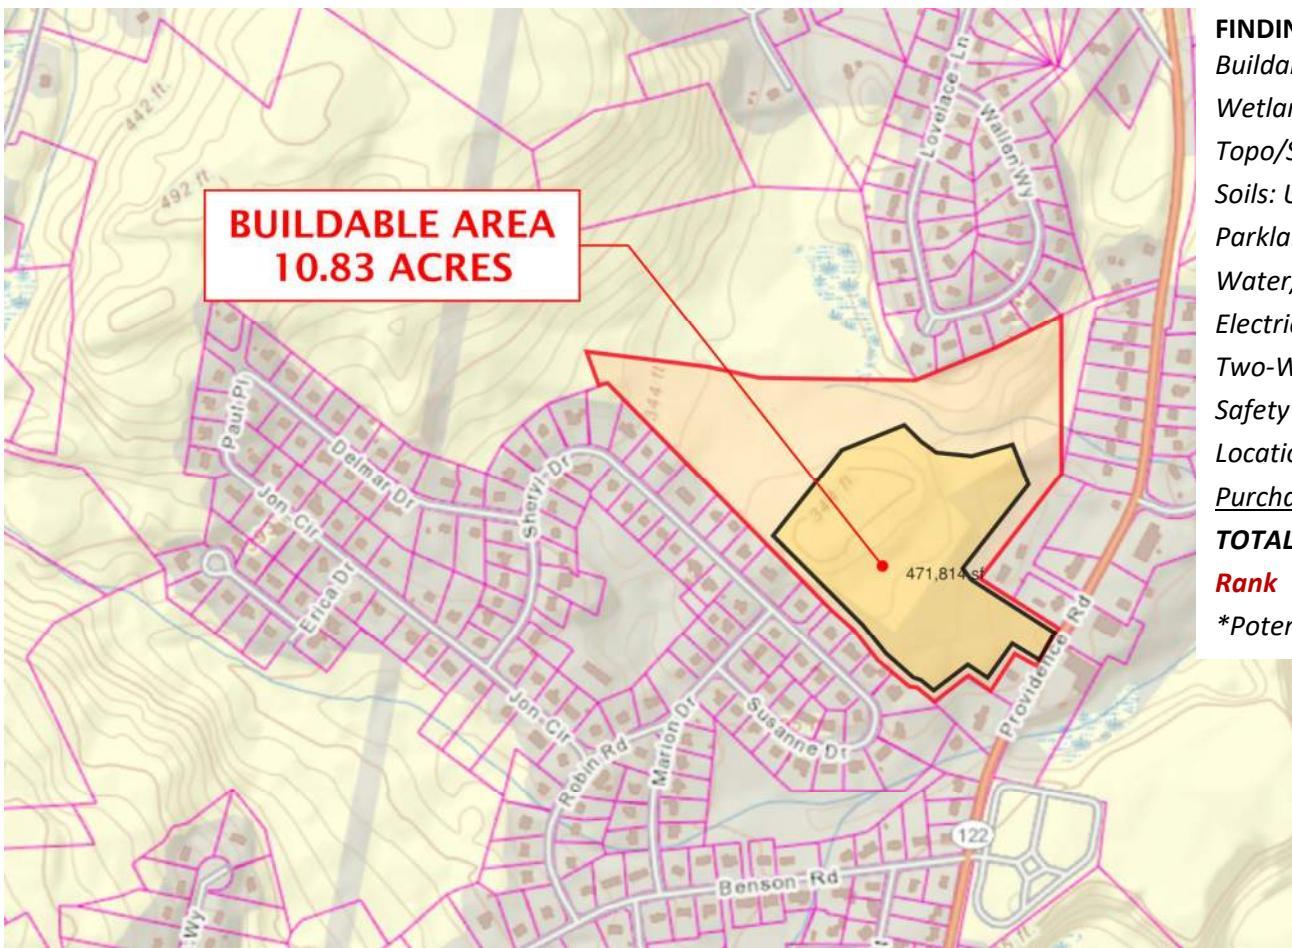
RIVERDALE MEMORIAL FIELD

Buildable site: 10.83 acres	3
Wetlands/ Riparian/ Flood	4
Topo/Slopes	3
Soils: Underlying stony/ muck	2
Parkland/ Art. 97	1
Water/WW	2
Electric	2
Two-Way Access	0*
Safety	4
Location/Bussing	3
Purchase Price	4
TOTAL	28
Rank	4
*Potential fatal flaw
