# W. EDWARD BALMER ELEMENTARY SCHOOL

NORTHBRIDGE PUBLIC SCHOOLS  
TOWN OF NORTHBRIDGE, MASSACHUSETTS

## PRELIMINARY DESIGN PROGRAM, SECTION 3.1.4

### EVALUATION OF EXISTING CONDITIONS

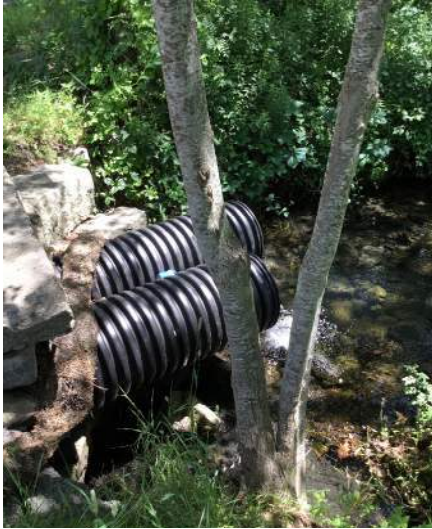
<p>Drainage Collection System: The existing drainage system includes a few catch basins and a non-standard drainage inlet structure (see figure A8) that connects to a pipe drainage system in Crescent Street that appears to ultimately discharge into the Bordering Wetlands associated with Arcade Pond at the corner of Crescent Street and Lake Street from two CPP pipes at a headwall See Figure A7. The discharge point appears to have recently been reconstructed based on site observations and the adjacent erosion controls that are still in place. The majority of the site drains overland toward Crescent Street. One field and one parking lot each appear to have a stone trench collection system along the edge.</p> <p>Street drainage system in Crescent Street appears to have been updated and is generally catch basin to manhole system. This also appears to discharge at headwall.</p> <p>Based on record plans the courtyard drains to the east under the building through a 14" cast iron pipe.</p>	<p>The existing drainage system does not comply with current standards or Massachusetts Department of Environmental Protection (MaDEP) requirements. In general the drainage system appears to be in fair to poor condition.</p>

*Figure A7: Discharge at Wetlands*

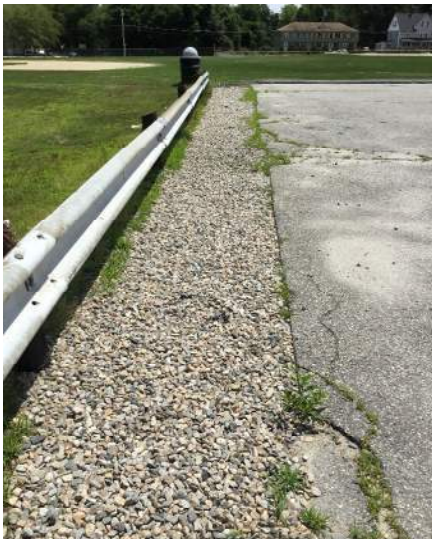
<p>Water Quantity Systems: No detention basins or infiltration systems were observed on site. There were crushed stone edges along one parking lot and one field. This may be an infiltration or collection system. Not shown on any records plans received. See Figures A9 and A10.</p>	<p>Stormwater design for a new school will require to meet MaDEP Stormwater Standards at a minimum.</p>
<p>Water Quality Systems: No water quality structures or Low Impact Development (LID) approaches were observed on site. There may be some water quality treatment in areas where the surface runoff flows over.</p>	<p><i>Stormwater design for a new school will be required to meet MaDEP Stormwater Standards at a minimum.</i></p>
<p>Other/Receiving Waters: There was evidence of erosion at several locations on site including in the playground and along the edge of the main parking lot and driveway. See Figure A11.</p> <p>The receiving water is Arcade Pond. Arcade Pond is listed as an impaired water body with a TMDL (MA51003_2008) Category 5 (Noxious Aquatic Plants).</p>	<p>Avoid additional flow of nutrients into Arcade Pond.</p>

*Figure A9: Crushed stone at parking*

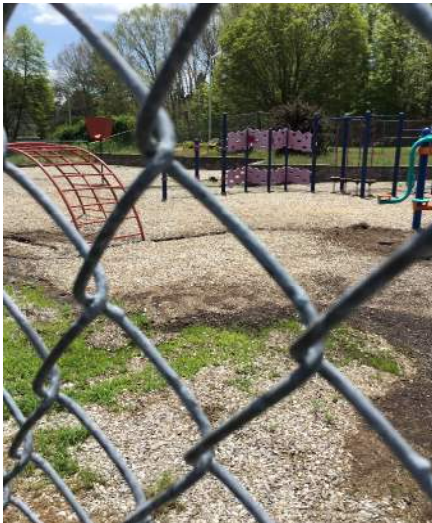
*Figure A11: Erosion at Playground*

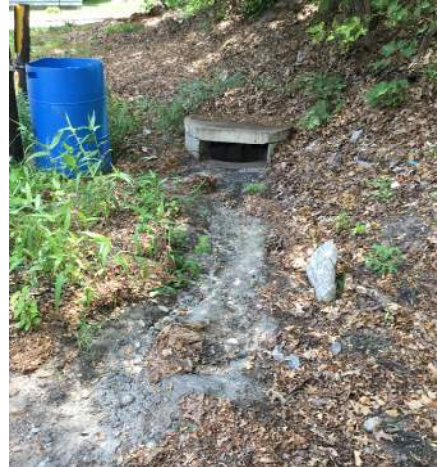
*Figure A8: Drainage Inlet at driveway entrance*

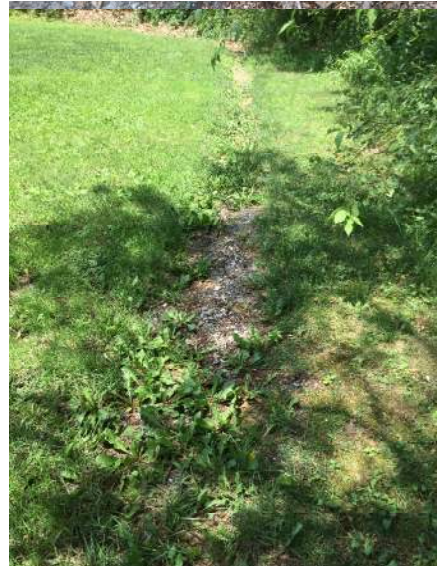
*Figure A10: Field stone swale*

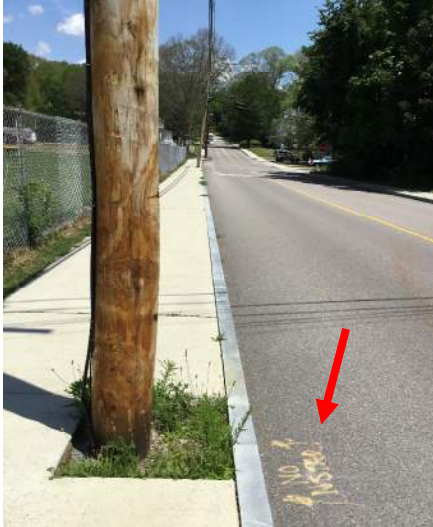
Figure A16: Utility pole with "no ser-

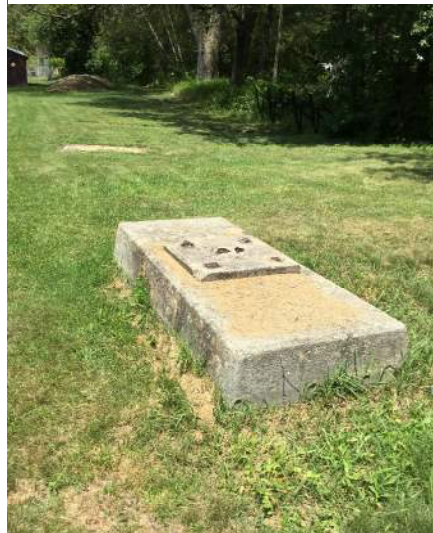
Vail Park has 2 baseball/softball fields with dugouts, unlined practice field, and play ground. There are several concrete slabs around fields that appear to be old light pole bases. Several utilities pass under the fields (see individual Utilities Section below).	The fields appear to be in good condition. See Landscape Section for additional information.
Balmer Elementary School (Balmer ES) and Vail Park are located off of Crescent Street near Lake Street and Arcade Street in a generally residential neighborhood. Arcade Pond and associated wetlands are located to the south of the sites and are bordered by Arcade Street, Crescent Street, and Lake Street. Whitins Pond is located to the west of the sites.	The site is in a generally residential area .

Figure A19: Old light base

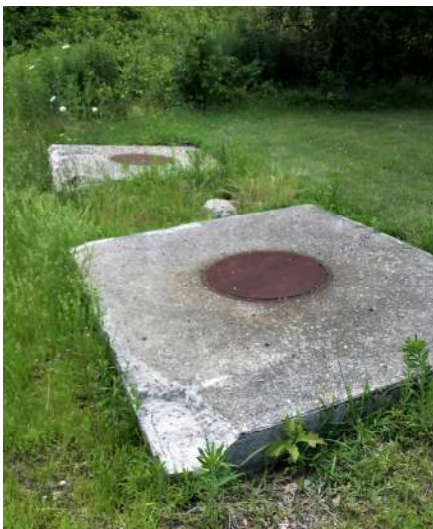
Fire Alarm: There is a fire alarm pull box at the front entry of the school. See Figure A18.	See MEP narrative for more information.
Unidentified Utilities or Structures: Two vaults or tanks were observed just off the pavement in the service area along with an observation well. See Figure A20. This has been confirmed as an underground fuel tank per Mark Bedard.  There is a manhole located on slope in the woods on the west side of the driveway towards Crescent Street. No readable markings on cover—electric service? See Figure A21.	Additional investigation is needed on these unidentified structures.

Figure A20: Unknown structures

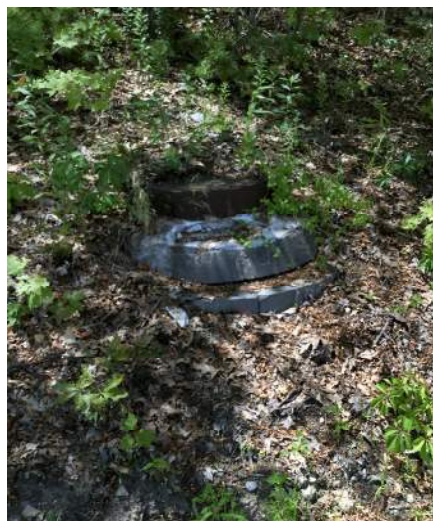
Figure A21: Unknown Manhole.

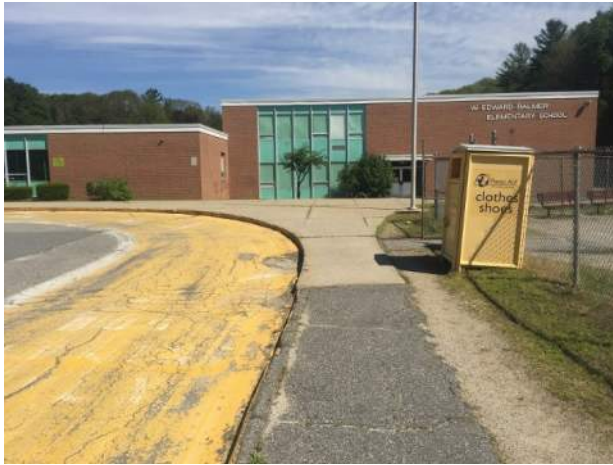
*Figure 1—Building façade lacks vegetative cover*

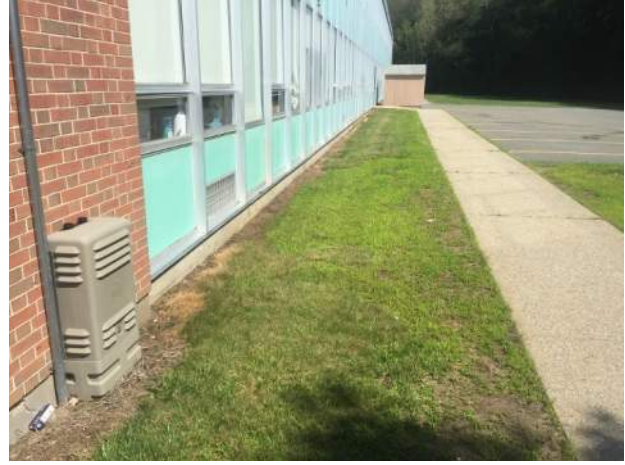
*Figure 2—Lack of foundation plantings at building*

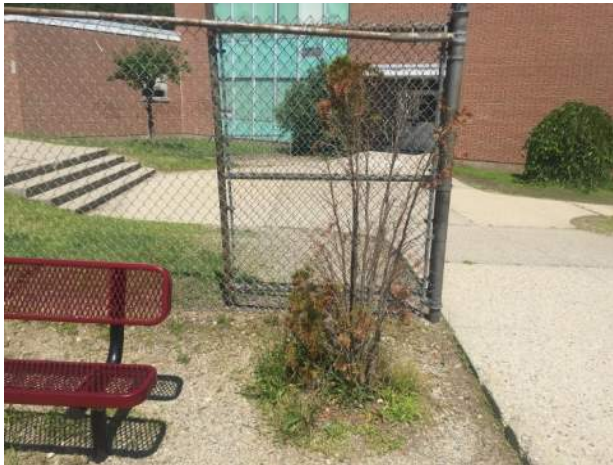
*Figure 3—Many plantings under stress require removal*

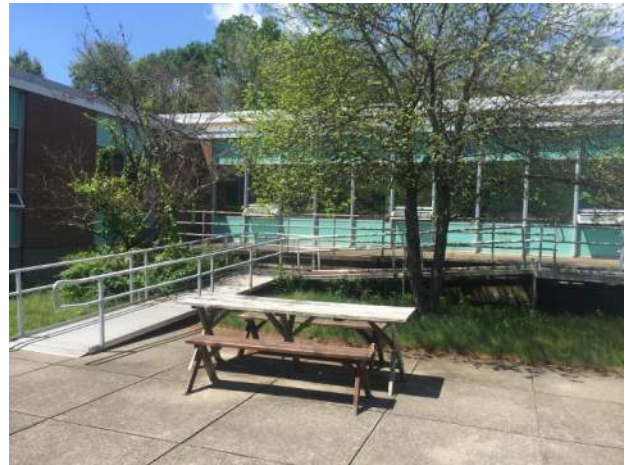
*Figure 4—Landscape lacks proper maintenance.*

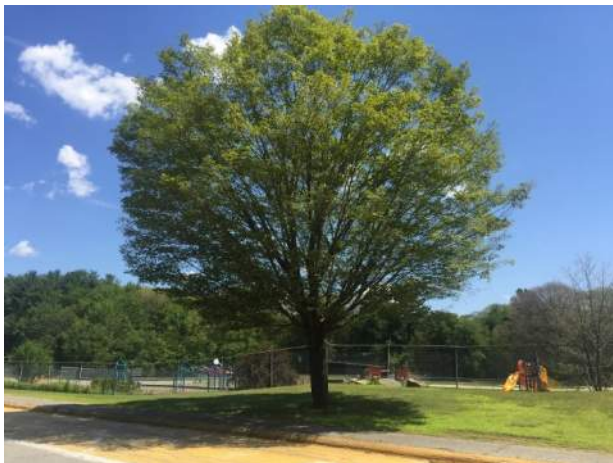
Though the surrounding area is lush and wooded, the spaces immediately adjacent to the school building lack substantial foundation and shade plantings, resulting in a harsher environment and no mitigation of climatic factors. A lack of ornamental plantings to soften the environment creates unpleasant spaces and contributes to discomfort. (Figures 1, 2)	Provide foundation and shade plantings throughout the site.
Ornamental plantings are in need of maintenance including irrigation, weeding, mulching, pruning, fertilization, etc. (Figures 3, 4)	Weed and edge beds, apply new layer of mulch. Prune dead and dying branches; feed if necessary. Provide irrigation to ornamental beds. Remove failing plants and replace.
Larger shade trees exhibit signs of insect damage, possibly caterpillars (Figures 5, 6)	Identify specific pest or pathogen and pursue treatment course appropriate to specific issue.

*Figure 5—Shade tree at ball fields*

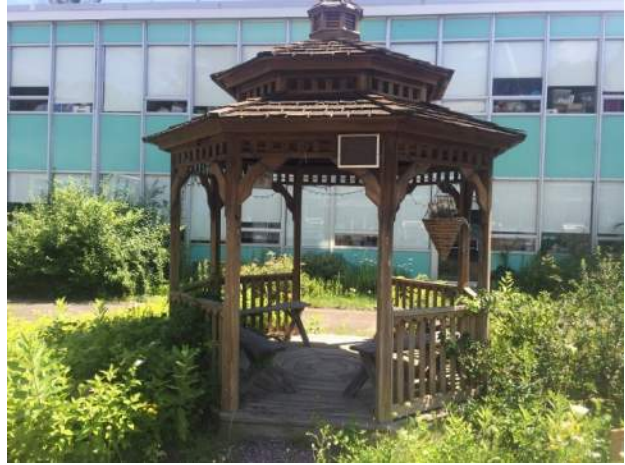
External structures are limited on site, but there are several elements that are unique to either the school or ball fields. The gazebo is in relatively good condition (Figure 8).

*Figure 8—Gazebo in courtyard*

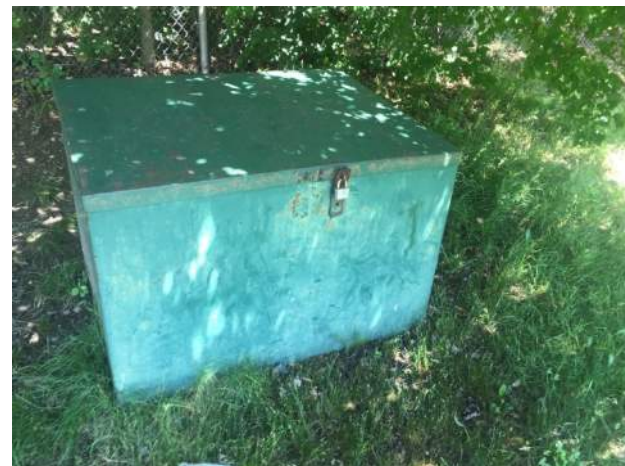
*Figure 12—Storage at athletic fields*

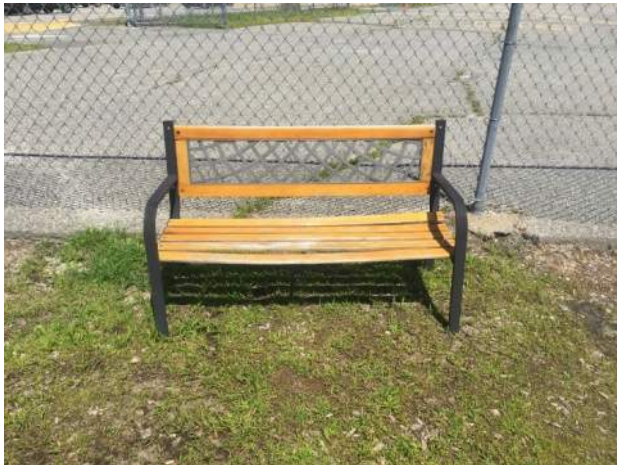
*Figure 15—Benches exhibit a range of styles / quality*

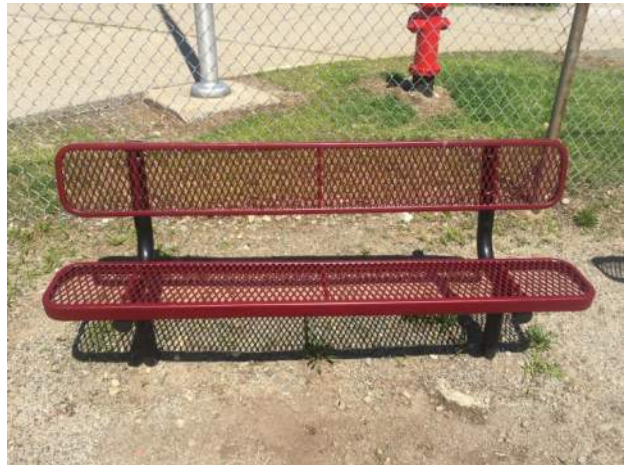
*Figure 16—Benches exhibit a range of styles / quality*

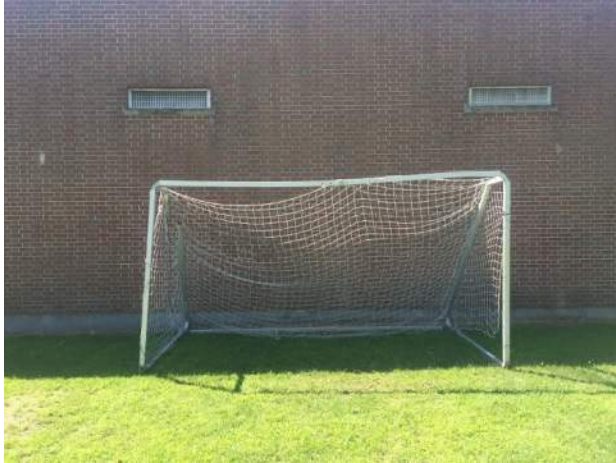
Athletic fields at the school itself were in good condition at the time of site visit, but require ongoing maintenance to preserve their quality. The fields at the school do not appear to have any formal athletic striping or designation despite the presence of soccer goals. The fields at Vail Playground have a higher degree of wear and compaction. (Figure 22)	Provide regular maintenance at school and playgrounds. Repair or replace turf fields at Vail playground to address compaction and erosion issues. Provide athletic striping at school fields to allow for structured athletic games.
A single pair of soccer goals were observed at the school, despite the fact that there exists at least two separate fields capable of supporting soccer play. Of the goals provided, one had broken structural members and another was missing netting altogether. (Figure 19)	Replace goals at the school. Provide new goals at playground soccer field.

*Figure 19—Goals have broken or missing components.*

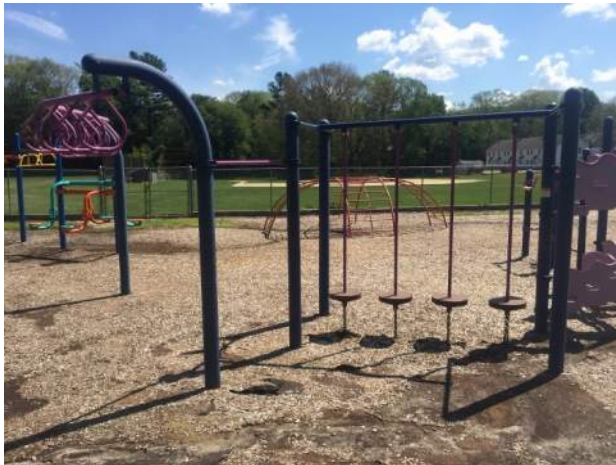
Playground equipment appears to be of fair to good quality. The playground surface consists of wood chips and is in poor quality and presents a safety concern. (Figures 20, 21) The playground equipment and play surfaces are not accessible.	Conduct a playground inspection by a certified playground safety inspector and respond to specific recommendations provided within. Replace wood chip play surface with new chips or ideally a poured-in-place rubber safety surfacing. Provide accessible playground equipment and play surfaces.
A large number of painted games were observed on pavement around the site. All are have faded and are unusable or close to becoming unusable.	Provide new painted games in key areas around site.
Fabric on backstop at rear baseball/softball field is in fair to poor condition from improper use. Paint on foul pole at front field is faded and peeling. (Figures 23, 24)	Repair and paint all posts and rails. Replace damaged fabric and components and replace all missing components.

*Figure 21—Play surface is of poor quality.*

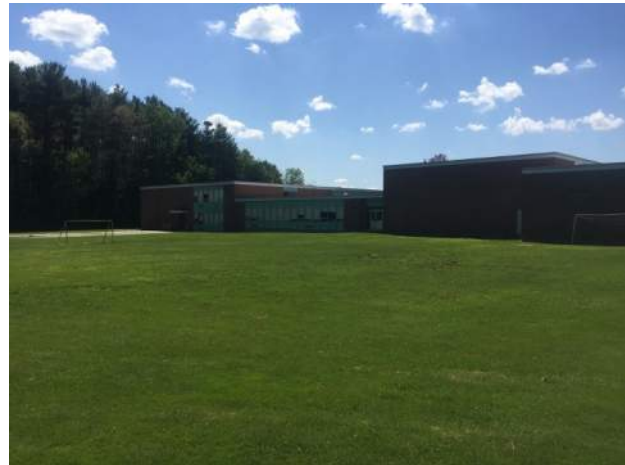
*Figure 22—Athletic fields at school.*

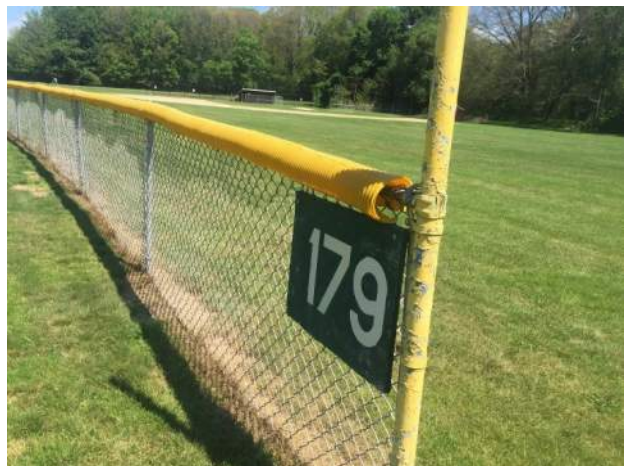
*Figure 24—Baseball field foul pole and fencing.*

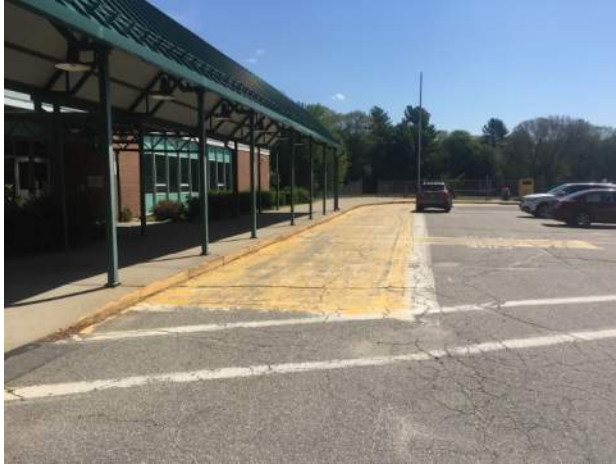
Bituminous pavement surfacing across the site is in poor condition and in need of replacement. Cracks, potholes, puddling, vegetative growth, and debris are prevalent. Painted markings, including crosswalks and handicapped aisles, are faded or worn away. These issues present safety and accessibility concerns. (Figures 25—30)	Provide new top coat at all bituminous pavement surfaces site-wide. Restripe and provide new painted markings for vehicular circulation.
--	--

*Figure 25—Bus drop-off at main entrance*

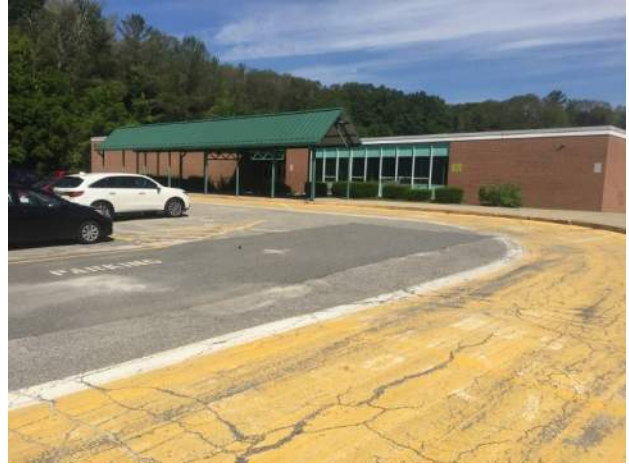
*Figure 26—Bus drop-off area*

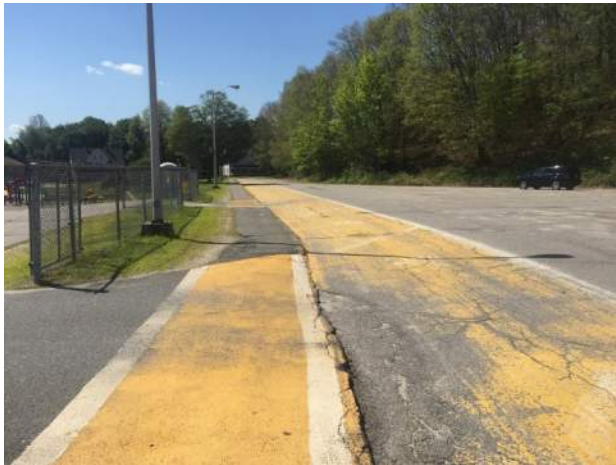
*Figure 27—Bus staging area at main entrance*

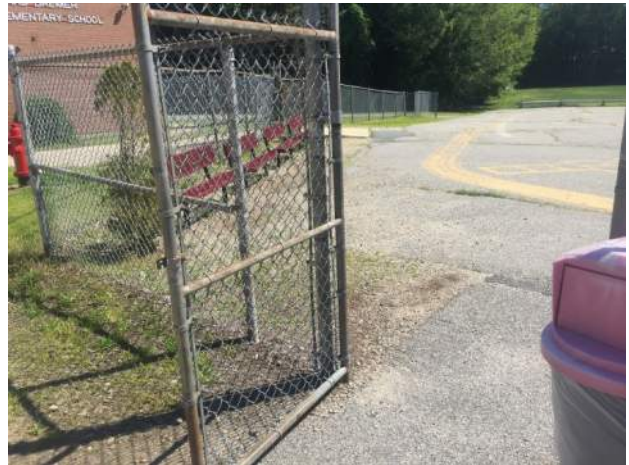
*Figure 28—Parent drop-off area*

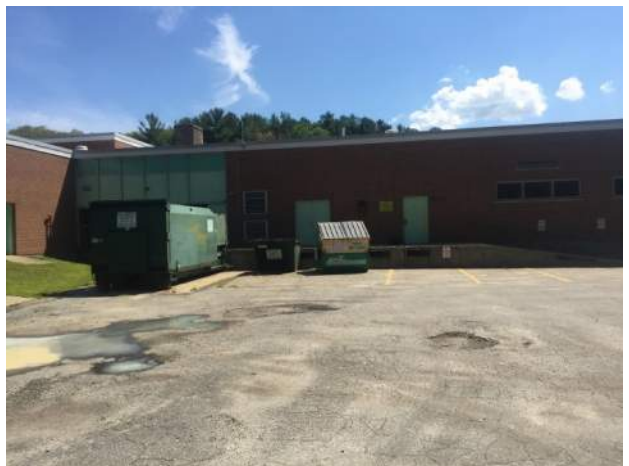
*Figure 30—Loading dock for deliveries*

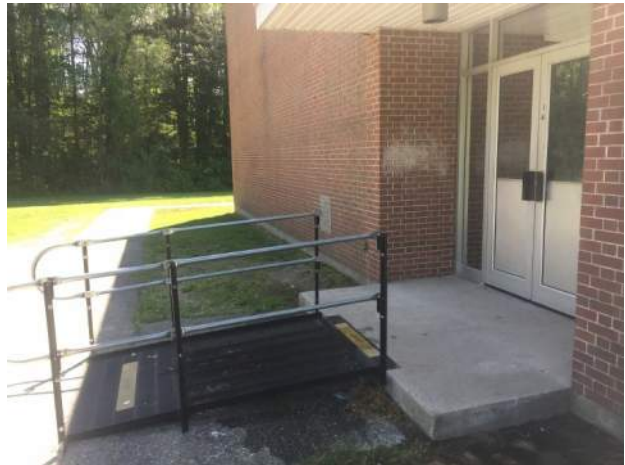
Because the school as built prior to the implementation of current MAAB rule and ADA guidelines and design standards, renovations and retrofitting was necessary in order to meet code requirements. This results in a less efficient and less attractive landscape, and draws unnecessary attention. (Figure 34.)	An accessibility study should be performed to ensure that all code requirements are being met, and a comprehensive plan put in place to address any and all shortcomings. Universal accessibility should be a priority in all new construction.

*Figure 34—ADA accessible retrofit at rear entrance*

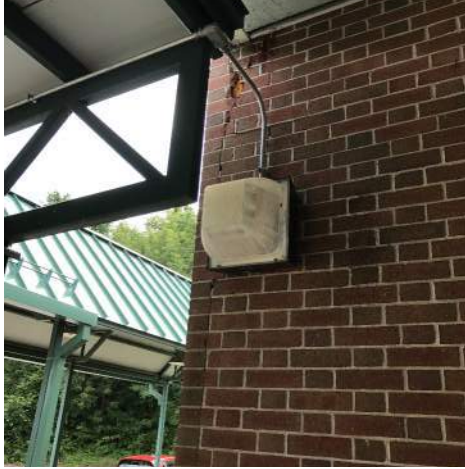
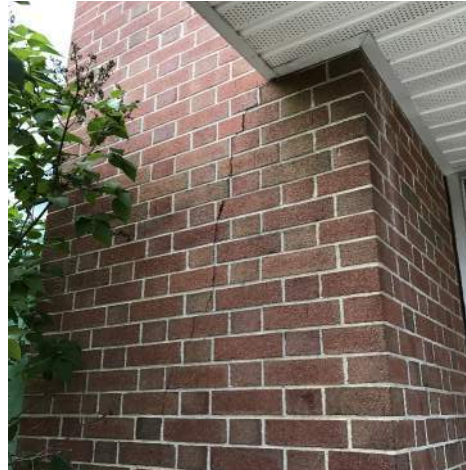
There are isolated areas of minor to moderate cracking in the brick and mortar joints. These are typically indicative of minor settlement over time or due to thermal stresses from solar radiation heating south-facing walls with no control joints to absorb stresses at corners. (Figures 7-8).	Repoint the brick, replacing damaged clay units. Install a control joint in the brick veneer within 16" of the corner on the side of wall facing the adjacent entry canopy.  Investigate cause of brick unit cracking; repair.
Some of the expansion joint caulking at the exterior wall is starting to dry out and crack. Open joints can allow precipitation to enter the building wall system and cause further deterioration; especially during freeze-thaw cycles. (Figures 9-10).	Undertake a building-wide caulking maintenance and replacement program to identify and replace all caulking and sealants that are at the end of their expected service life.

*Figure 7—Cracking at masonry joint*

*Figure 8– Cracking at masonry joint*

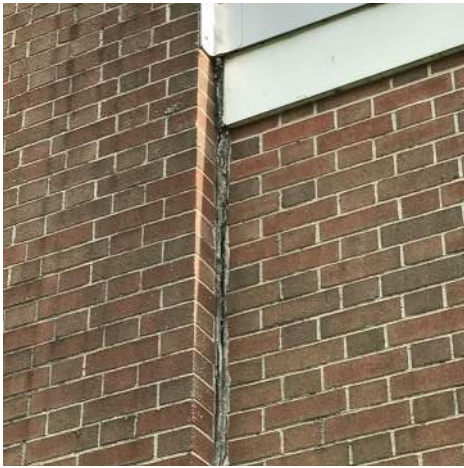
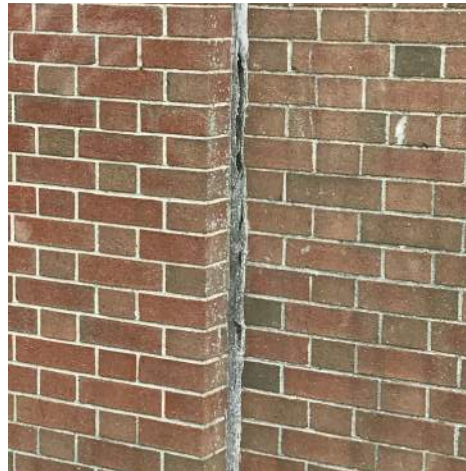
*Figure 9—Dried up cracked expansion joint caulk*

*Figure 10– Dried up cracked expansion joint caulk*

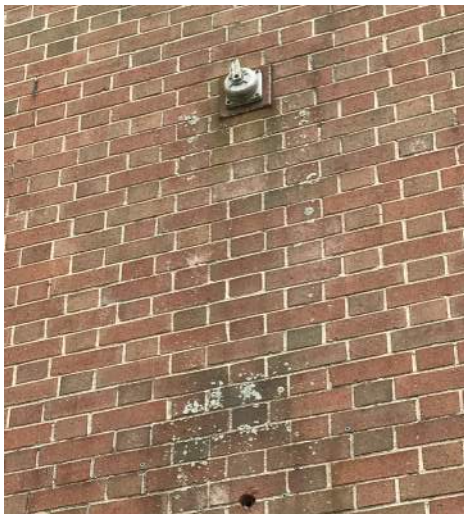
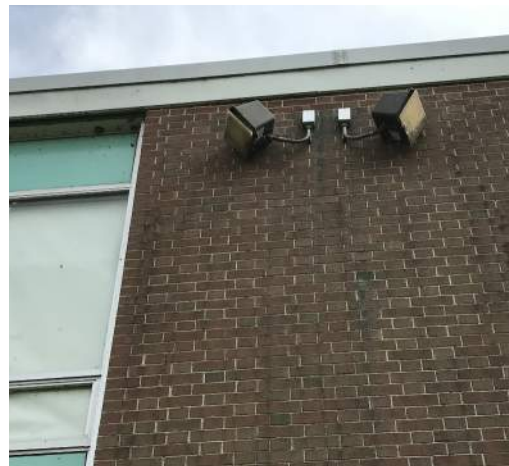
There are several areas on the exterior brick veneer that have some staining due to vegetative growth on the face of the brick. This issue is mainly one of aesthetics. (Figures 11-12).	Clean the masonry with a low-acid masonry cleaning detergent.

*Figure 11—Lichen growth on exterior brick veneer*

*Figure 12—Lichen growth on exterior brick veneer*

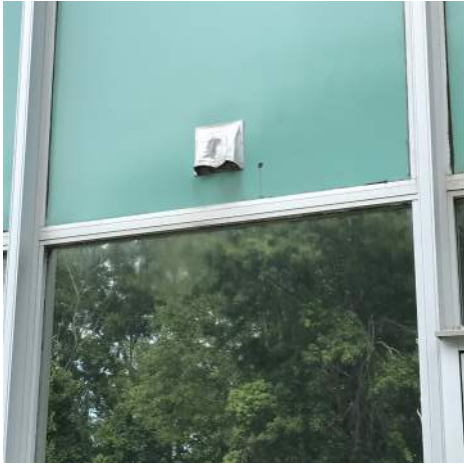
<p>Curtainwall framing does not appear to be thermally broken, and glazing and infill within the system is single-pane plate glass. (Figures 13, 14, 15).</p> <p>The presence of any Low—E coatings on the glazing could not be confirmed, however given the age of the systems, it likely has no such coatings. There appears to have been a previous attempt to reduce solar thermal heat gain by the application of a reflective coating on the glass, however this is deteriorated. The result is poor energy performance, and increased heat gain from solar incidence.</p> <p>The paint finish on the spandrel panels is at the end of its expected service life, and several panels are rusting through the finish, staining the system with rust. (figures 16, 17).</p>	<p>Replace existing window and curtainwall systems in their entirety with high-performing, energy efficient curtainwall systems with insulated glazing.</p>

*Figure 13—Non Low-E coated window glazing*

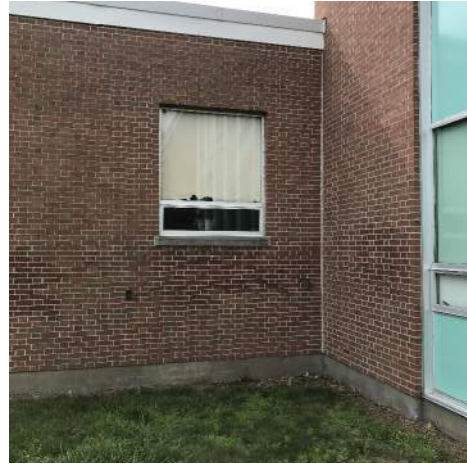
*Figure 14—Non thermally broken windows*

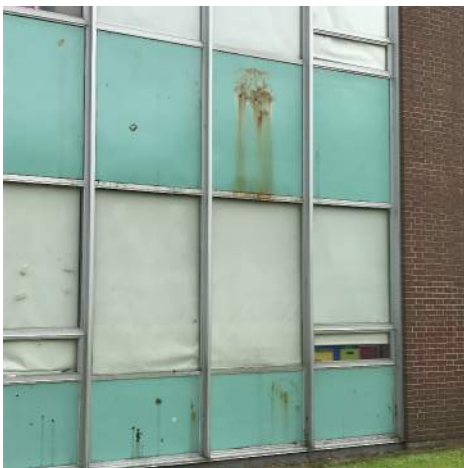
*Figure 17—Rusting enameled metal spandrel panels*

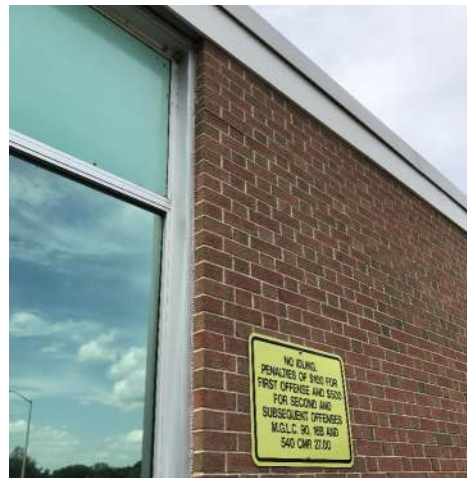
<p>The glazing compounds and gaskets at the perimeter of the glazing units are significantly deteriorated, with some gaskets falling out of their frames and glazing compounds drying out, increasing the potential for leaks within the window and curtainwall systems. (Figure 18).</p>	<p>Lacking complete replacement of window and curtainwall systems, reglaze the current glazing with new sealants and gaskets to prevent further deterioration and the potential for leaks..</p>
<p>Caulking and sealants at the perimeter of curtainwall and window systems is at the end of its expected service life. Many joints are cracked or visibly drying out; potentially opening the potential for leaks to develop in the façade. (Figure 18)</p>	<p>Undertake a building-wide caulking maintenance and replacement program, identifying and replacing all sealant joints that are deteriorated.</p>
<p>Some windows include protective steel mesh barrier screens at the exterior, which are rusting and staining the wall construction below. (Figure 15)</p>	<p>Replace protective screens with new screening with corrosion-resistant coating.</p>

*Figure 18—Degraded caulk at window*

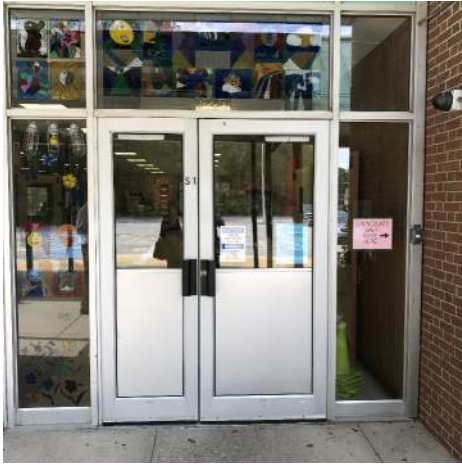
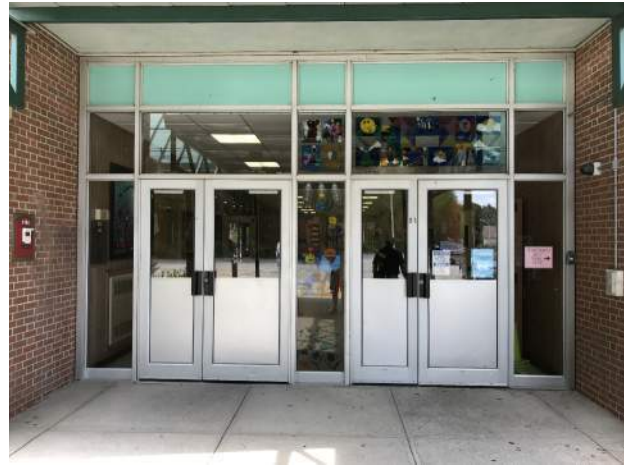
The exterior aluminum storefront and curtain wall doors are in fair condition, as they function well however they are frequently missing weather-seal bottom sweeps and gaskets (Figures 19, 20).	Replace these doors as part of a building-wide curtainwall replacement project; refer to Windows and Curtainwall section listed previously in this report.  Lacking the complete replacement of curtainwall systems, inspect all aluminum entrance doors for proper weather-seals, and replace or install new seals to help prevent air leakage through the openings.
The H.M. doors are generally in fair condition. It is unclear if the doors are insulated. The doors and frames exhibit some rusting along the bottom edges at the pavement, and are often missing weather stripping. The paint finish on the doors is at the end of its service life and is failing, with a chalked appearance. (Figures 21, 22).	Replace all hollow metal doors with insulated units. Treat rust on frames and paint all openings with high-performance rust inhibiting paint.  Inspect all doors for proper weather-seals, and replace or install new seals to help prevent air leakage through the openings.

*Figure 19—Exterior storefront / curtain wall doors*

*Figure 20—Main Entrance Doors*

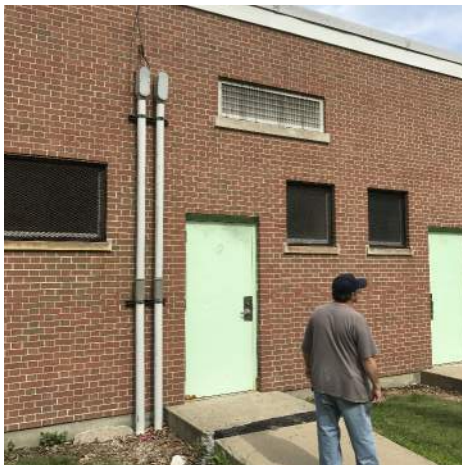
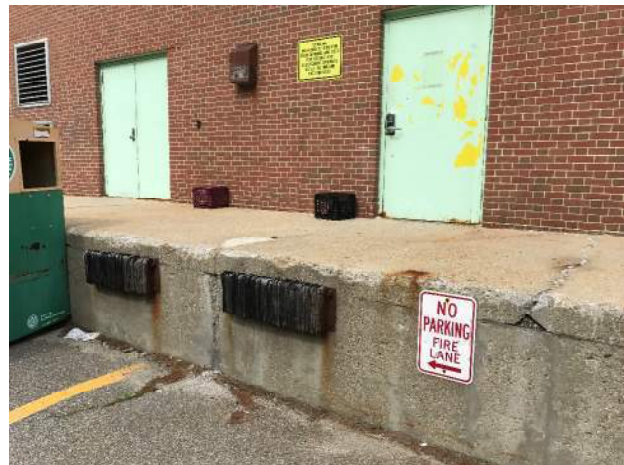
*Figure 21—Exterior hollow metal doors*

*Figure 22—Exterior hollow metal doors*

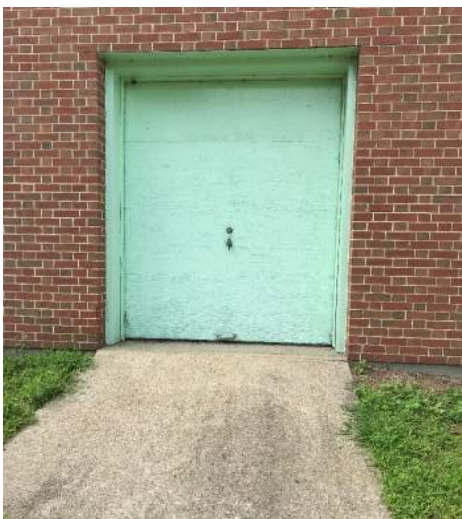
The wooden overhead door is in fair condition. It is not insulated, and does not meet the current energy code for required R value. The paint finish is at the end of its service life, and is checkered and flaking. The weather stripping / caulking is falling away from the door. The door hardware is in poor condition (Figure 23).	Replace the overhead door with a new insulated steel or aluminum door system with factory-applied corrosion-resistant finish..
Caulking and sealants at the perimeter of the hollow metal door frames is deteriorating and starting to crack.	Undertake a building-wide caulking maintenance and replacement program, identifying and replacing all sealant joints that are deteriorated.

*Figure 23—Wooden overhead door*

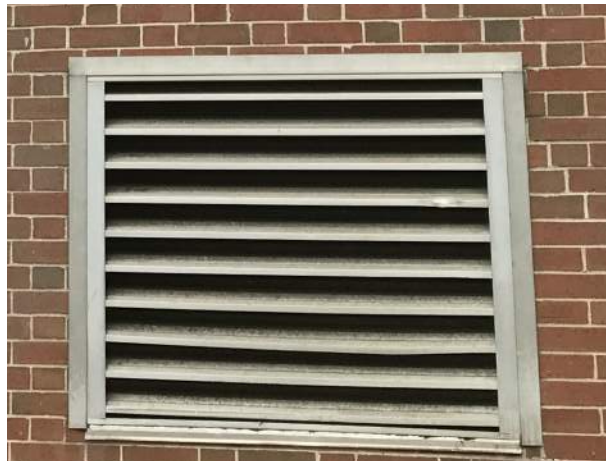
*Figure 26—Stained and dirty louver fins*

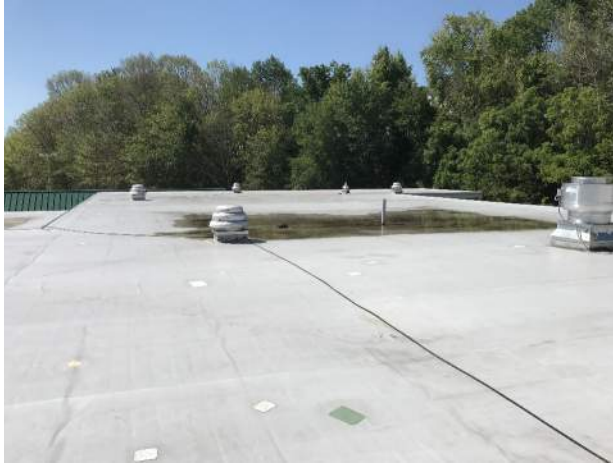
*Figure 28– Ponding water at and around roof drain*

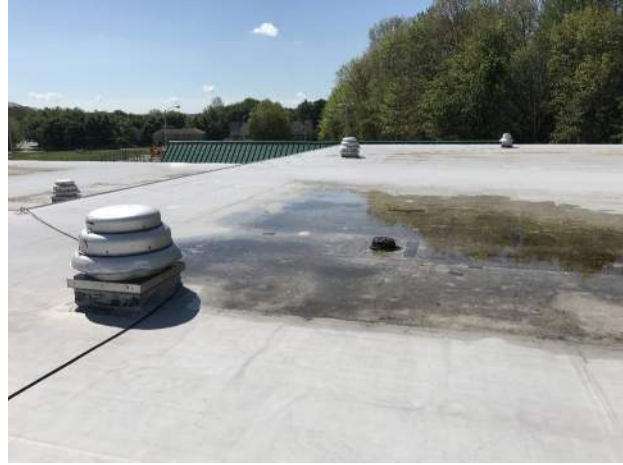
The amount of insulation in the roofing system is unknown. Any reroofing project will require the roof insulation to meet current energy code requirements.	The age and condition of all roof areas, coupled with the likelihood that the roof insulation value is below the current energy code is such that we recommend total roof replacement, with a minimum R value of R-30, and a .060 EPDM fully adhered membrane roof system.
There are areas of minor ponding water on the roof in proximity to the roof drains (Figures 30, 31).	As part of a re-roof project, provide tapered insulation to provide positive drainage at drains.  Lacking complete replacement, investigate any existing roof warranties for exclusions related to ponding water. Current Sarnafil warranties permit some ponding water.
There are several areas where the membrane termination bar is pulling away from the base of high roof areas (Figures 32, 33).	Remove lengths of damaged termination bar at base of high roof areas and replace with new termination bar. Also see recommendation below regarding flashings..

*Figure 30– Lifting and damaged termination bar*

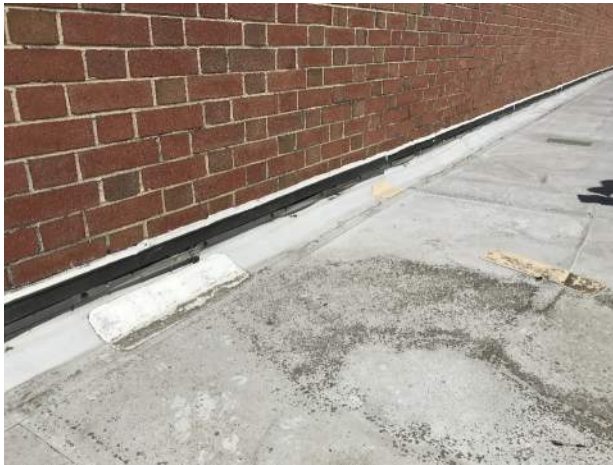
*Figure 31– Lifting and damaged termination bar*

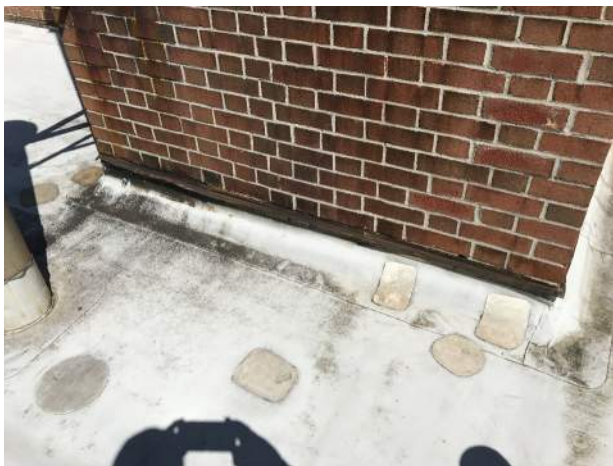
*Figure 32– Damaged flashing at base of the chimney*

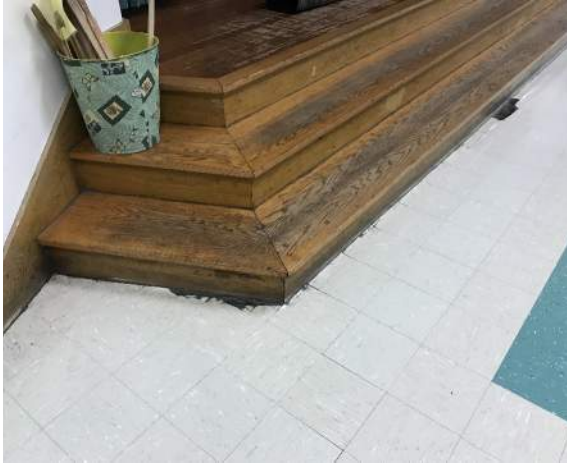
VAT tile at some spaces is cracked and friable. (Figures 36, 37). At some locations the VAT is heavily worn and worn through in high traffic areas. (Figure 38).	Replace and abate all VAT with resilient flooring such as sheet linoleum or vinyl composition tile.
The wood sports floor is in poor condition, due to previous moisture damage that warped the floor. (Figure 39).	Remove the flooring system down to the substrate slab, and provide a new resilient wood sports floor system on a plastic sheet vapor retarder.
The terrazzo floor in the entrance lobby features a large crack starting at the cafetorium door and extending to the entry walk off mat. There are multiple other cracks as well, and evidence of previous “repairs” using caulking material. (Figures 40, 41).	Refer to recommendation above; with any building-wide replacement of VAT, install new resilient flooring over the terrazzo.

*Figure 36—Friable VAT tile at stage*

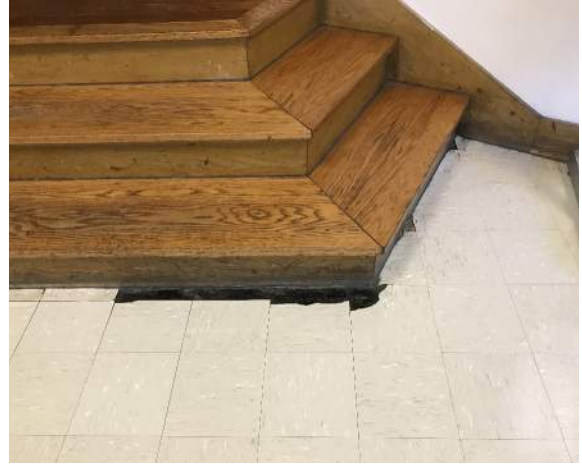
*Figure 37—Friable VAT tile at stage*

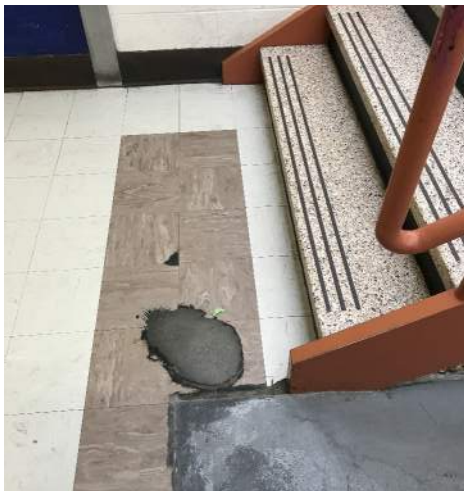
*Figure 38—Worn down VAT tile at stairs*

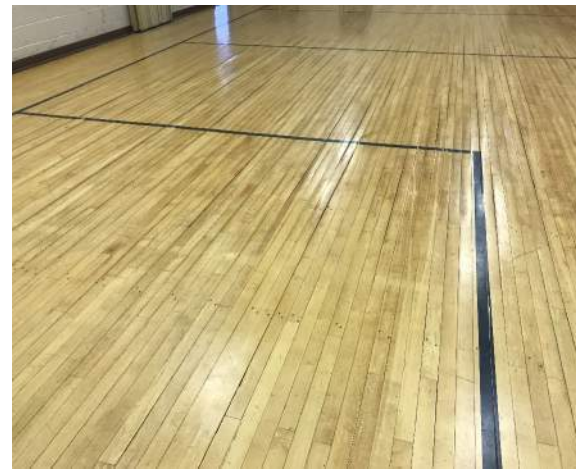
The gymnasium features a wood strip floor system, which is in poor condition due to previous water or humidity damage.

*Figure 39—Warped gym floor*

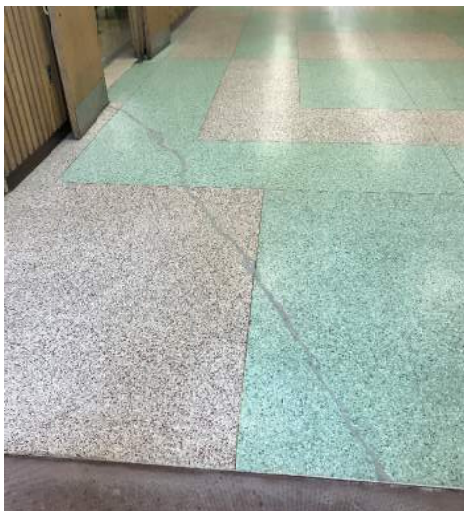
The flooring in the lobby is terrazzo, which is in fair condition, and features multiple settlement cracks.

*Figure 40—Crack in terrazzo floor at cafetorium*

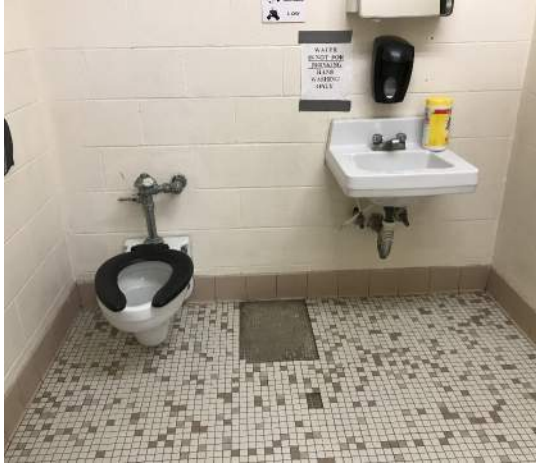
Mosaic tile in bathrooms is dated in appearance, and appears to be dirty due to grout being soiled. Tile is missing from floor patches in many locations. (Figures 42, 43).	Remove all bathroom tile and base and replace with new tile, with floors sloped for positive drainage where floor drains exist..
There are many areas of missing cove base in bathrooms where there is mosaic tile (Figure 44).	In bathrooms with missing cove base remove old base and install new cove base to match existing mosaic tile floor.
In most of the areas that have sealed concrete as the floor finish the sealer has worn off, exposing the concrete. In some locations the concrete has shrinkage or minor settlement cracks. (Figure 45).	Repair cracks with concrete patching compounds, and reapply a protective barrier such as concrete deck paint or other protective coatings to prevent spilled chemicals from being absorbed and trapped in the concrete.

Figure 42—Large area of missing mosaic tile

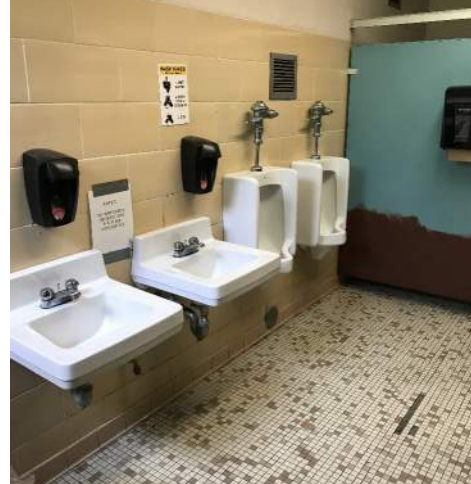
Figure 43—Area of missing mosaic tile

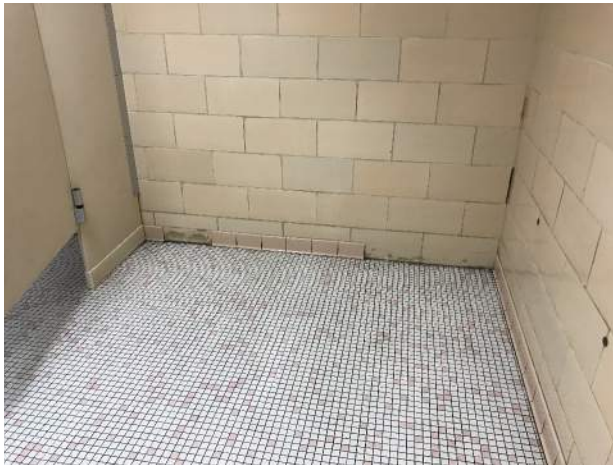
Figure 44—Typical missing cove base at bathrooms

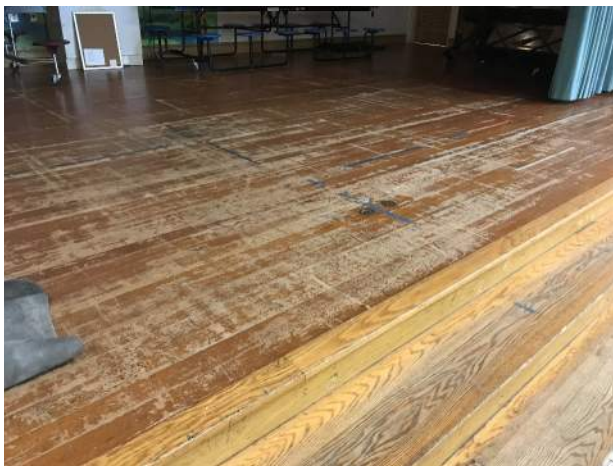
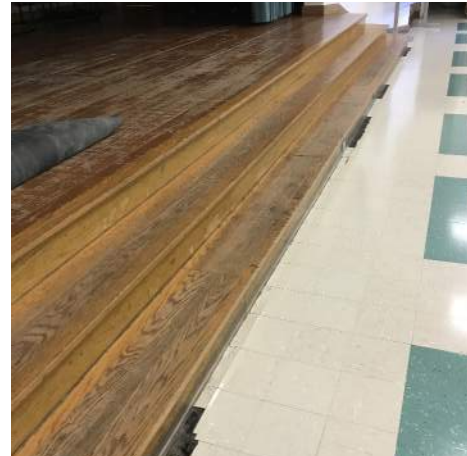
The stage floor appears to be sound, however the finish is heavily damaged and almost consistently scuffed. (Figures 46, 47)	Strip and refinish the entire wood floor and all wood components at the front of stage steps. Refer also to the Regulatory Assessment section for discussion of providing accessibility to the stage via a wheelchair lift.

Figure 46—scuffed and gouged stage floor

Figure 47—scuffed and gouged stage floor

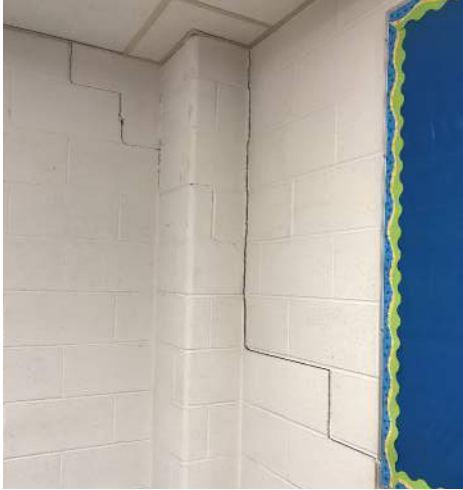
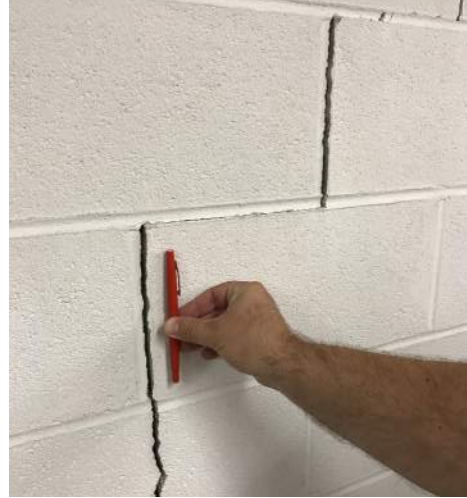
There are several cracks in the CMU walls in various locations throughout the school, with notable cracks in the Audio Visual room off of the library. These appear to be due to the load-bearing nature of unreinforced CMU construction. The cracks at this room are approximately 1/4" wide, with the CMU on each side being out of plane. (Figures 48, 49).	Repoint cracks in mortar joints. At the AV Room, replace broken CMU with new faces shells, and fill CMU cavities to the greatest extent possible with mortar and reinforcing to prevent reoccurrence of cracking.
The paint finishes throughout the school are beyond their expected life span, and are soiled and peeling in various locations. Some walls appear to be damaged from previous removal of wall-adhered fixtures. (Figures 50, 51, 52).	Undertake a building-wide repainting program to freshen the spaces.

*Figure 48—Severe crack in corner of A.V. room*

*Figure 49—Severe crack in corner of A.V. room*

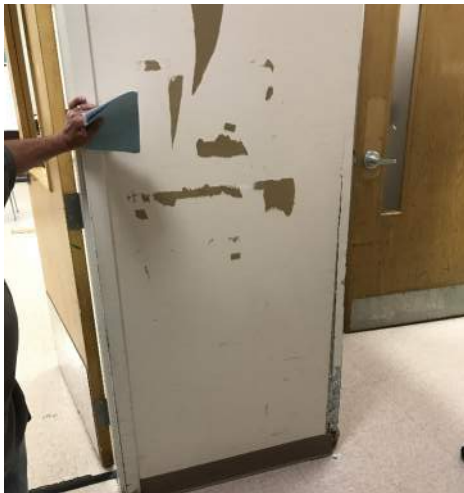
*Figure 50—Paint peeling off of GWB wall surface*

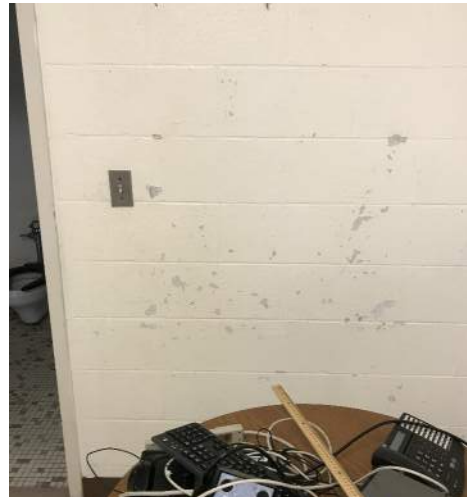
*Figure 51—Paint peeling off of CMU wall surface*

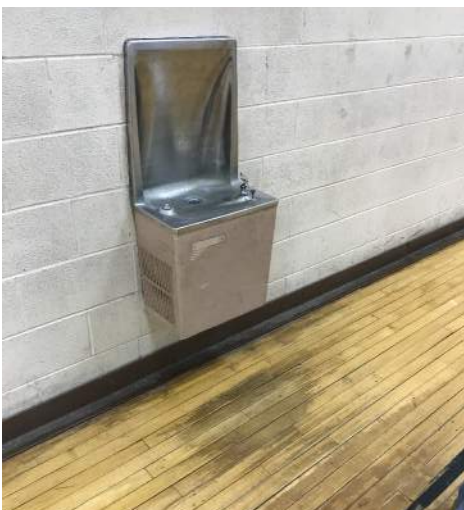
*Figure 52—Grimy worn out paint typical*

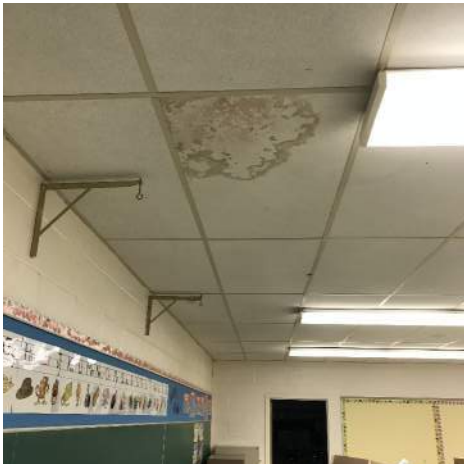
The ACP ceiling panels throughout the building are beyond their expected service life, and exhibit significant sagging from humidity. Some tiles are no longer supported by the grid members. Several tiles throughout are stained from water damage. (Figures 53, 54, 55, 56, 57).	Replace acoustic panel ceilings throughout the school with new humidity resistant panels in grids that are corrosion resistant.
In all the bathrooms and wet areas the ceiling tile and grid system is not humidity resistant (Figure 58).	Replace ceiling grid and tiles with a moisture resistant grid and ceiling tile system.
The acoustic ceiling panels in the kitchen are a mix of styles, including moisture susceptible fissured type panels that are not washable.	Replace acoustic ceiling panels throughout the kitchen with a system with washable panels in a grid system that is corrosion resistant and approved by the USDA for use in commercial kitchens.

*Figure 55—Water stained ACP tile*
