# W. EDWARD BALMER ELEMENTARY SCHOOL

NORTHBRIDGE PUBLIC SCHOOLS  
TOWN OF NORTHBRIDGE, MASSACHUSETTS

## PRELIMINARY DESIGN PROGRAM, SECTION 3.1.4

### EVALUATION OF EXISTING CONDITIONS

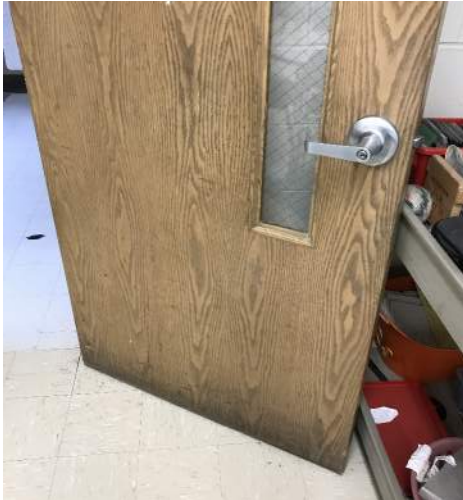
The wood doors through out the building are nearing the end of their service life. Door finishes are showing surface isolated damage and are soiled at several locations, especially along the bottom edge where mop plates do not exist. (Figure 59).	Replace doors within the facility with new wood doors, with ratings where appropriate to the opening rating. Provide mop plates at all doors to prevent soiling. Refer to Regulatory Compliance section for discussion of accessibility issues related to doors and hardware.
Wired glass is used throughout the building in door vision panels and sidelights. Wired glass has been shown to adversely impact the fire and impact performance of the glass, and when broken the exposed wire represents a significant threat to cutting of hands and amputation of fingers. Wired glass is no longer permitted as “safety glass” in openings in impact areas such as door vision panels and sidelights. (Figure 60, 61, 62).	Replace all glazing in door vision panels, borrowed lights, and sidelights subject to pedestrian impact with tempered or laminated safety glass, with fire ratings where appropriate to the frame assembly rating.

*Figure 59—Typical natural finish wood door*

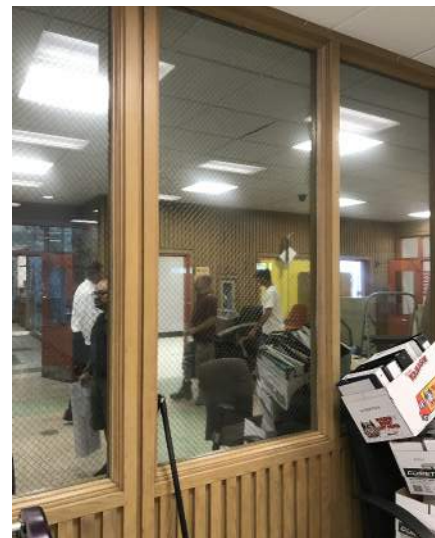
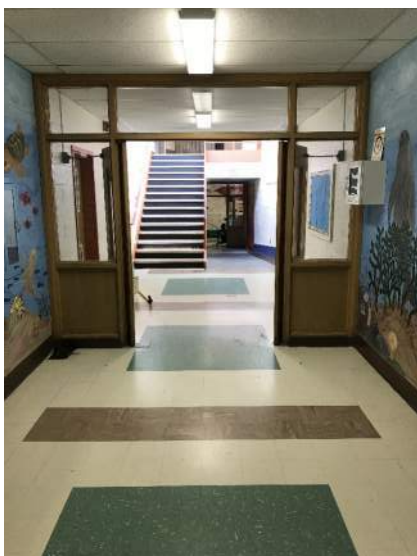
Wood doors along corridors do not appear to include fire ratings necessary to separate corridors, especially at stairs from second floor. Refer to Regulatory Assessment for discussion of the corridor fire rating. (Figures 62, 63)	Replace doors and frames including borrowed light frames at perimeters of corridors with 1 hour rated doors, frames, and windows to improve separation of corridor.

*Figure 62—Borrowed lite system with wired glass*

*Figure 63—Wired glass corridor door system*

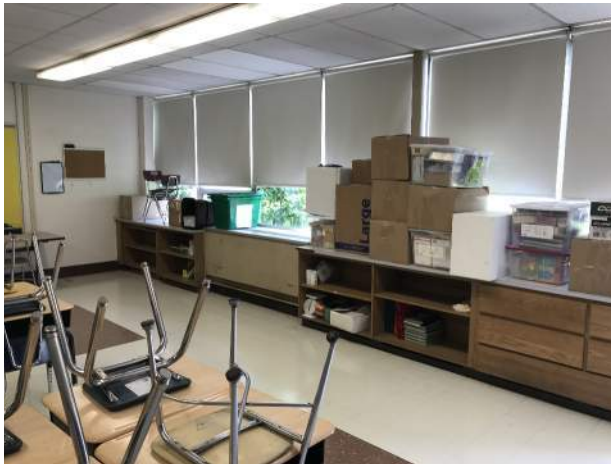
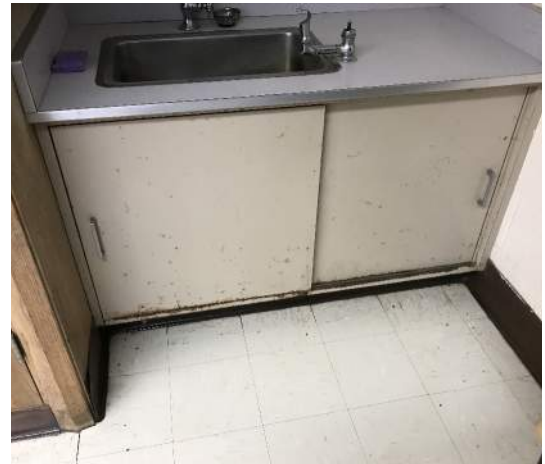
In general classroom casework is nearing the end of its service life. In many places, laminates are chipped or delaminating from substrate, countertop edges are delaminating, some drawer glides no longer operate smoothly. Sink cabinets do not meet accessibility requirements (Figures 66, 67)	Replace classroom casework with new units that are compliant with accessibility rules for the age of the intended users, and with a uniform appearance throughout the school.
Window sills at curtainwall systems appear to be stained plywood. Most are in poor condition, and exhibit water damage, and no clear finish on the stain such as polyurethane. (Figure 68).	Replace all window sills with new clear finished hardwood sills.
Classroom wall surfaces commonly feature chalk boards that are no longer used and create inefficient surfaces that are not compatible with modern teaching methods. The area of marker board surfaces is limited, and the current boards are mounted too high for smaller children to use effectively, which is limited by the existing chalk board trim. (Figure 69).	Remove existing chalk and cork boards and related trim from walls; provide new marker and tack boards following repair of scars at wall surfaces. Assume two new 8' marker boards and two new 6' tack boards per classroom.

*Figure 66—integrated window casework*

*Figure 67—Classroom casework sink base*

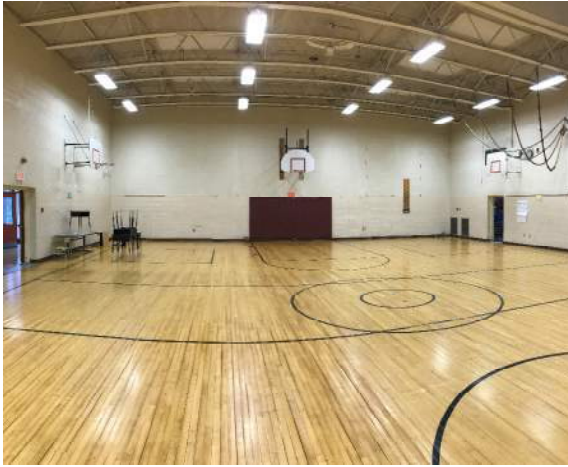
In the Gymnasium, wall padding only exists directly below the main basketball goals. Given the close proximity of the out-of-bounds lines, the lack of wall padding can create a hazard to those playing sports on the court. It appears at one time there was more padding, however this has been removed. The wall padding that exists is in fair condition and near the end of its service life (Figure 70).	Install new wall padding at all walls of the gymnasium from 4" above floor to approximately 6' above floor.
The second floor classroom wing corridor has lockers on both sides of the corridor for the entire length of the corridor. The lockers are in fair to poor condition; many of the doors have dents, and some rust is beginning to form. Some of the locker doors have been pulled out of alignment with the face of the locker frames (Figure 71).	Remove and replace old lockers with new heavy duty locker systems.

*Figure 70—Gymnasium wall padding*

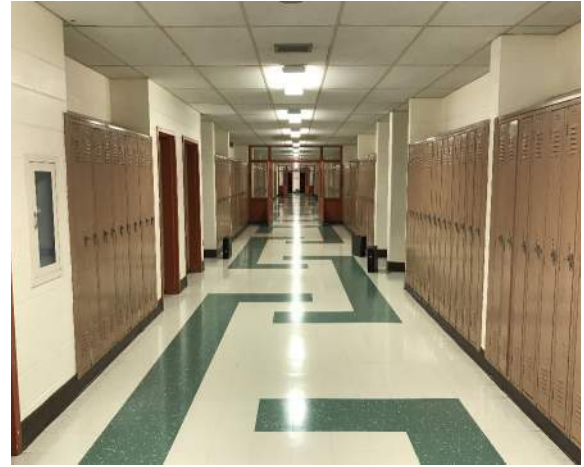
*Figure 71—Second floor corridor lockers*

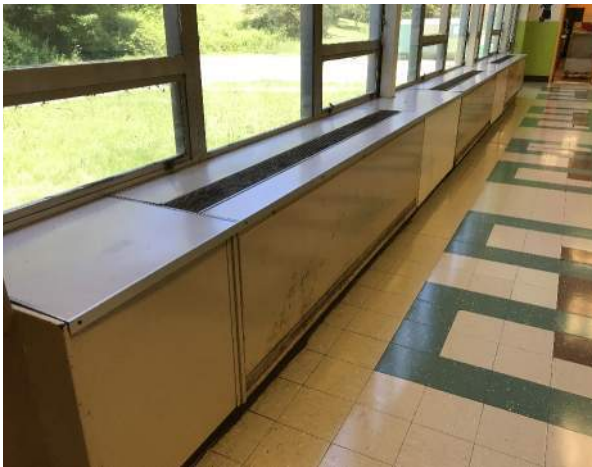
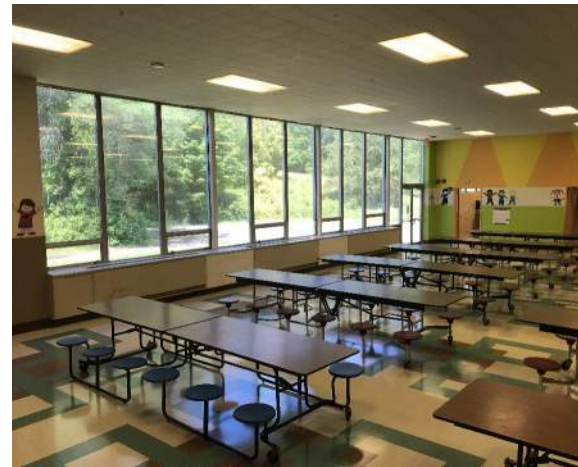
The unit ventilators in the cafetorium are in poor condition. The metal face of the ventilators is rusting as well as the side panels are getting some scuffs and rust. The top panels are dirty and dingy (Figures 72, 73).	Remove old unit ventilators and replace with new ventilator system. Refer to the HVAC Assessment for further discussion.
At the Stage/Platform, there are no true stage lighting elements or controls in the space appropriate for an elementary level, only what appeared to be some work lights. Curtains are generally fixed, with one traveling main curtain downstage, and a traveler at the back, upstage. Fixed curtain battens are dead-hung. (Figures 74, 75).	Provide new, basic-level LED stage lighting and controls appropriate for an elementary school setting. Professionally clean and re-hang stage curtains, and adjust travelers for smooth operation.

*Figure 72—Unit ventilators in cafeteria*

*Figure 73—Unit ventilators in cafeteria*

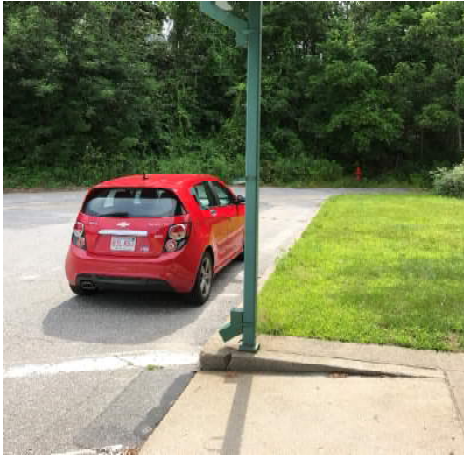
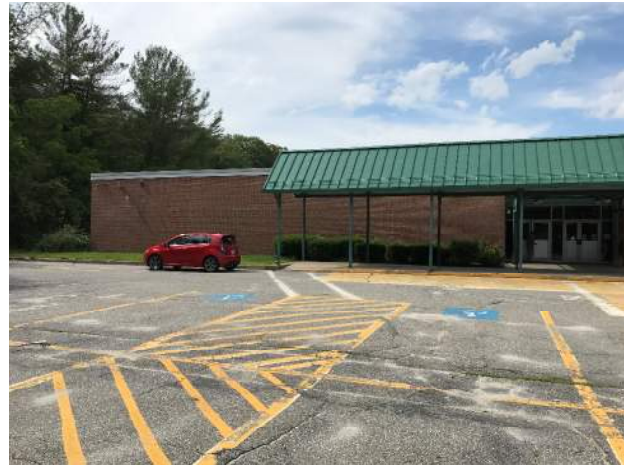
An accessible route appears to exist from accessible parking to the main entrance, including curb ramps that appear to comply with slope requirements. Concrete walks are fair condition; there are a few areas of cracking. Refer to the Site Assessment for discussion of pedestrian paving (Figures 1, 2).	Investigate grades and slopes of all accessible routes to verify that slopes meet current MAAB and ADA slope requirements.
57 on-site, striped parking spaces exist. Four spaces near the main entry are designated with pavement markings as accessible spaces which is in excess of MAAB and ADA requirements, however they do not feature required signage. None of the spaces are designated as van-accessible, however restriping the lot and signage could accommodate this.	Install signage required by MAAB rules, and restripe parking to create a space compliant with van accessible size and aisle standards.

*Figure 1—Accessible entrance with curb ramp*

*Figure 2—Accessible entrance with curb ramp*

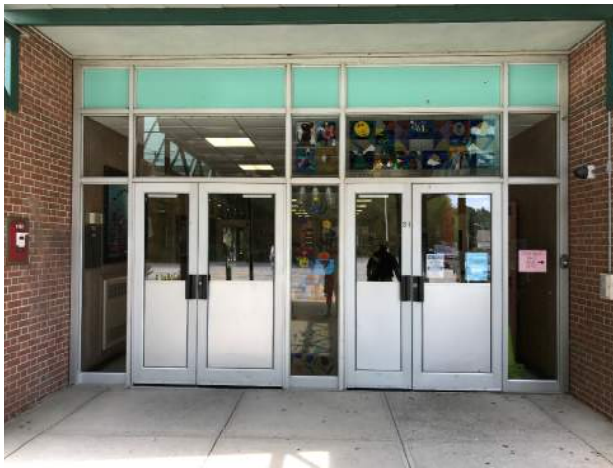
*Figure 3—Accessible entrance*

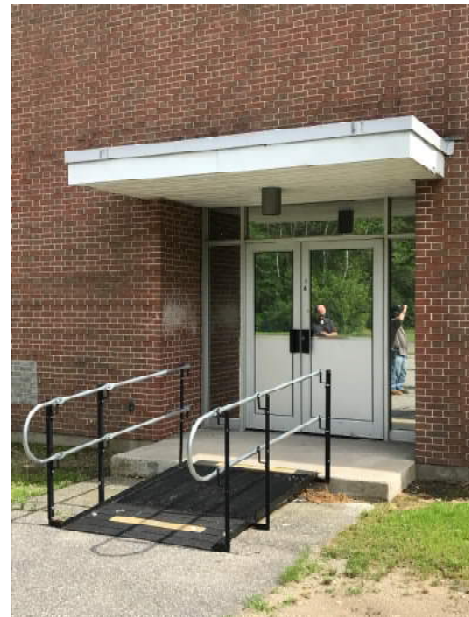
*Figure 4—Accessible side entrance typical*

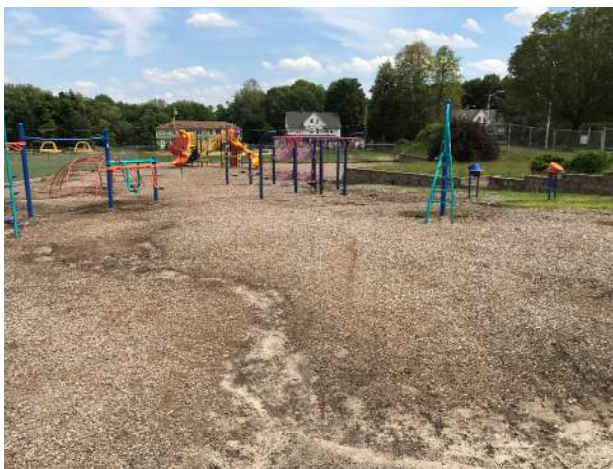
*Figure 5—Playground surface and equipment issues*

The playground surface under the equipment is wood chips, which does not comply with MAAB accessible surface requirements, also these wood chips are not preventing erosion within the play area; a drainage path is visible where the wood chips wash out, further affecting accessibility. (Figure 5, previous page)	Refer to Site Assessment section of this report for discussion of replacing playground surfacing.
Nearly all of the required exterior egress doors from interior spaces have a 6"(+/-) step down to grade. Doors intended to be used as entrances should be accessible. (Figure 6)	Adjust grading of sidewalks and adjacent landscaped areas leading up to exterior frost pads at doors to provide an accessible path. Ideally, slopes should be maintained at less than 1:20. See Site Assessment section for additional discussion.
The ramp adjacent to the loading dock does not feature guardrails and handrails compliant with MAAB and the building code, and is too steep for MAAB requirements (Figure 7, 8).	Replace the ramp with a ramp meeting accessibility requirements for slope; include guards and handrails meeting accessibility and building code requirements.

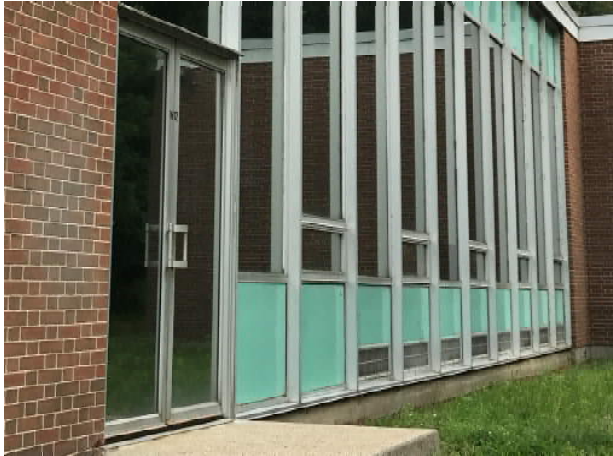
*Figure 6—Exit stair discharge door with step*

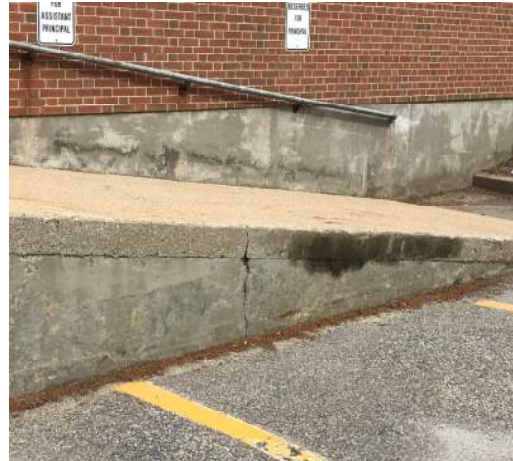
*Figure 7—Ramp at loading dock missing guardrail*

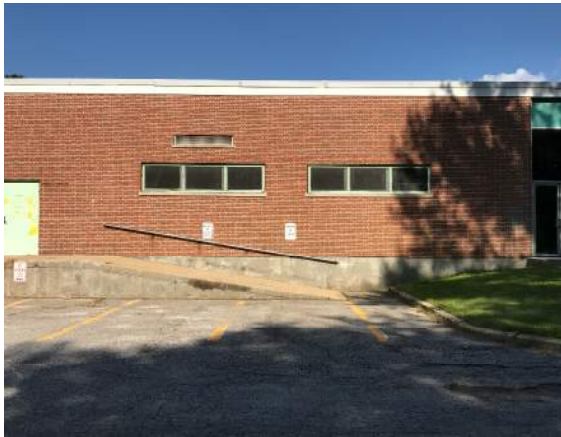
*Figure 8—Ramp at loading dock missing guardrail*

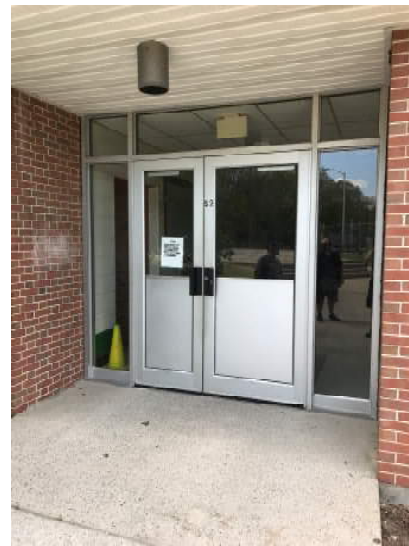
*Figure 9—Corridor exit vestibule door classroom wing*

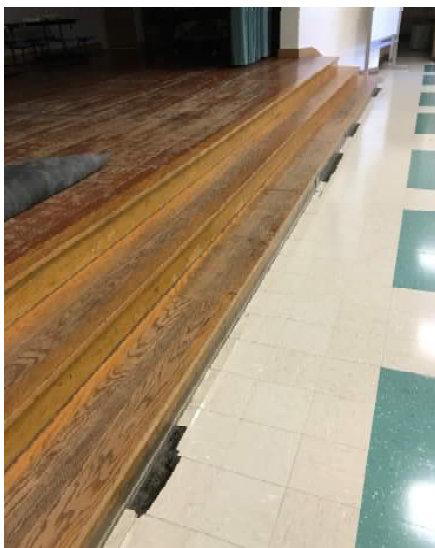
*Figure 10—Stage access via stairs at front of stage*

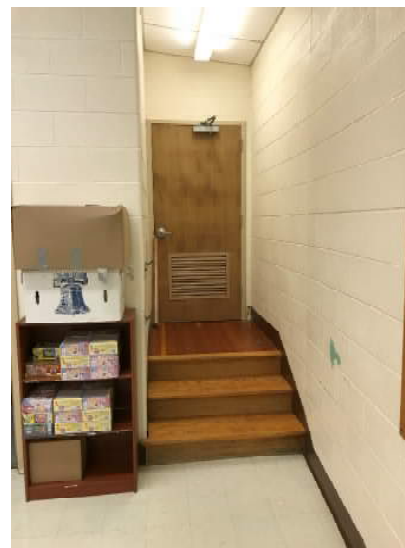
*Figure 11—Stage access via stairs in SAC office*

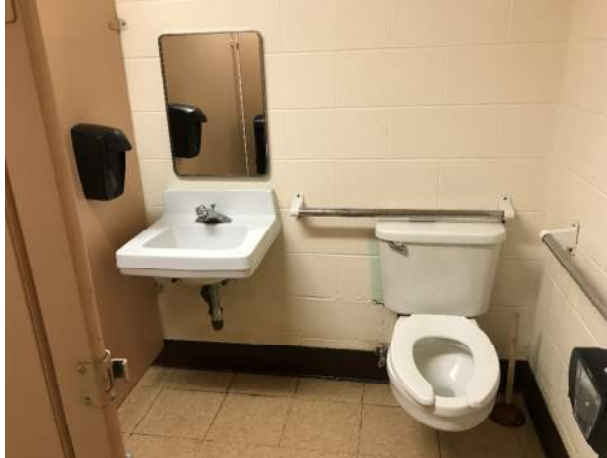
While some previous attempts were made to improve accessibility at toilet rooms by the addition of grab bars, they are not fully compliant with MAAB or ADA requirements. Fixtures and accessories such as mirrors are not compliant. In toilet rooms with more than 6 total toilets and/or urinals, ambulatory stalls are not provided. Mounting heights of fixtures and accessories such as mirrors must be coordinated with the grades and ages served. (Figure 12)	Reconfigure toilet rooms to provide accessible toilet stalls, possibly including reduction in total fixture count. This would include demolition and replacement of floor slabs to facilitate relocation of underground piping.
Gang toilet rooms feature pedestal mounted sinks which do not provide knee clearance. There are no paper towel dispensers in proximity to any sinks. (Figure 13).	Refer to recommendation above.
The toilet room in the Nurse's suite is not accessible; the configuration of walls does not provide the required floor clearance for any fixture or door openings. The sink is located outside the toilet room. Reconfiguration of walls in the area would be needed to provide a compliant room. (Figures 14, 15).	Demolish inaccessible toilet room in its entirety including doors, frames, and walls. Provide new toilet room layout that is in compliance with current MAAB and ADA requirements.

*Figure 12—Non accessible toilet room.*

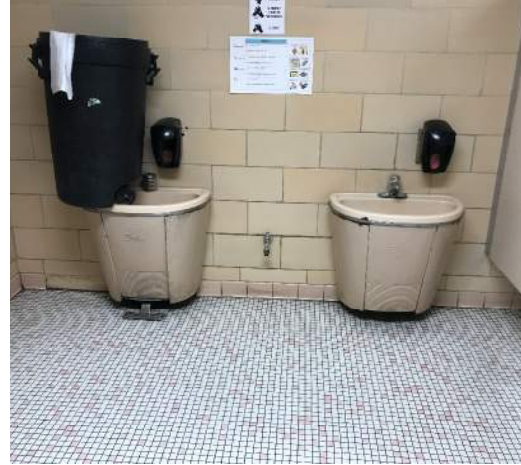
*Figure 13—Non accessible gang bathroom typical*

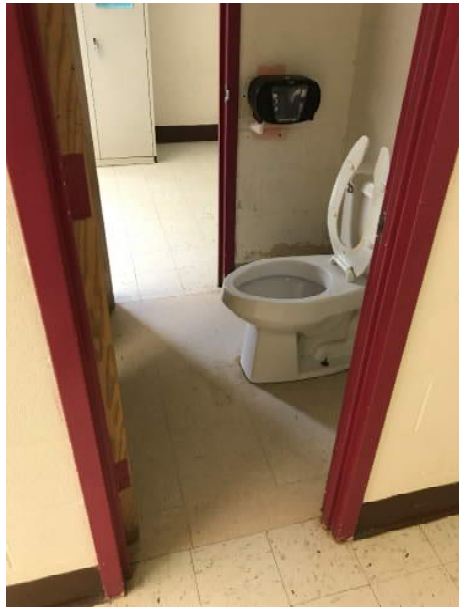
*Figure 14—Non-accessible toilet in nurses suite*

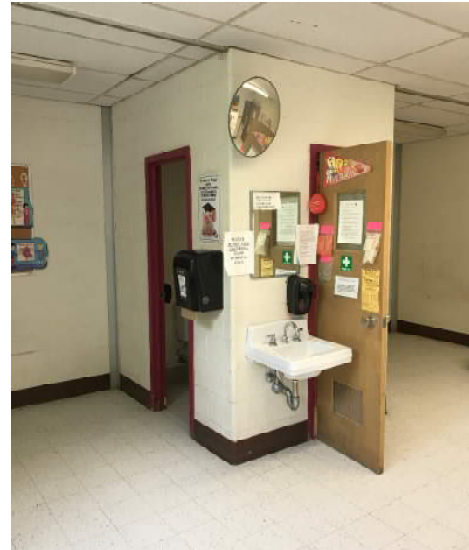
*Figure 15—Non-accessible toilet in nurses suite*

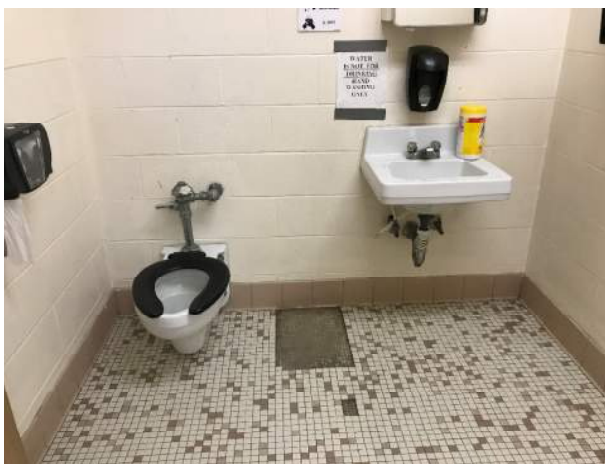
Faculty single user toilets are not in compliance with current MAAB regulations; the required floor clearance at toilets is not provided, there are no grab bars at the toilet, the toilet paper dispenser is not mounted in an acceptable location. Relocation of walls will likely be required to create compliant spaces (Figure 16)	Demolish inaccessible toilet room in its entirety including doors, frames, and walls. Provide new toilet room layout that is in compliance with current MAAB and ADA requirements.
Drinking fountains in the building are not the high/ low configuration required by ADA, and do not provide knee space for forward approach. (Figure 17).	Remove all non compliant drinking fountains and replace them with the high / low configuration that is compliant with the current MAAB regulations.

*Figure 16—Non accessible single user toilet room.*

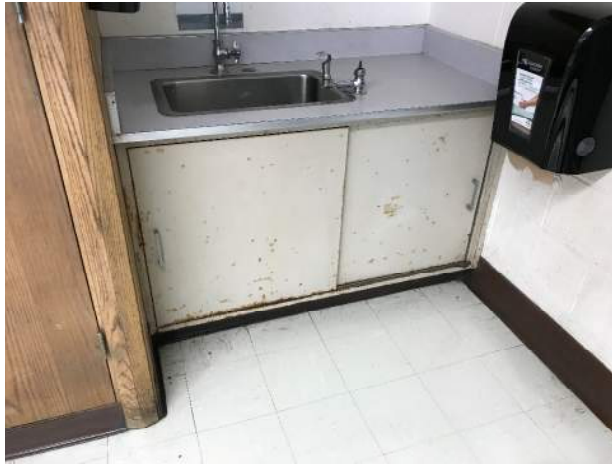
All of the casework and sinks in the classrooms are not accessible. There is no knee space under the sinks and there are paper towel dispensers in the approach to the sinks. (Figure 18).	Remove all of the casework and sinks from the classrooms and replace them with new casework and sinks that meet the requirements of the current MAAB regulations.
There are four classrooms that have toilet rooms which are not accessible. Two of those bathrooms are being used for storage. It is our interpretation that the occupants in these classrooms are not covered by accessible gang facilities on the floor; if these facilities are provided for a specific use such as pre-K or Kindergarten-only, in-class use, they should be accessible. (Figure 19)	Demolish and reconstruct the toilet rooms, including the surrounding walls and doors, to provide accessible toilet rooms. Use child-height fixtures and mounting heights as appropriate to the ages of the intended users.

*Figure 18—Typical non-accessible sink*

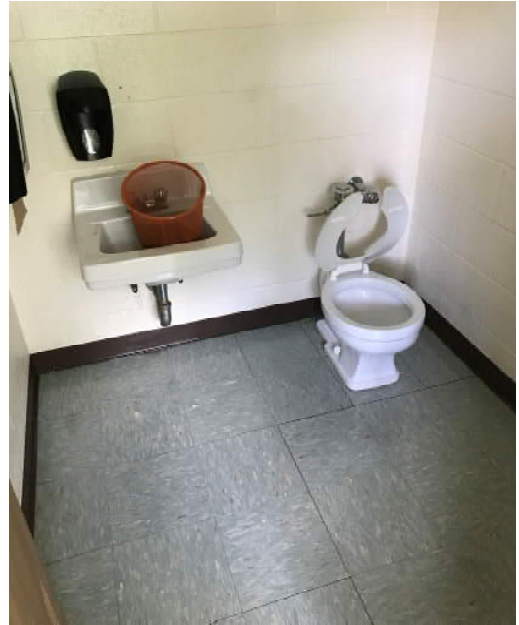
*Figure 19—Non-accessible classroom toilet*

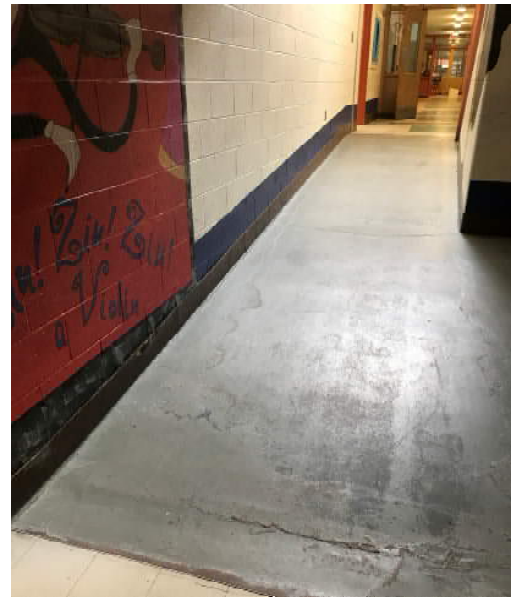
*Figure 21 —No handrails at interior ramp*

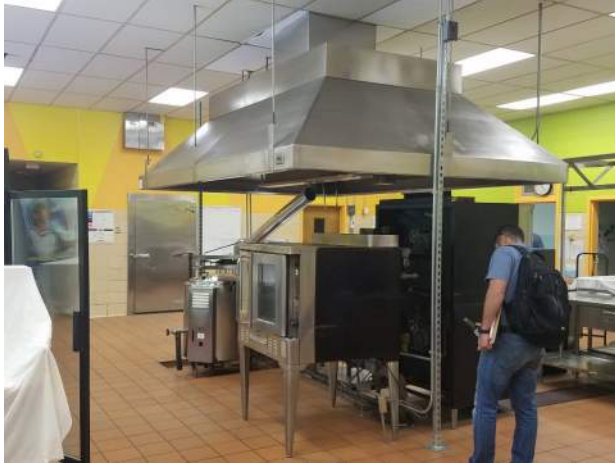
*Figure 11*

The Kitchen is provided with a ducted exhaust range-hood for control of cooking grease and fumes. (Figure 11) This exhaust system appears to be adequately sized for the associated cooking range. There did not appear to be any means of make-up air for the range-hood exhaust system; this condition is not code compliant and should be remediated. All systems appear to be original to the building and have surpassed their expected service lives.

Code-required make-up air for the Kitchen Range hood is not provided.	Add tempered make-up air system to kitchen tied to existing kitchen hood, or replace hood with model that includes compliant makeup air.
---	--

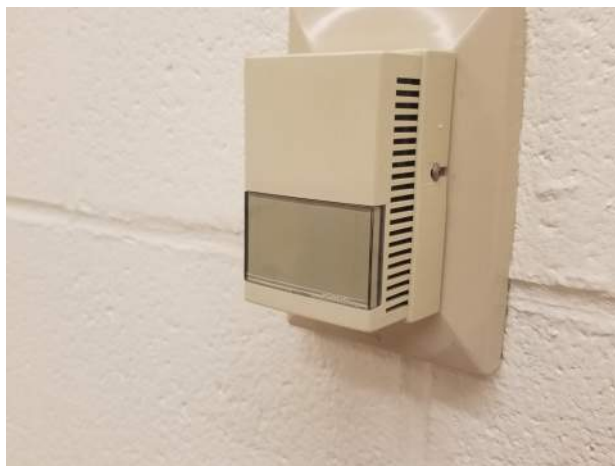
Figure 18

Many spaces are provided with two (2) pneumatic temperature sensors; one for use during occupied building schedule periods and one for unoccupied building set-back temperatures. (Figure 18) In general, the controllability and dependability of pneumatic control systems are lacking and do not compare to current electronic communication technologies. The pneumatic control system leaks and is beyond its expected service life.

<i>Specific Issues</i>	<i>Recommendations</i>
Pneumatic Control system air leaks were noted in various spaces throughout the building and at the boiler room control panel.	Replace control system entirely with Direct Digital Control system.

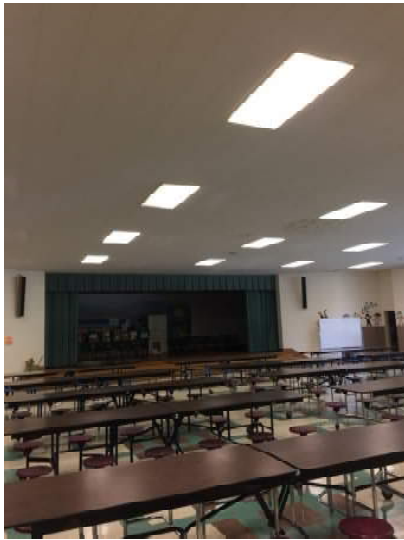
*Figure 8*

The cafetorium lighting consists of 2x4 lensed troffers and (2) T8 lamps. The platform contains a theatrical lighting system with incandescent fixtures. The system is in poor condition. All lighting is switch controlled. (Figure 8)

Lighting fixtures are not energy efficient.	Replace existing lighting throughout the building with LED fixtures and provide an automated lighting control system with occupancy sensors to reduce energy usage and comply with the latest energy code.
---	--

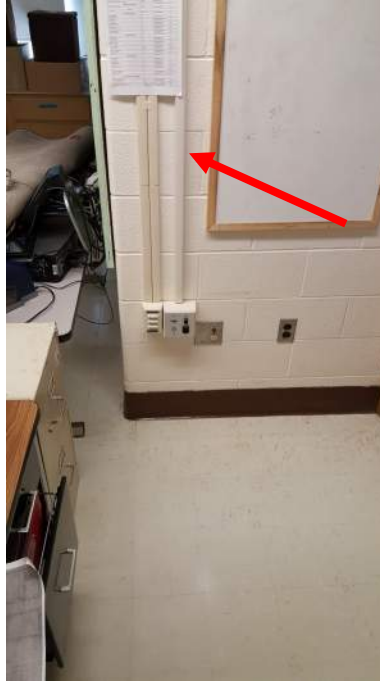
*Figure 2—Surface Mount Cabling*

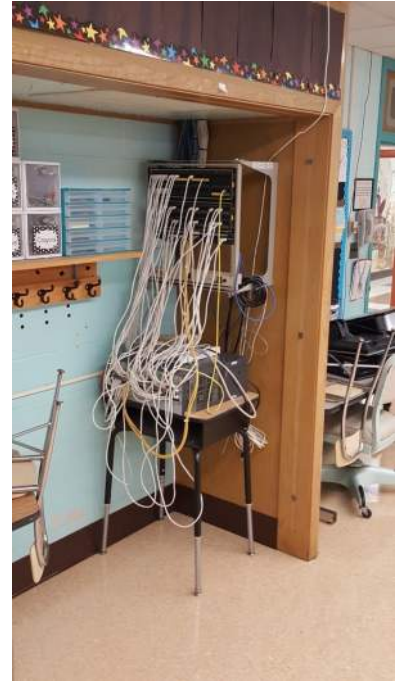
*Figure 3—IDF in Classroom*

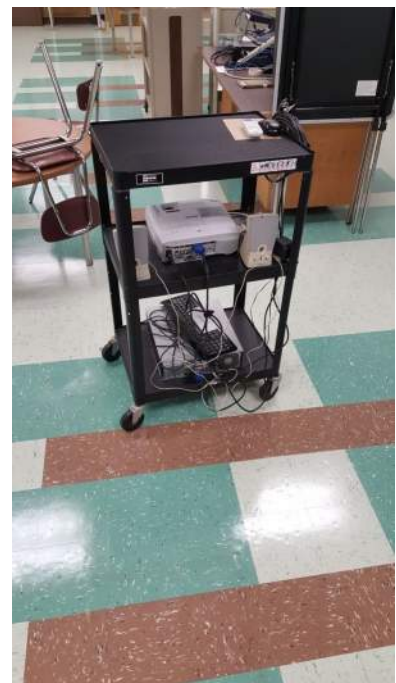
The Gymnasium has poor quality audio system speakers and no real permanent sound system. A mobile projection cart and audio system are used in this space (Figure 16)

Figure 16 –Multimedia Cart

<i>Specific Issues</i>	<i>Recommendations</i>
Audio system in the primary assembly area was not working.	Install new permanent sound equipment.
There is a portable projection cart with a low lumen projector used in Cafeteria.	Install a permanent mounted high lumen projector with connections to new audio system and inputs at the stage for presentations. Upgrade screen.
Gymnasium is without permanent AV equipment	Install new audio system and projection screen on the wall. Upgrade portable cart with high lumen projector for use in the Gym.

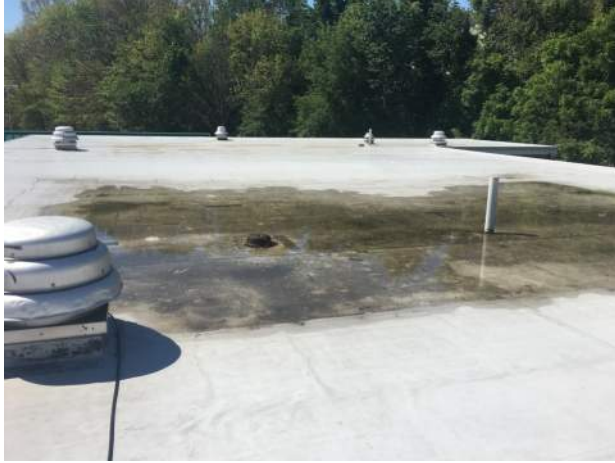
<i>Specific Issues</i>	<i>Recommendations</i>
There is considerable ponding on roof in vicinity of the roof drains. Roof drain bodies are heavily corroded, and some strainers are loose. (Figures 1,2, 3)	Refer to architectural assessment for discussion of roofing slope and drainage.  Replace roof drain bodies and strainers with new drain assemblies.
Plumbing vent stack is heavily corroded, and flashing at roof penetration appears to be loose, potentially leaking into the building. (Figure 4)	Replace plumbing vent through roof and re-flash to roofing membrane.
Flue for water heating / boiler is located adjacent to a higher wall. Supports for the flue are showing significant corrosion. (Figure 5)	Flue may not achieve proper draft. Evaluate performance of equipment. Replace flue and supports.

*Figure 1— Ponding around Roof Drain*

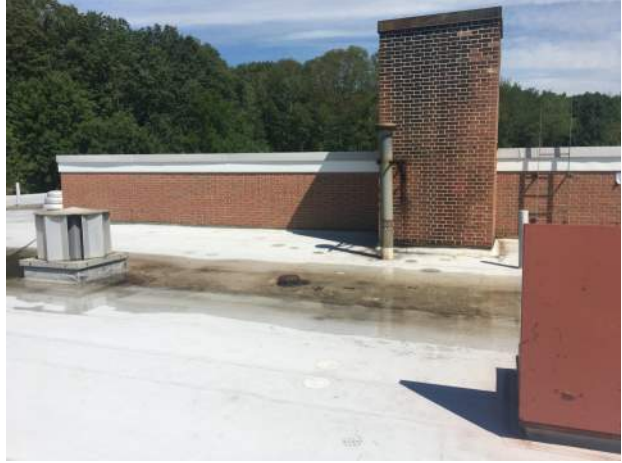
*Figure 2— Ponding around Roof Drain*

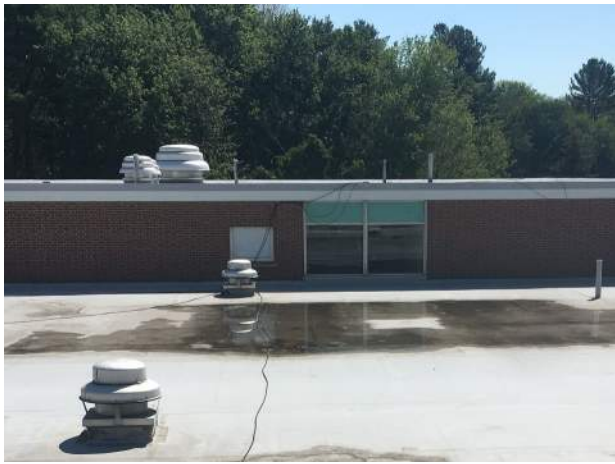
*Figure 3— Ponding on roof*

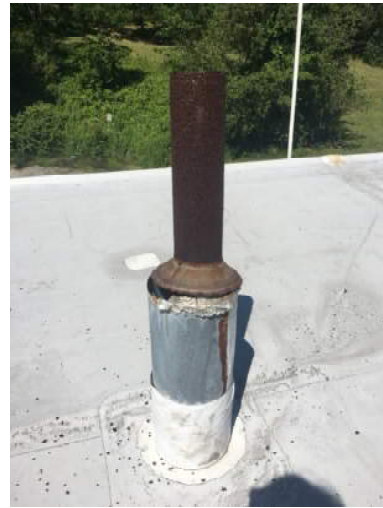
*Figure 4— Plumbing Vent. Appears to be disconnected.*

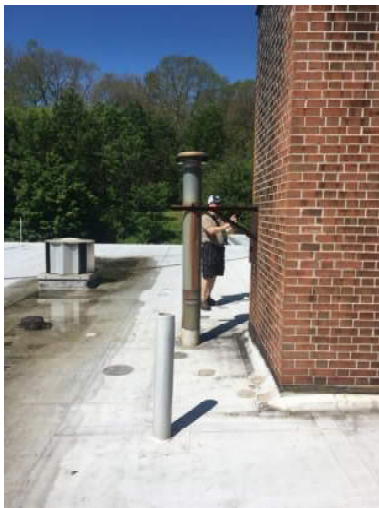
*Figure 5 — Chimney*

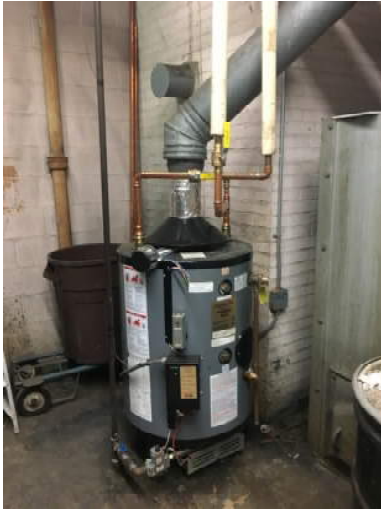
Domestic hot water originates from 35 gallon hot water heater (Figure 6) and is stored in a 1235 gallon storage tank (Figure 7).	Based on age of equipment and domestic hot water demand of an elementary school, it is very inefficient to heat and store that amount of water. Replace with high efficiency gas fired domestic hot water plant.
Janitor's sink has a chemical dispenser. However, there is no backflow preventer installed to prevent cross-contamination (Figure 9).	Backflow preventers are required and will need to be installed per plumbing code.

*Figure 6 — 35 Gallon Domestic Hot Water Heater*

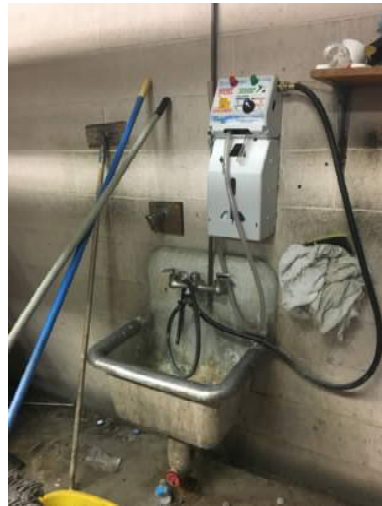
*Figure 9 — Mechanical Room Janitor's Sink*

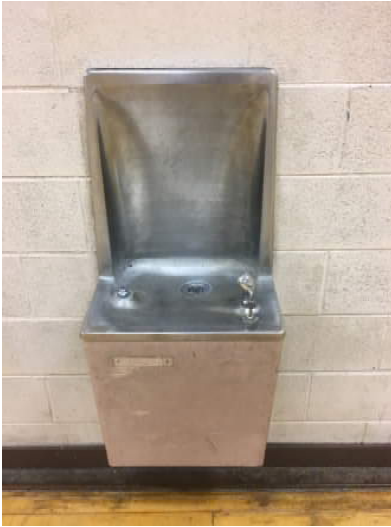
Drinking fountains are not accessible. (Figure 20)	Refer to the Regulatory Assessment section of this report for further discussion.
The shower rooms are used as storage (Figure 22, Figure 25).	Showers are required for schools that include physical education and sports.  Determine proper use of the space, and if not required, cap and remove plumbing at shower units.
Most classrooms have a sink with a drinking spout tapped off of the sink (Figure 23). Signs above the sinks state water is not for consumption, due to past testing that showed lead in the water supply. (Figure 22).	Replace supply piping to sinks or throughout building to remove iron piping and lead solder. Continue testing water service to attempt to isolate sources of lead contamination.
The water service is largely inaccessible, and appears to be being used as a support for a makeshift counter. (Figure 25)	Remove stored materials from the water entry piping and valves.

*Figure 20— Drinking fountain*

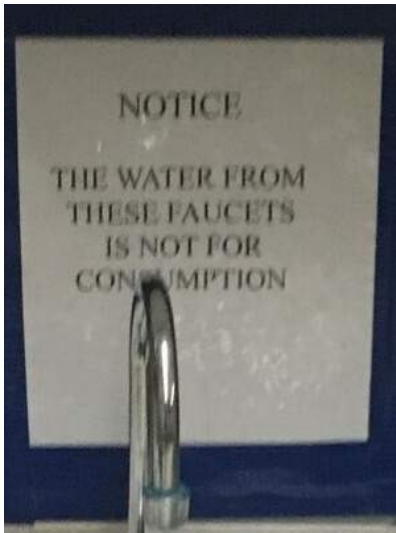
*Figure 22— Not for consumption Sign*

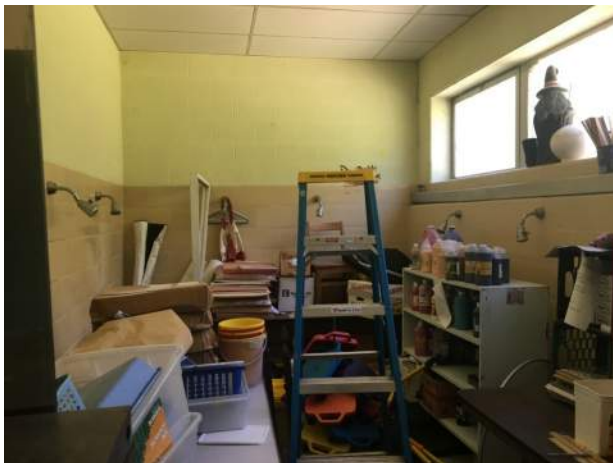
*Figure 24— Shower room used as storage*

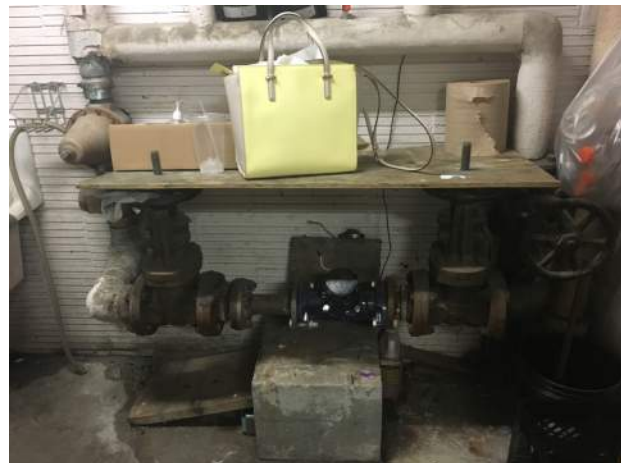
*Figure 25— Water Meter in Janitor's Closet*

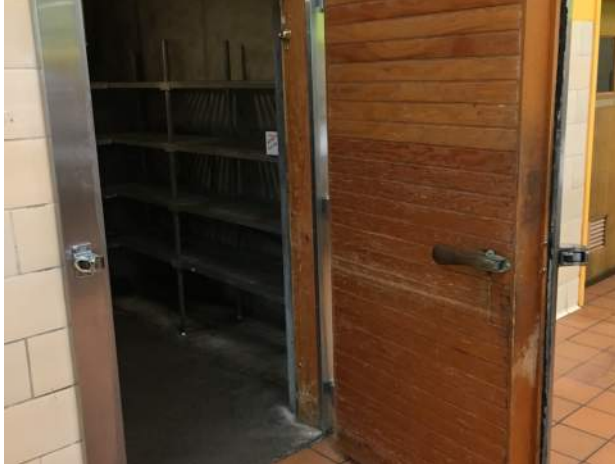
The walk-in cooler and freezer are original to the facility. Wood is used as some of the finishes within the rooms. The rooms are constructed of two layers of caulk insulation covered with a vapor barrier and a stucco finish. (Figure 1).	Replace with a modern walk-in panel assembly that is compliant with modern food safety standards for sanitation. All wood must be eliminated. Upgrade the refrigeration system and the insulation to current Department of Energy standards for insulation R-values.
The shelving within the walk-in rooms is galvanized steel. Galvanized steel is not a compliant food contact surface, due to fear of contamination by zinc in the galvanizing. Also, in time the zinc wears away and the mild steel begins to corrode, as is the case here. (Figure 2)	Replace the shelving with food grade shelving that is non-corrosive and easy to clean.
The interior wall finish of the walk-in units is a rough stucco finish. It is not smooth or easy to clean. It is also absorbent and prone to cracking. It appears that mold is forming in various locations. (Figure 3).	Replace the walk-in units as noted above.

*Figure 1—Walk-in Cooler wood door*

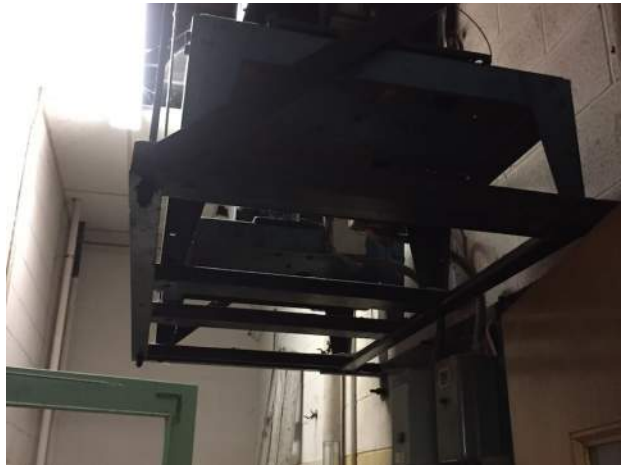
The condensing unit for the walk-in units are located indoors at the receiving corridor. Because they are indoors the units reject heat and noise into the kitchen space. (Figure 4).	Replace with new more energy efficient units located outdoors.
Wood topped tables are allowed in kitchens, but only for use with baking functions. A majority of the tables in the kitchens are wood topped. Wood is difficult to maintain as they need to be oiled regularly. These tables are in fair shape, as it is clear they are well-maintained. However, as a food preparation surface stainless steel is required. (Figure 5).	Replace all wood topped tables with stainless steel constructed tables.
The table bases are constructed of painted galvanized steel. As paint wears off the mild steel begins to corrode. (Figure 6).	Replace with new tables that are constructed with 100% stainless steel.

*Figure 4—Walk-in cooler remote condensers*

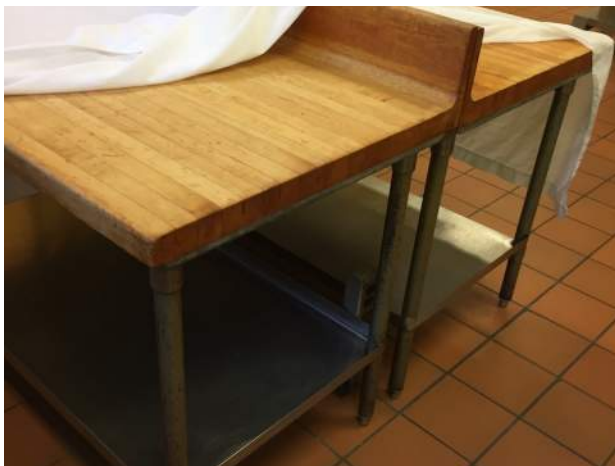
*Figure 5—Two of many wood topped tables*

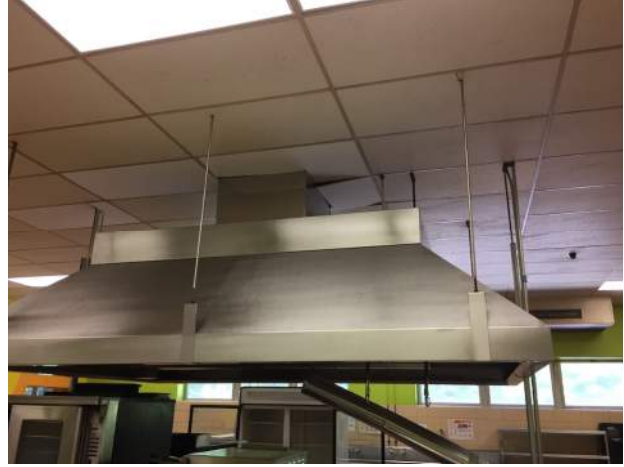
<p>The kitchen hood includes a large horizontal surface below the ceiling, where conduits and utility piping is visible dropping from the ceiling above. The area above the hood is required to be closed off. The horizontal surfaces become a place for dust to settle. Cleaning that horizontal surface on a regular basis is not practical in this case. (Figure 7).</p>	<p>Replace the hood with a modern UL listed hood with appropriate closure trim.</p>
<p>The health code mandates that kitchen ceilings be a smooth, non porous, and an easily cleaned surface. The current ceiling is a typical soft stippled finish that is easily damaged and degrades in moist environments. (Figure 8).</p>	<p>Replace grid and lay in tiles with melamine faced or kitchen rated smooth ceiling panels that are washable and resistant to moisture.</p>
<p>The extent of the utility lines and the manner in which they have been added over time has created a condition that makes it very difficult if not impossible to maintain and keep clean. (Figure 9).</p>	<p>Implement a Utility Distribution System (UDS) to conceal the utility lines. The enclosure around the utility lines will provide for a smooth water tight surface that can be easily cleaned.</p>

*Figure 8— Exhaust hood and floose ceiling tile*

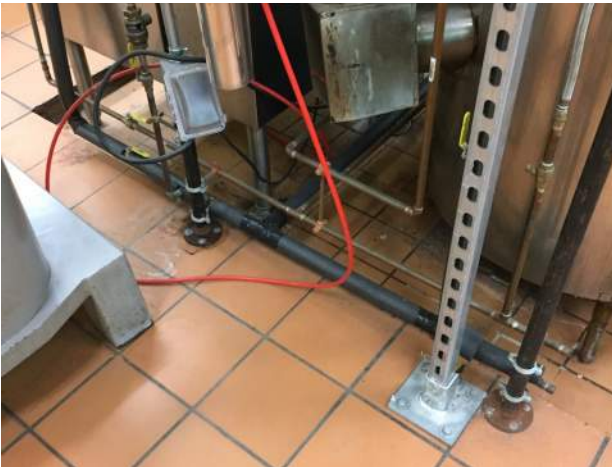
*Figure 9—Extensive utilities at cooking line*

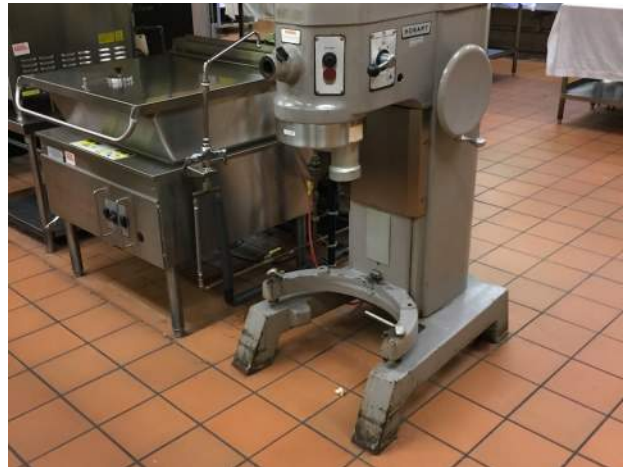
<p>The mixer in this case works well but lacks the modern safety features required with a new mixer.</p>	<p>Replace the mixer with a new unit that offers the safety features meeting OSHA compliance and providing attachments that will allow expanded functions in the preparation of food.</p>
<p>The serving counter is outdated and lacks the components needed to effectively maintain proper serving temperatures. The glass shields needed to protect the food from contamination are missing or inadequate. The sneeze shield on the counter is not compliant and does not offer the minimum coverage needed to shield the food. The old hot wells appear to have been cut out of the counter and replaced with a unit that was slid into the cut out. It is an installation with many rough edges. (Figure 11).</p>	<p>A serving counter replacement is warranted. Adequate hot and cold wells along with proper sneeze shields are a necessity. A new counter will also be equipped with additional power sources to offer flexibility.</p>

*Figure 10— Large mixer lacking safety guard*

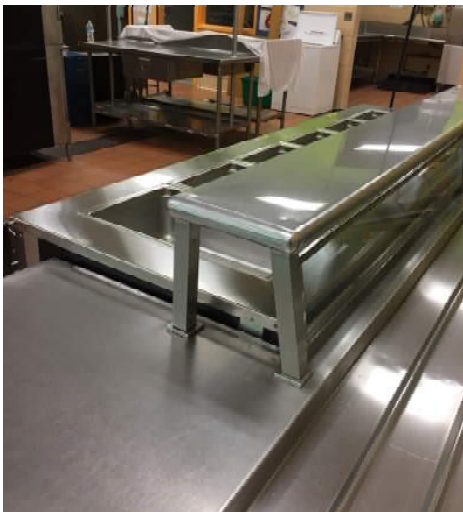
*Figure 11—Repaired serving line*

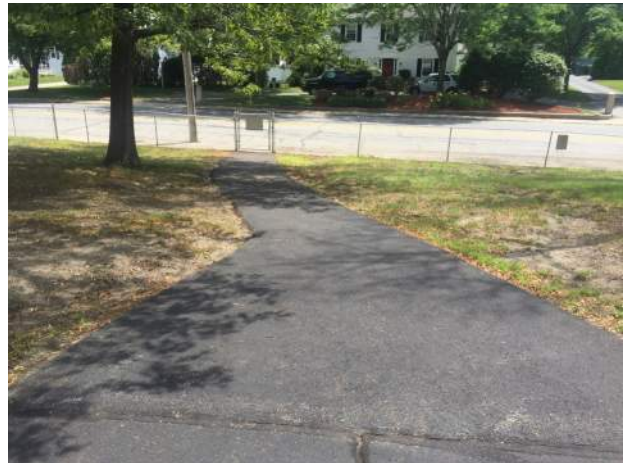
There are a number of large shade trees on site; Elm, Oak, Maple and Beech were observed. These trees provide a great deal of shade in the outdoor areas and also offer historic value for the entire community. At least one of these trees was observed to be in declining condition, but most appear to be in good health. (Figure 2., Figure 3.)	Have trees evaluated by a certified arborist and follow the recommendations provided. Likely maintenance will include edging and mulching, and airspading at base of tree, pruning of dead and dying limbs, and fertilization as needed.
The original school building is constructed on a steep hill, with the rest of the school occupying a relatively flat site beneath it. Topography is generally not a factor except where access is impeded by steep slopes at the original school building. (Figure 4., Figure 6.).	See Sidewalks and Pedestrian Routes section for specific recommendations.

*Figure 4—School and playground at top of steep slope*

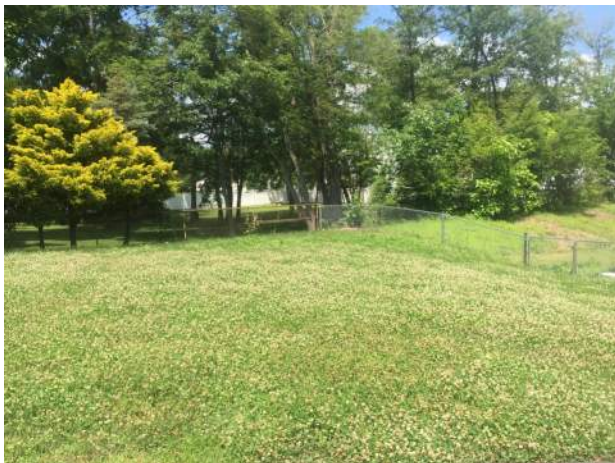
*Figure 5—Limited lawn areas on site*

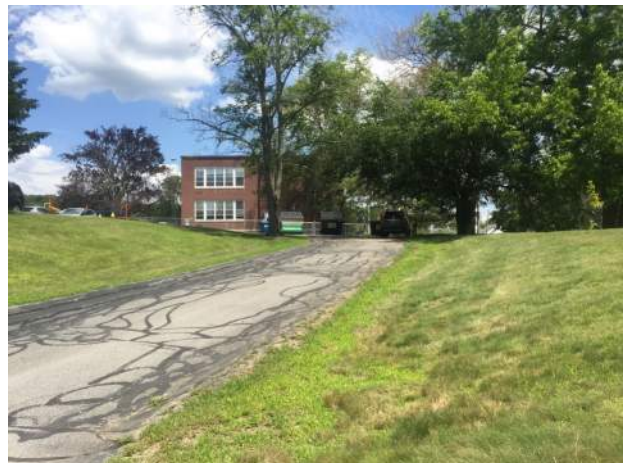
*Figure 6—Original building sited atop steep hill*

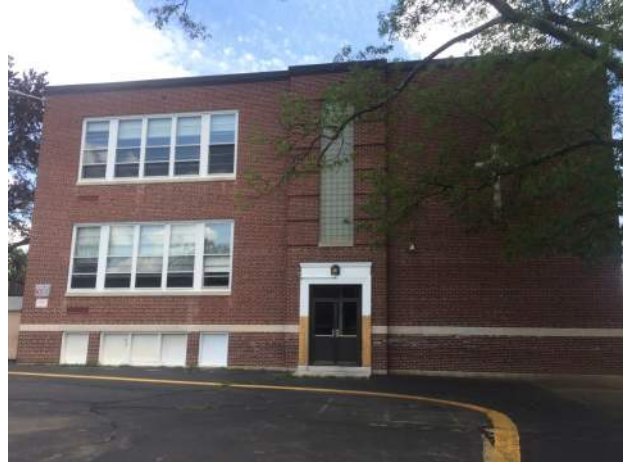
*Figure 8—Original school building*

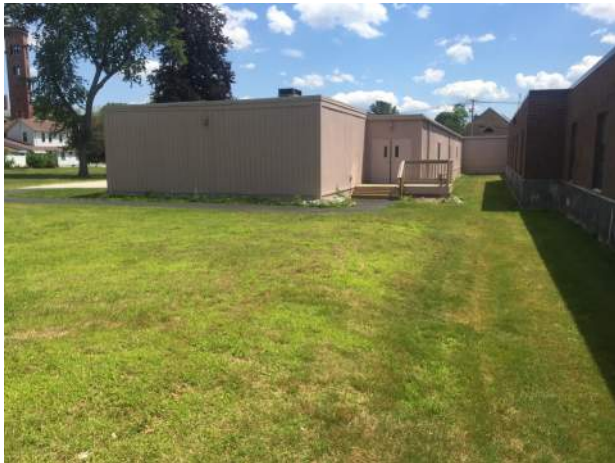
*Figure 9—1983 school addition.*

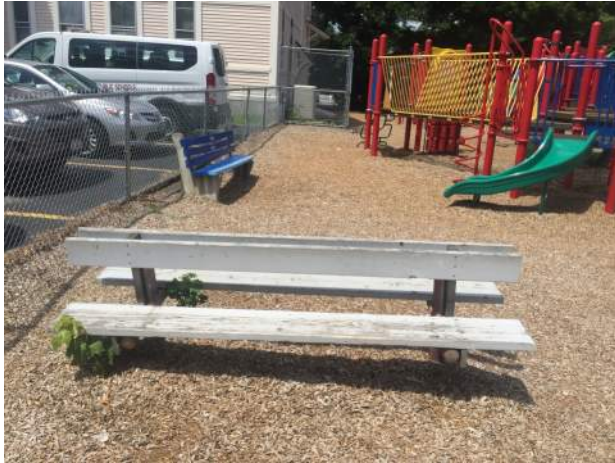
Benches are worn and in fair condition, and represent a variety of styles and designs. There is a lack of diversity in outdoor seating opportunities such as picnic tables or individual chairs. (Figures 13, 14, 15)	Remove old benches. Furnish and install new benches and picnic tables. Provide better distribution around site and at waiting areas.
One bicycle rack was observed and was in poor condition, and was located in an unsuitable location for proper access. The bicycle rack did not present sufficient capacity for the number of students. No bicycle racks were observed at other entrances. (Figure 16.)	Provide more high quality bicycle racks to encourage student to bike to school and sports. Place bicycle racks on level, undamaged concrete pads for safety and accessibility. Provide bike racks at appropriate areas.

*Figure 13 Bench at play area*

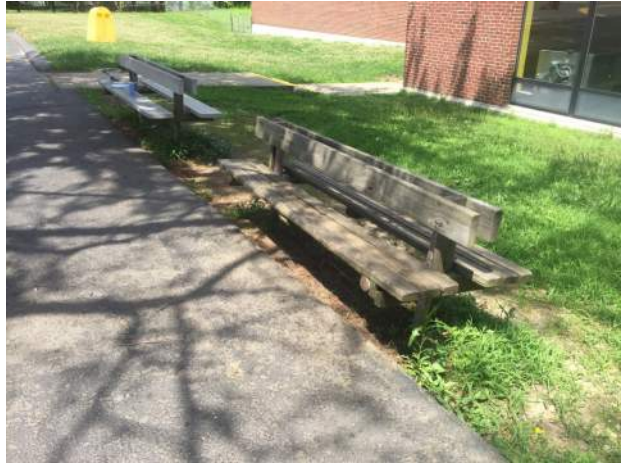
*Figure 14—Benches at schoolyard*

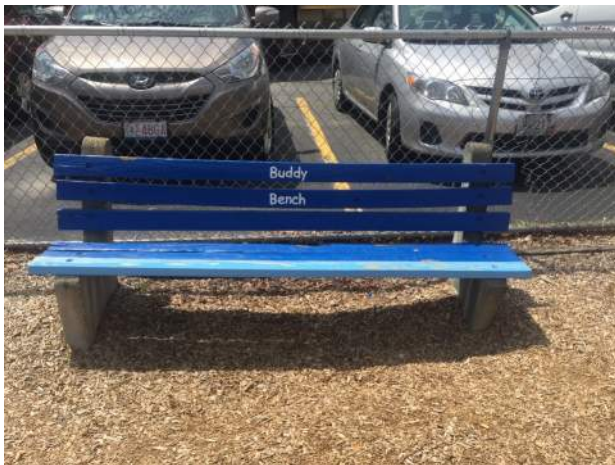
*Figure 15—Bench at play area*

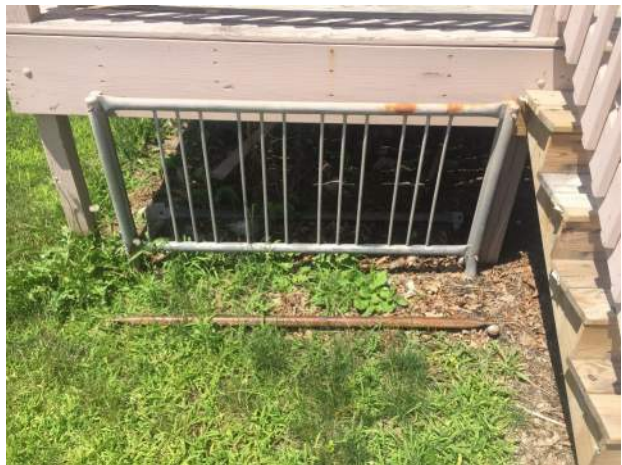
*Figure 16-Bicycle rack at drop-off area*
