# W. EDWARD BALMER ELEMENTARY SCHOOL

NORTHBRIDGE PUBLIC SCHOOLS  
TOWN OF NORTHBRIDGE, MASSACHUSETTS

## PRELIMINARY DESIGN PROGRAM, SECTION 3.1.4

### EVALUATION OF EXISTING CONDITIONS

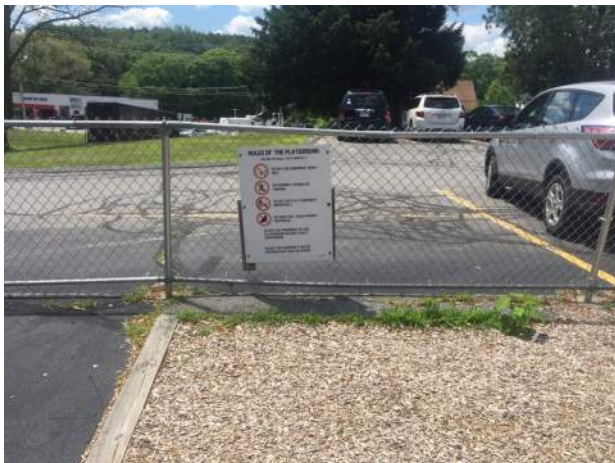
There is a fair amount of galvanized chain link fencing around the school property, most of it is in fair to good condition. There is securely enclosed fencing around the rear schoolyard perimeter, which is common in similarly urban settings. There were instances of rusting fabric, bent rails, and missing hardware components. None of the chain link fencing was black-vinyl coated (Figure 17.)	Replace all missing or broken fence components to match existing galvanized construction. Consider replacing all fencing with black vinyl coated for greater longevity.
Only one trash receptacle and no recycling receptacles were observed at the school site. The single trash receptacle was not of suitable quality for permanent exterior use. Trash and litter has accumulated in some areas . (Figure 18.)	Furnish and install more trash and recycling receptacles of suitable quality for exterior use and of a uniform style and performance standards.

*Figure 17—Chain link fencing at school.*

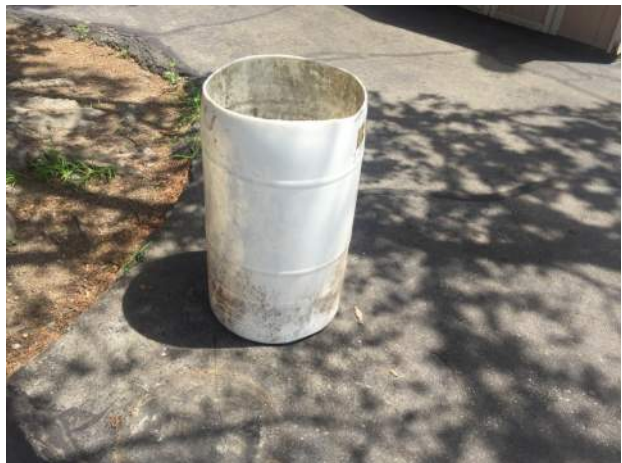
*Figure 18—Waste barrel at schoolyard*

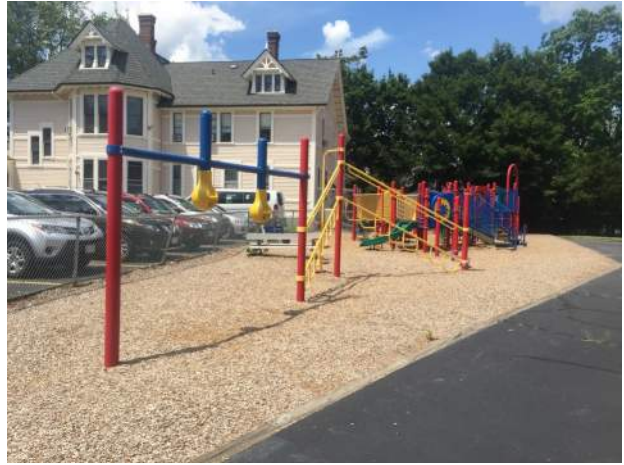
Playground equipment is generally in good condition; it appears to have been constructed within the last 10 years. There are fencing and edging in close proximity to the play equipment, which should be reviewed for compliance with equipment setback requirements. This should be conducted as part of a comprehensive playground safety inspection by a certified CPSI. The area itself is relatively small for the number of students it serves and would benefit from expansion (Figures 20, 21) No Accessible playground equipment was noted.	Perform a playground safety inspection by a certified CPSI. Refurbish and repaint all properly functioning equipment displaying visual wear. Provide accessible play equipment.
The surfacing at the playground is constructed of wood chips, and appears to be of fairly recent installation. The chips themselves appear to be in good condition, but migration and lack of maintenance has left some bare areas in the play area and some chips out on the paved area. (Figure 24.)	Provide regular maintenance of wood chip surfacing. Rake chips to avoid bare areas and prevent excessive mounding. Consider replacing wood chips with poured in place rubberized safety surfacing for increased safety and visual appeal, and reduced maintenance.

*Figure 20—Play equipment at schoolyard.*

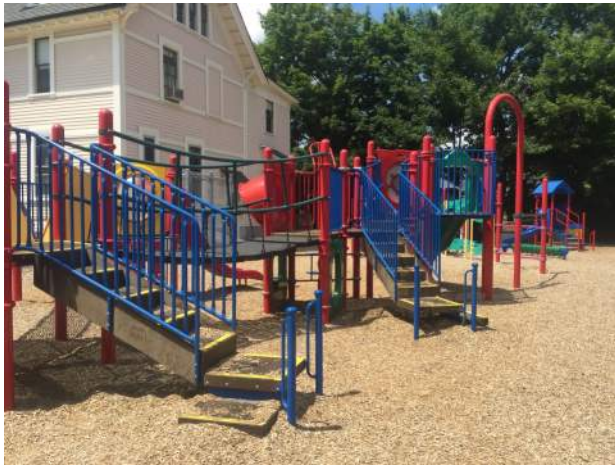
*Figure 21—Play equipment at schoolyard.*

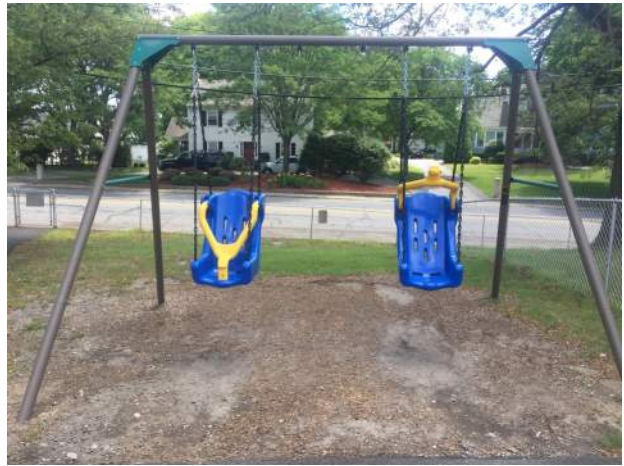
There is a single swing set with two swings, both designed for toddlers. It is in very good condition. The wood chip surface below has eroded and no longer provides any impact attenuation. (Figure 22)	Provide additional swing sets to allow more and older children to use them simultaneously. Provide adequate safety surfacing in fall zones surrounding all swing sets.
Although there is an abundance of paved surface in the play area, there are very few painted games. There is a single four square court, an unidentified painted game, and a painted line around the perimeter of the area which may be a bigwheel racetrack. (Figures 19, 23)	Provide more painted games and graphics for a range of ages and levels of skill, such as four square, hopscotch, maps, and other games or graphics.

*Figure 22—Swingset at schoolyard.*

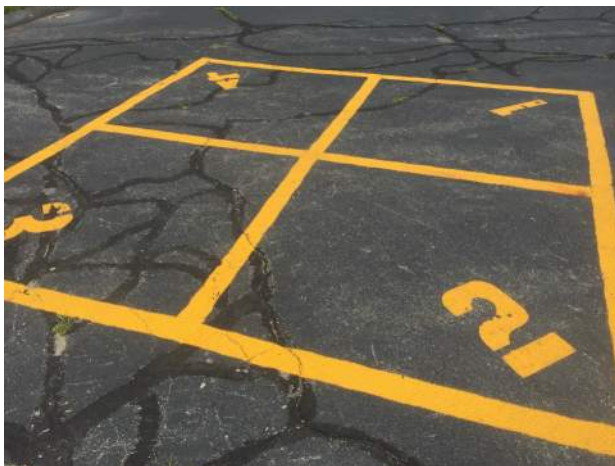
*Figure 23—Painted games at schoolyard.*

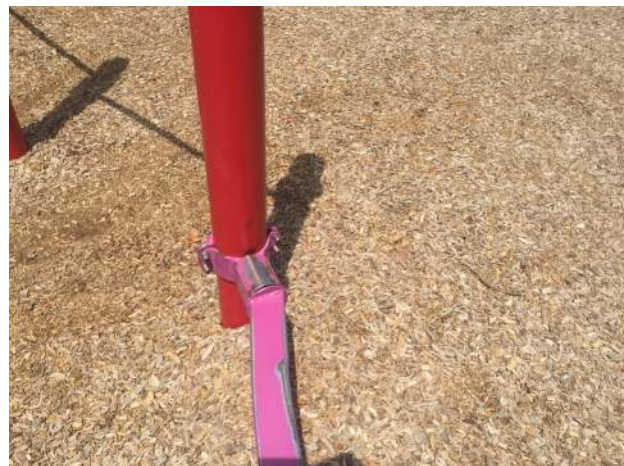
*Figure 24—Play equipment and mulch surfacing*

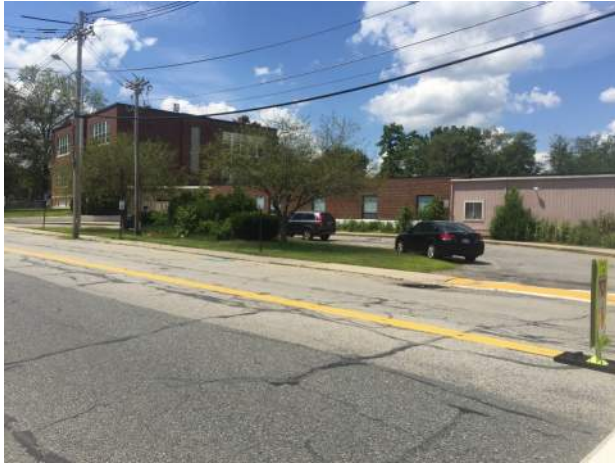
A lack of separation for parent, bus, and delivery drop-off is a safety concern. (Figure 25.)	Explore options for providing better separation for these various access needs.
Bituminous concrete surfaces are in poor condition, with significant cracking and patchwork. This contributes to issues with vehicular and pedestrian accessibility and safety, as well as drainage and erosion. Painted lines and markings like crosswalks are faded and difficult to read, creating safety concerns (Figure 27.)	Repair and repave all vehicular bituminous concrete surfaces. Repaint and restripe traffic markings.
Parking is limited to 21 vehicles for the school administration, staff, and visitors. This is insufficient for a school of this size. It is likely that a lot of people are utilizing parking at the Pleasant St Church located across Cross St. (Figure 29.).	Explore options for increasing parking and expanding existing parking lot areas on site.

*Figure 25—Entrance at school drop-off*

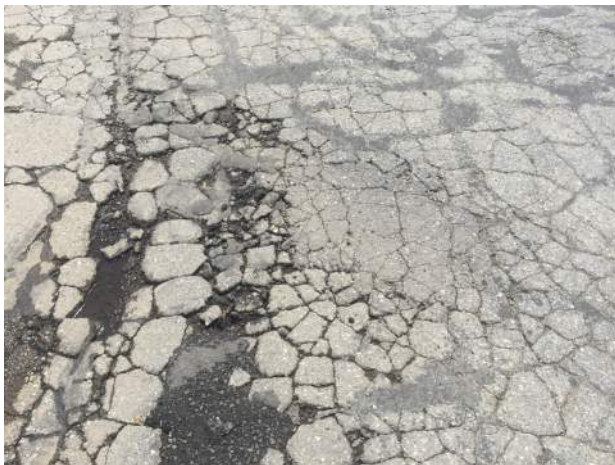
*Figure 27—Poor condition of bituminous concrete*

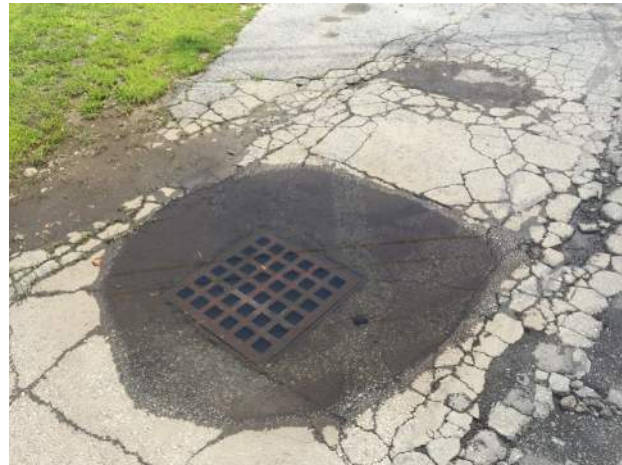
One catch basin in the school drop-off area was observed to be failing and a large puddle was observed during a dry period of no rain, suggesting it is clogged. The degree of cracking and erosion in the immediate area suggests that this is a serious problem and must be addressed. (Figure 28.)	Consult with a Civil Engineer to examine the catch basin and other drainage structures, and develop a repair or replacement plan.

*Figure 28—Catch basin at drop-off loop*

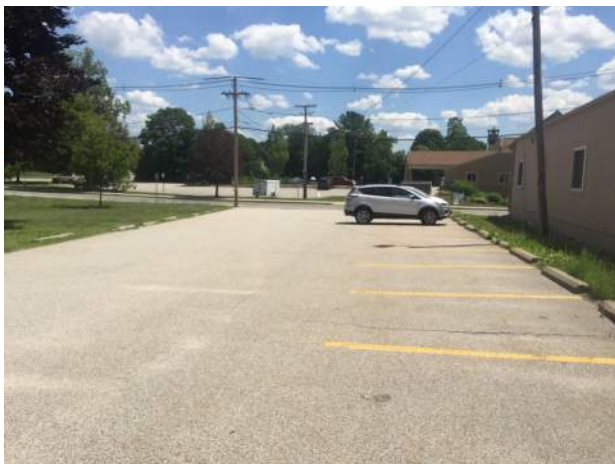
*Figure 29—Parking at school.*

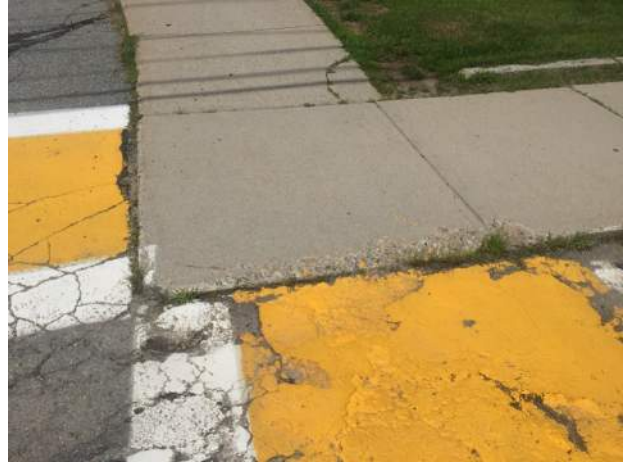
Concrete sidewalks are in poor condition-spalling, heaving, cracking and crumbling were all observed. In many instances the damage has resulted in cracks or gaps in excess of 1/2", rendering the routes unacceptable for MAAB or ADA access. Additionally, displacement from frost heaving has created irregularly sloped surfaces that do not meet accessibility regulations. (Figures 32, 33, 35, 36.)	Repair or replace all damaged concrete sidewalks. Provide accessible routes where necessary.
Bituminous concrete sidewalks and portions of sidewalks have been similarly damaged over time, particularly at the intersection of dissimilar surfaces, creating significant gaps. There is a portion of new bituminous concrete walkway from the parking lot to the north side of the school but it lacks an accessible entrance. (Figure 34.).	Repair or replace all damaged bituminous concrete sidewalks. Provide accessible routes to all building entrances and site amenities intended for use by the public.

*Figure 32—Excessive gap at crosswalk and sidewalk*

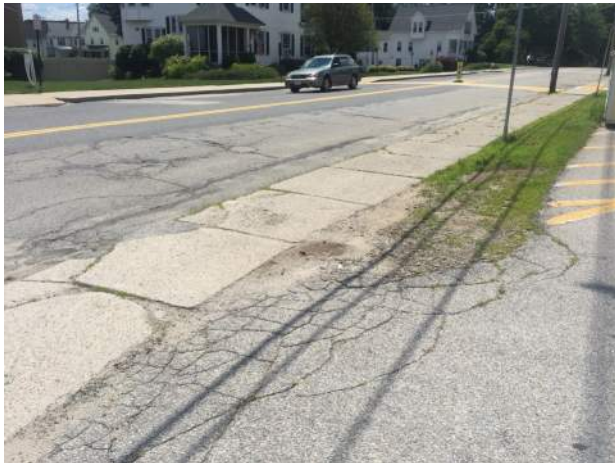
*Figure 33—Damaged pedestrian surfaces*

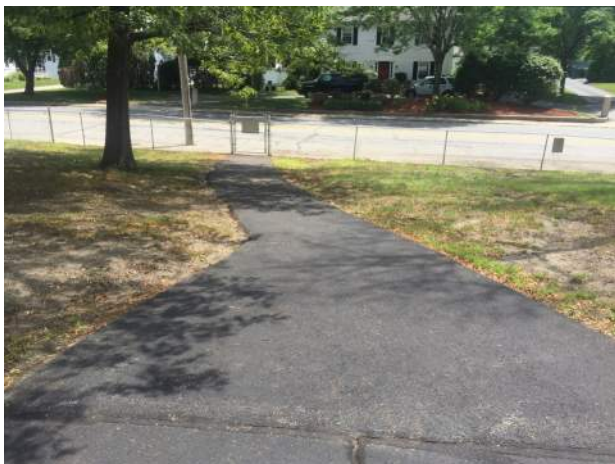
There does not appear to be an ADA accessible route to access the schoolyard, which is currently accessed through the building with a step, or from the street below by way of a steep bituminous concrete walkway (Figure 35.)	Explore various design options for provide access to the upper schoolyard by way of an ADA accessible walkway.

*Figure 35—Steep slope at schoolyard access walkway*

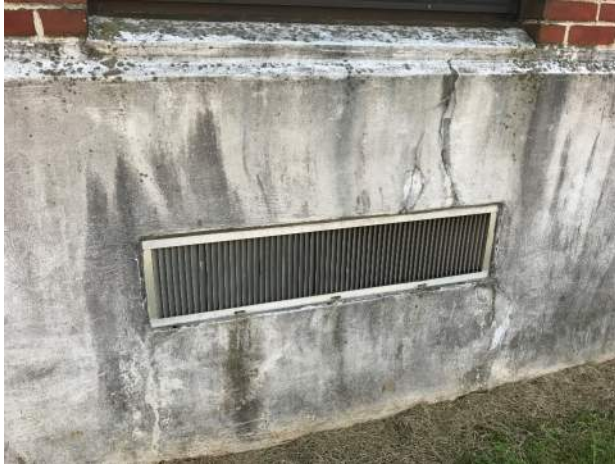
On the '83 wing, there is a recurring crack pattern at unit vent grille openings, at the upper corners of the opening. The cracks allow moisture to enter the wall thickness, where freeze-thaw cycles cause the moisture to deteriorate the concrete further, spalling the face and exposing deeper layers of concrete to moisture penetration. Evidence of past repair attempts are visible on the largest and deepest cracks. There are similar cracks on the '52 building, however they are much less severe. (Figures 1, 2, 3)	Undertake a concrete restoration program at all unit vent louvers where cracking exists. Remove all loose and unstable concrete material, and install new concrete repair mortar or patching cement. Consider applying an elastomeric coating or water repellant sealer to all exposed concrete to prevent further damage due to exposure to the elements.
The concrete parging has become significantly dirty due to years of accumulated weathering and grime. At some locations, mildew, mold, or lichens growth is apparent. (Figures 4, 5)	Either as part of the concrete repairs, or as a separate project, clean the concrete surface with a masonry cleaning product. Consider including application of an elastomeric coating or a water repellent sealer..

*Figure 1—Cracking at unit vent grille*

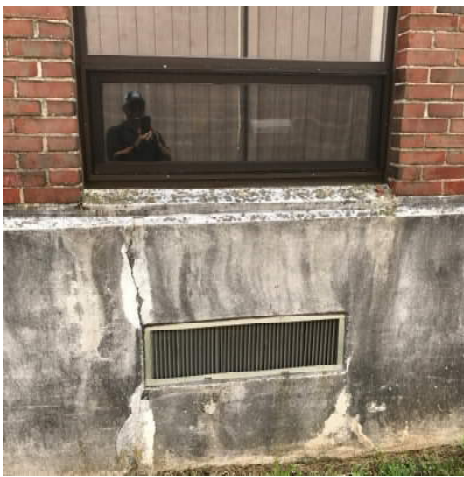
*Figure 3—Cracking at unit vent grille*

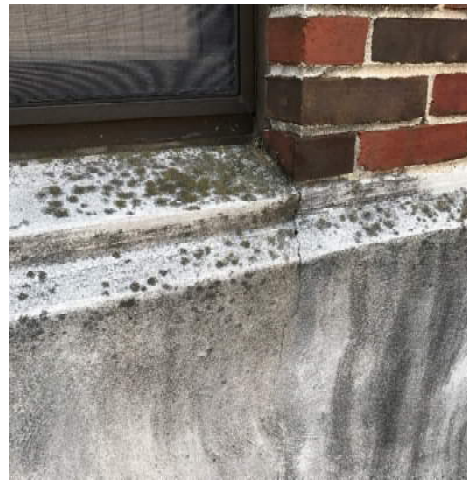
Northbridge Elementary School has two sections: the 1952 original school, and the addition built in 1983. The foundations of both areas are of similar cast-in-place concrete construction with spread footings, and both sections are rubbed and parged with an architectural finish. Both sections are, overall, in similar, fair condition, with some cracking at louver penetrations, and considerable staining of the concrete surface.

*Figure 4—Discolored and dirty foundation wall*

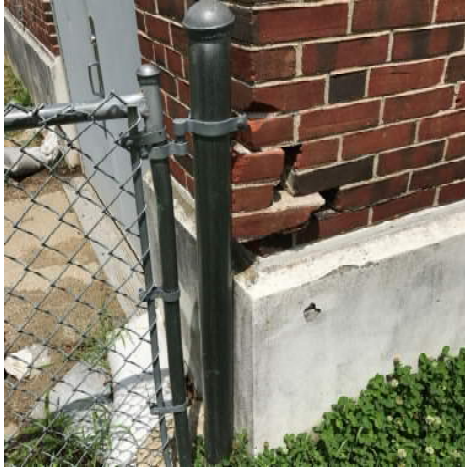
There are a few cracked bricks, most notably a section at the NW corner of the 1983 wing where brick are displaced from the corner. Directly above that location, there is a vertical crack at the building corner, possibly indicative of stress due to temperature expansion of the large field of west-facing brick with no relief joints (Figures 6, 7)	Remove and repair damaged brick; tooth-in areas of repair. Repoint or repair crack above displaced brick. Assume 30 SF.
The concrete at the sill of several windows is cracked, which will allow water to penetrate and cause further spalling and breakup of the concrete if left untreated (Figure 8)	Remove loose and spalling material and seal with elastomeric concrete crack repair product or sealant. Consider cleaning and coating all concrete at the foundation with an elastomeric coating..
Some mortar joints are deteriorated, which may allow water to enter the wall and cause further damage. (Figure 9)	Undertake a building-wide masonry repointing program to identify and repoint all deteriorated joints. Assume XX SF.

*Figure 6—Cracked and displaced brick NW corner*

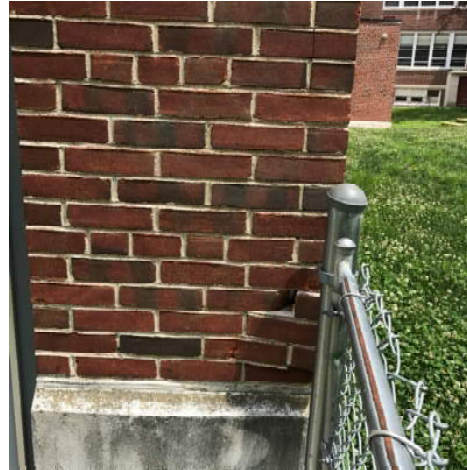
*Figure 7— Cracked and displaced brick NW corner*

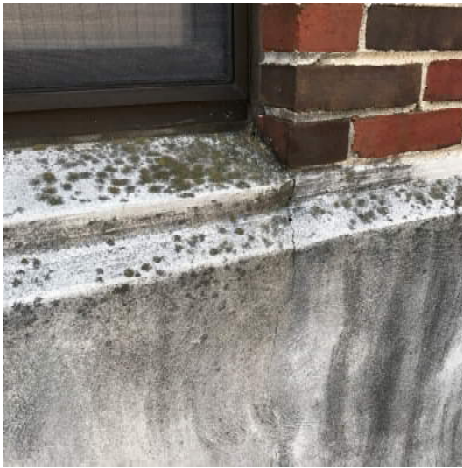
*Figure 8—Crack at precast concrete window sill*

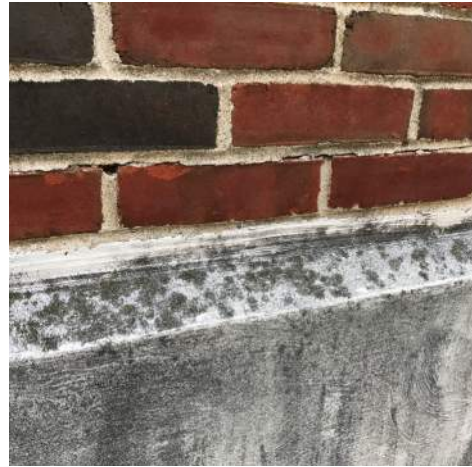
*Figure 9— Degrading mortar joints typical*

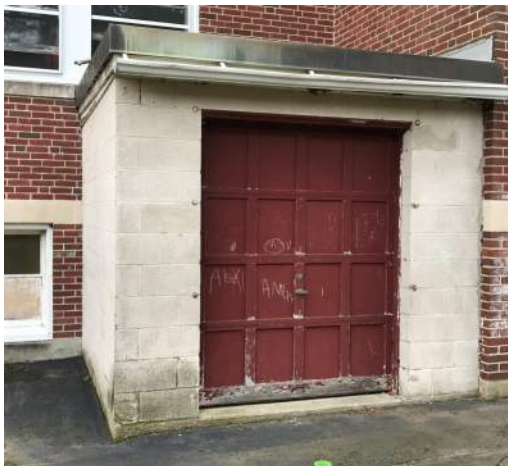
The "garage" attached to the original building is in poor condition. The base of the painted exposed CMU block walls are showing signs deterioration due to exposure to moisture. The gutter at the front edge of the roof does not include a downspout; and discharges collected water to the pavement at the corner with the worst deterioration. (Figure 10)	Repaint the CMU with an elastomeric paint. Install a downspout to control the gutter discharge to grade and direct the water away so as to limit splashing.  Alternatively, remove the existing garage in its entirety and replace with new construction with brick veneer to match the adjacent school building.
The soffit above the overhead door is rotted and is missing a section adjacent to the original building, suggesting a leak at the roof or roof edge. (Figures 10, 11)	Inspect the roof and gutter mounting detail to verify if any leaks are present, and make repairs as necessary.

*Figure 10—Garage attached to '52 building*

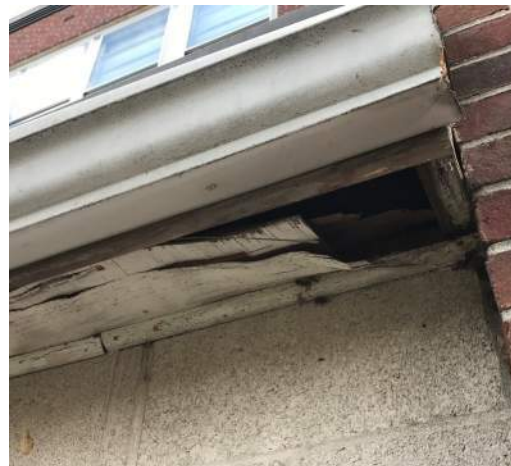
*Figure 11—Rotted soffit at garage*

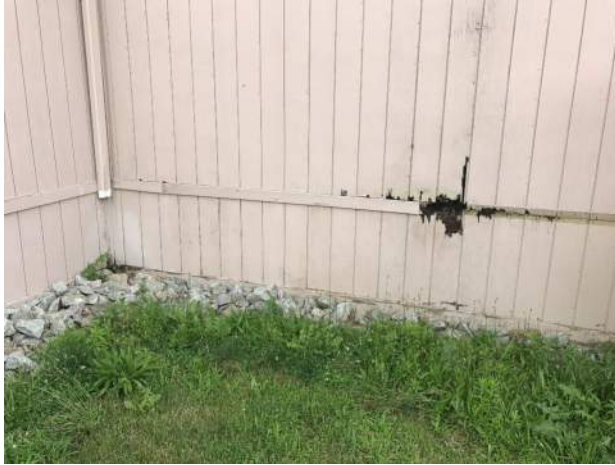
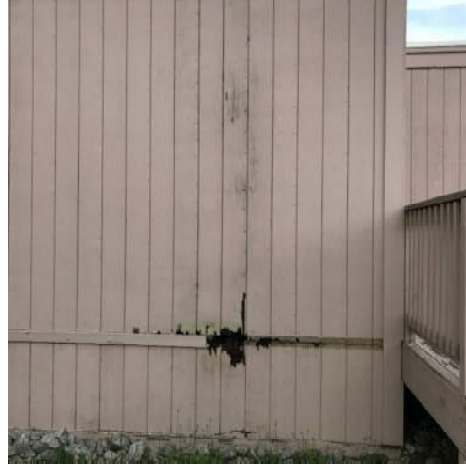
The modular classrooms are in fair to poor condition. There are a few areas where the T-111 wall paneling has rotted, exposing the inner wall to the elements. There are also areas where large sections of trim board have fallen off or are hanging from the walls (Figures 12, 13, 14).	Remove entire section of T-111 siding board that is rotten and replace with new siding; paint to match existing. Reinstall loose trim, and replace missing, sealing all joints between trim and siding with a durable exterior caulking..
The downspout at the corner of the modular building stops a foot or more above grade, allowing effluent to splash on the stone below and deteriorate the siding at the skirting. (Figure 12)	Replace the downspout to extend it to grade, with a neck angled to direct water away from the skirting.
The caulking at a control joint in the 1983 building is drying out and losing its elasticity, and losing its bond to the brick. This will potentially allow water to penetrate the wall system. (Figure 15).	Remove old caulking and completely clean out the joint. Install new caulking with a bond breaker or backer rod within the joint.

*Figure 12—Rot at exterior wall of modular classrooms*

*Figure 13—Rot at exterior wall of modular classrooms*

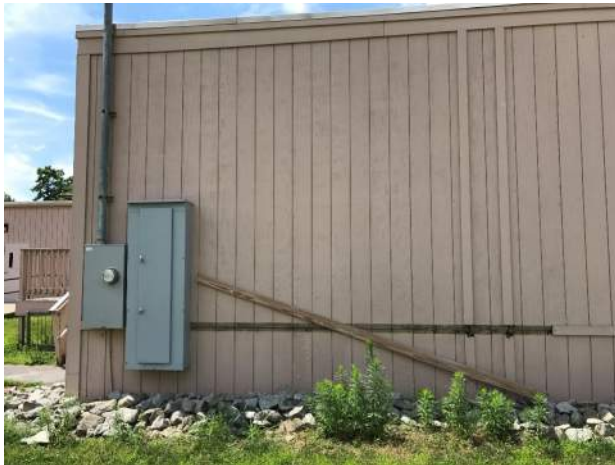
*Figure 14—Trim board fallen off side of modulars*

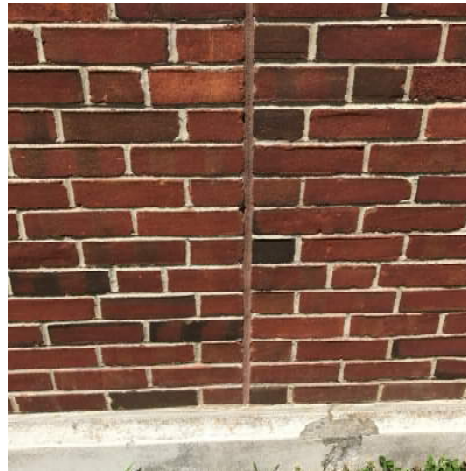
*Figure 15—Dried out expansion joint caulking*

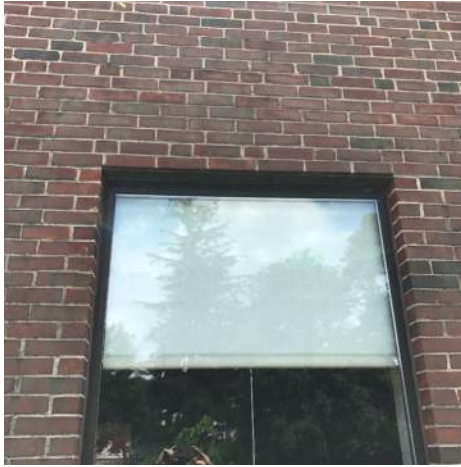
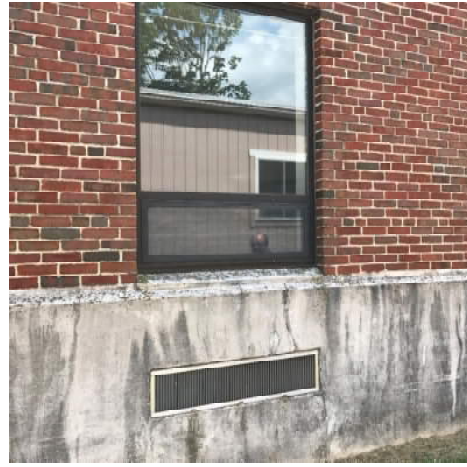
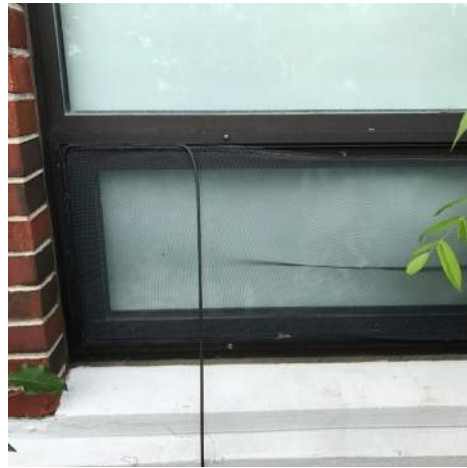
Given the era they were installed, aluminum window and curtainwall framing is likely not very energy efficient, and glazing likely does not perform very well to prevent heat gain. (Figure 16, 17, 18, 19))	Replace all aluminum window and curtainwall systems with new thermally broken, high-performance window and curtainwall systems with insulated Low-E glazing.
External screens at aluminum windows are deteriorated with loose screen fabric and splining. (Figure 20)	If not replaced with new windows, perform maintenance on screens by installing new fabric and splines.
Wood windows at the 1952 building are in poor condition, with significant deterioration of glazing compound caulking. Wood sashes and framing in poor condition with peeling or missing paint and rot in some places. The general condition is causing significant air leakage and creating significant heat loss in winter months. (Figure 21).	Replace all wood window with new thermally broken, high-performance window and curtainwall systems with insulated Low-E glazing.

*Figure 16—Non Low-E coated window glazing*

*Figure 17—Non thermally broken windows*

*Figure 19—Loose screening and splines*

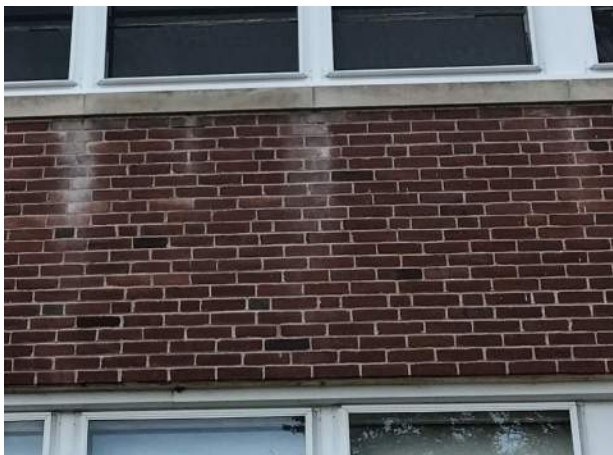
*Figure 20—Failing sealant stains on brick*

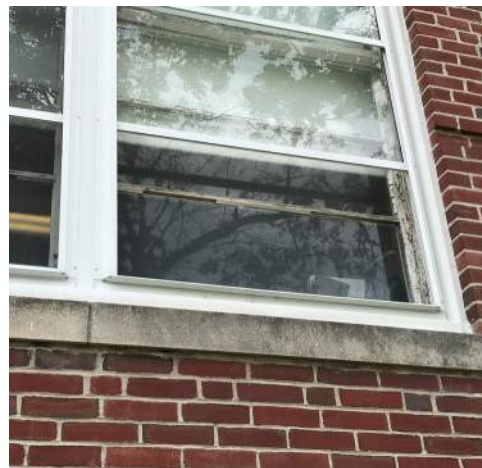
The windows in the 1952 building are the original wood sashes with single-pane glazing, and are very inefficient thermally. The wood windows are substantially deteriorated, with glazing compound loose or missing at glass, and peeling or missing paint on the sashes and framing. Aluminum storm windows have been installed over most of the original wood windows, which is evidence of unsatisfactory performance of the windows.

*Figure 21—Deteriorating wood windows '52 bldg.*

Interior sills and trim at the wood windows in the 1952 building have deteriorating finishes; trim in general needs refinishing or replacement.	With any window replacement project, include replacement of interior wood sills and casing trim with new clear finish oak trim to match or approximate existing.
Significant staining is evident on the face of brick below some windows, suggesting that the caulking at the window or at joints in the precast sill is deteriorating, and water is washing the chemicals in the sealant down the wall. (Figure 20)	Undertake a building-wide maintenance program for all exterior caulking; replace all sealants that have been in place for 5 or more years, or which show failure.

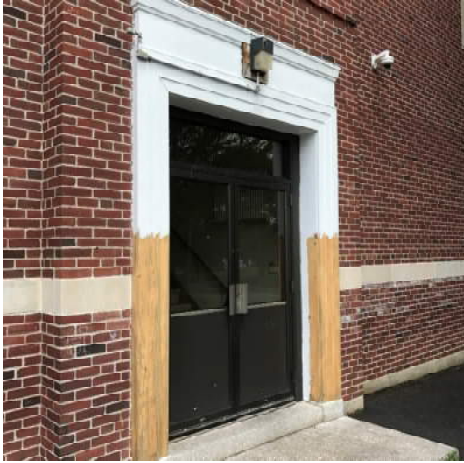
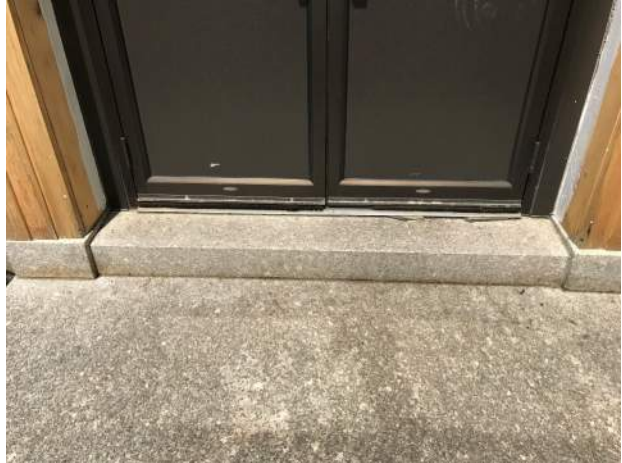
The exterior aluminum storefront door is in fair condition, however it is not thermally efficient and appears to have required maintenance. The framing and glazing do not appear to be very thermally efficient. The door is missing portions of the bottom sweep and weather stripping (Figures 22, 23).	Replace this door and frame with a new, thermally broken door and frame, with insulating safety glass in transom and vision panels
The hollow metal doors are generally in fair to poor condition with failing paint finish and corrosion along the bottom edges. It is unclear if the doors are insulated. Some doors are missing weather stripping. Vision panels include wired glass, which is a significant danger in cases of glass breakage, and is not allowed under present building code: The wire decreases the performance of the glass, increasing the likelihood of breakage; once broken the wire represents a significant cutting or finger amputation risk. The vision panels do not comply with accessibility codes. (Figures 24, 25).	Replace all exterior hollow metal doors and frames with new thermally broken frames and insulated door panels, with insulating safety glass in transom and vision panels..

*Figure 22—Storefront door at '52 building*

*Figure 23—Storefront door at '52 building*

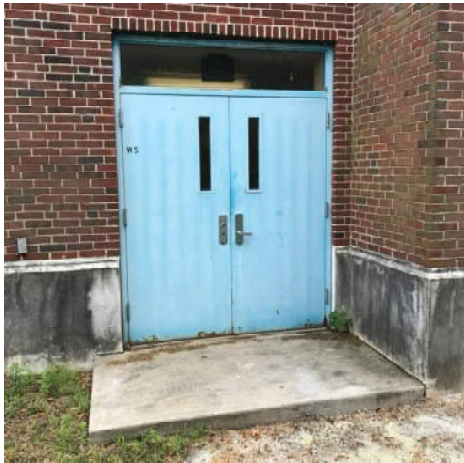
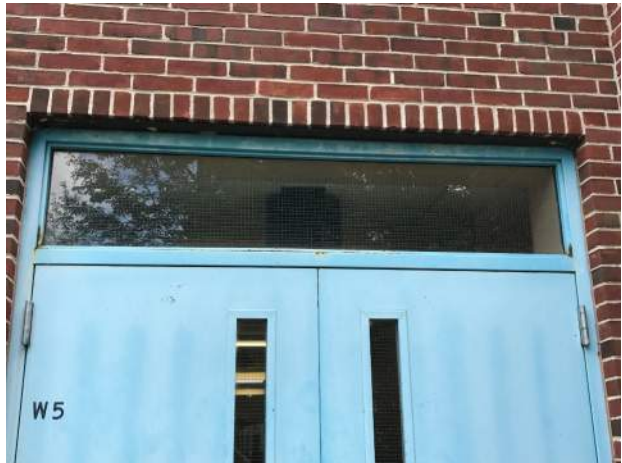
The majority of the hollow metal doors and frames are in fair to poor condition, with failing paint finishes that have become chalky, and corrosion along the bottom edges of most doors.. Vision panels in these doors is wired glass, which is a significant safety concern .

*Figure 24—Exterior hollow metal doors*

*Figure 25—Exterior hollow metal doors*

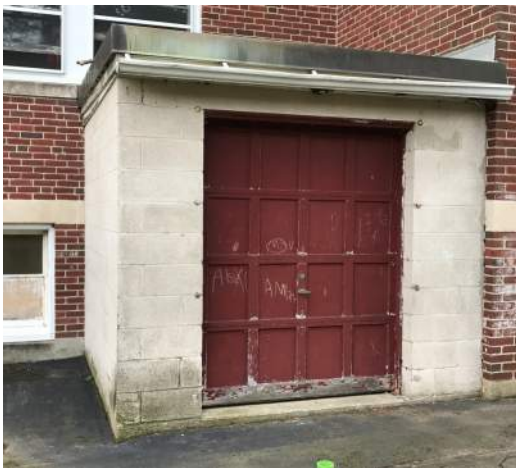
The wood overhead door is in poor condition, with damage to the finish and peeling paint. The bottom of the door has no paint finish left on it and is being damaged and weathered by exposure to the elements. The door hardware is in poor condition. (Figure 26).	Replace overhead door with new steel or aluminum door assembly with corrosion resistant construction and finish.

*Figure 26—Wood overhead door*

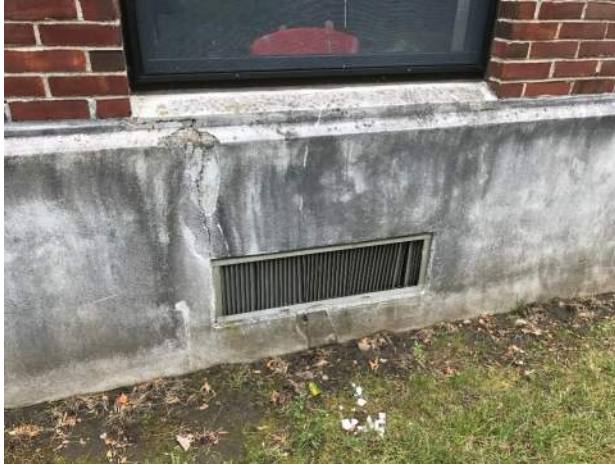
Some of the vertical blade louvers at grade for unit ventilators have bent or broken fins. Some fins are actually disconnected at the bottom and are hanging free. Vertical blade louvers do not perform well at preventing moisture from entering the building. (Figure 27).	Replace vertical blade louvers with prefabricated horizontal blade louvers that are resistant to wind-driven rain..
The paint on the louvers at the '52 building is visibly deteriorated, and the substrate metal is showing through the paint at some locations. (Figure 28).	Replace vertical blade louvers with prefabricated horizontal blade louvers that are resistant to wind-driven rain.  Alternatively, scrape and repaint existing louvers with a durable exterior grade paint.
Various louvers have degraded and cracking caulk around the perimeter of the louver frame and staining on the face of the brick below. (Figure 29).	Undertake a building-wide maintenance program for all exterior caulking; replace all sealants that have been in place for 5 or more years, or which show failure.

*Figure 27—Damage at '83 addition.*

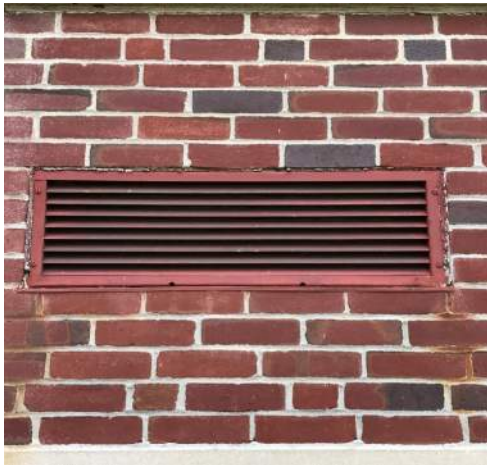
*Figure 29—Degraded caulking around louver typical*

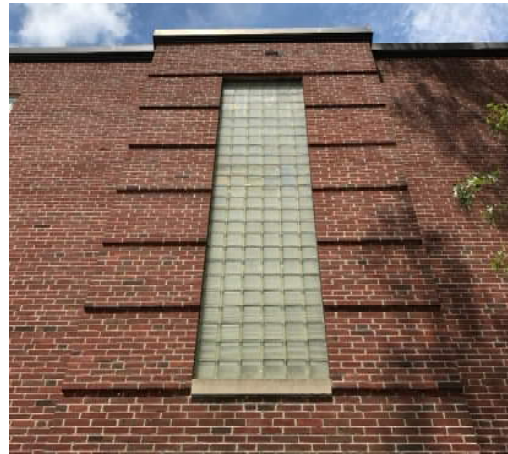
Glass block above the storefront entrance door is showing signs of sealant failure at the perimeter. While the block appears to be in good condition, glass block performs very poorly thermally. (Figure 30)	Replace glass block with a new high performance thermally broken window system with insulated glazing.

*Figure 30—Glass Block Fenestration*

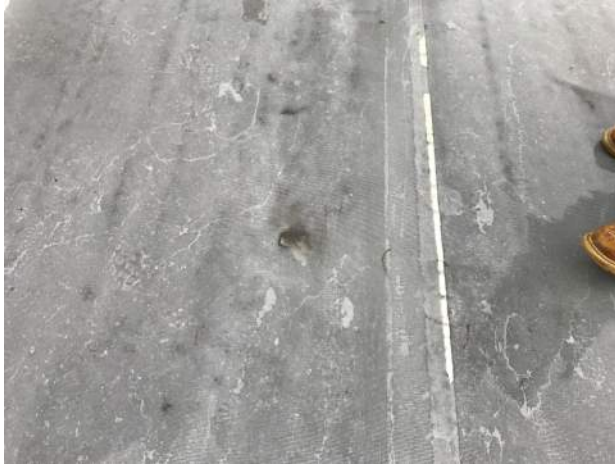
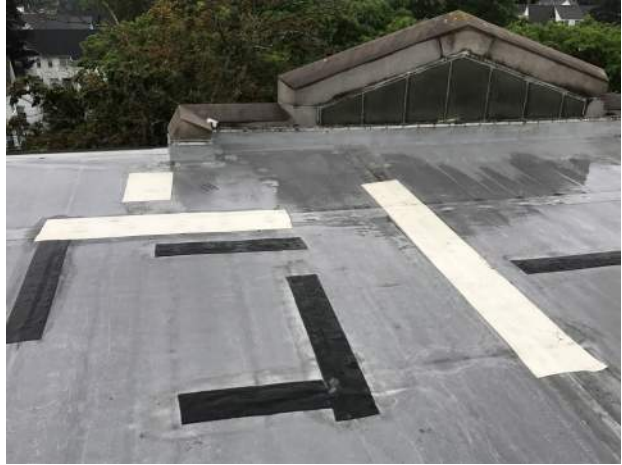
The roof at the 1952 roof is beyond its serviceable life, heavily worn to the point of exposing inner layers of the membrane, and patched in multiple locations. (Figures 31, 32).	Replace this roof with a new roofing system, with new insulation board meeting or exceeding Stretch Energy Code requirements and meeting the intent of the Town's Green Community initiatives. A recommended R value for insulation is R-50.
The roof of the 1983 addition features multiple areas of poor drainage and ponding, and several areas of "soft insulation" under the membrane. This could be indicative of insulation board being damaged by leaks. Water damage compromises the insulating value of insulation. There are several insulation fasteners poking through or nearly penetrating the membrane from below. (Figure 33, 35)	Replace this roof with a new roofing system, with new insulation board meeting or exceeding Stretch Energy Code requirements and meeting the intent of the Town's Green Community initiatives. A recommended R value for insulation is R-50. At the time of the replacement, verify the integrity of underlying roof decking, which appears to be wood fiber or gypsum based. Increase slope of tapered insulation to 1/4" per foot or more to resolve ponding issues. With reroofing, replace existing skylight units with energy efficient high performance units.

*Figure 31– Visible scrim layer on '52 building roof*

*Figure 32– Patches on '52 building roof*

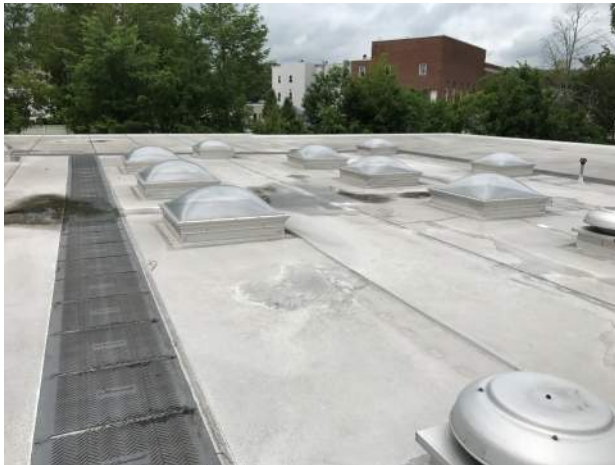
*Figure 33– Areas of minor ponding on '83 roof*

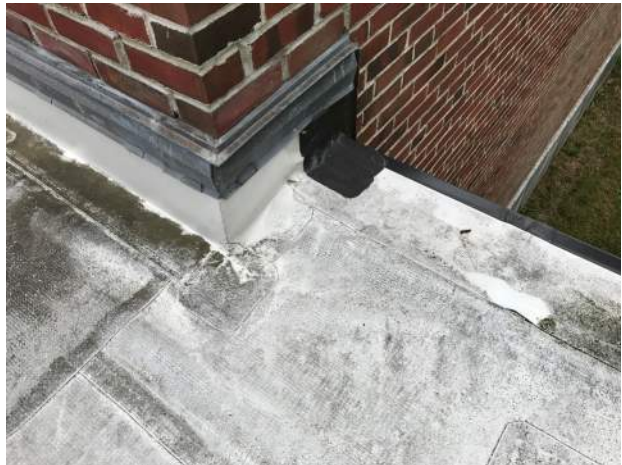
The flashing where the 1983 roof meets higher walls appears to be at the end of its serviceable life. Joints do not appear to be tight, and the flashing does not appear to be consistently tight to the vertical wall. Limited areas of flashing are damaged. (Figure 34).	At the time of roof replacement, consider installation of new through-wall flashing at the high walls, to extend to the face of the CMU backup wall. Include removal of brick in sections, shoring of the brick above, and reinstallation of brick after placement of the new flashing .
On the link that attaches the two buildings there is evidence of poor drainage on the roof this is apparent from the abundance of staining on the surface of the roof membrane (Figure 36).	See comments above regarding replacement of the roofing at the 1983 addition. If total replacement of the roofing is only considered long term, consider reroofing this section and increasing the taper of the insulation to resolve ponding.

*Figure 34– Undulating flashing on '83 addition roof*

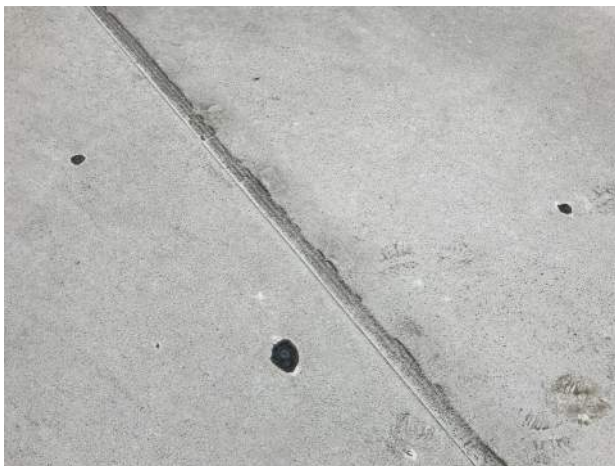
*Figure 35– '83 roof fasteners torn through membrane*

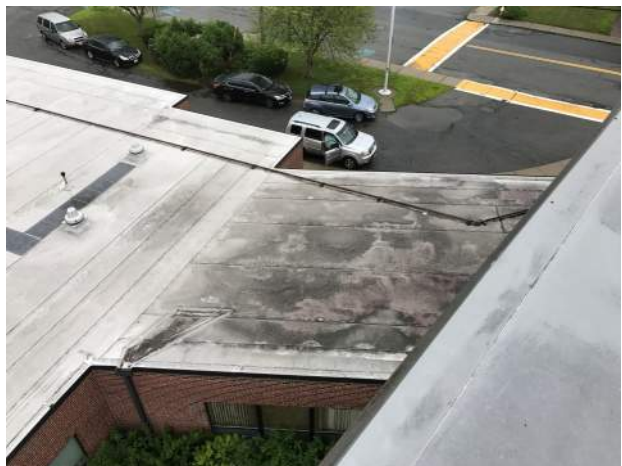
*Figure 36– Poor drainage at link to '52 building*

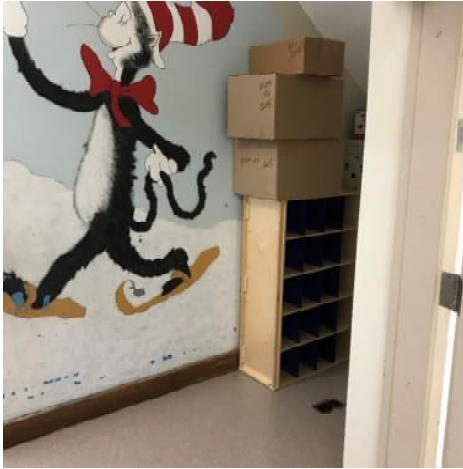
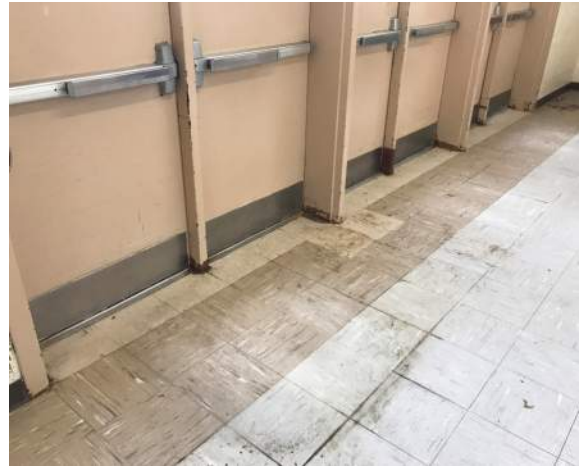
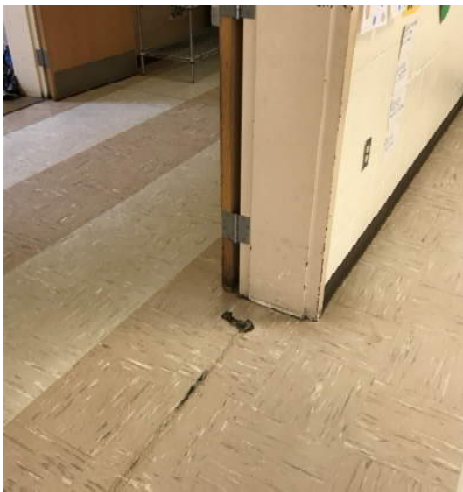
Vinyl composition tile (VCT) is stained, worn, and chipped at high traffic areas. Many types and colors of floor tile are used throughout the building. VCT at many areas of the 1983 building is known to contain asbestos. (Figures 37, 38, 39).	Replace worn areas of VCT in high traffic areas such as entrance lobbies and corridors with new resilient flooring, abating any asbestos-containing flooring; especially broken and chipped tile. A low maintenance product such as sheet linoleum is recommended. Prior to covering slab, determine slab humidity and moisture emissivity levels. Remediate any moisture vapor drive issues by applying a moisture remediation topping compound to the slab prior to installation of the sports floor.  Consider replacement of flooring building-wide in order to abate all asbestos-containing flooring.
The gymnasium floor is painted concrete which is badly worn. Concrete does not provide resiliency suitable for athletic type activities. (Figures 40, 41).	Install a sheet or poured resilient athletic sports floor system. Prior to covering slab, determine slab humidity and moisture emissivity levels. Remediate any moisture vapor drive issues by applying a moisture remediation topping compound to the slab prior to installation of the sports floor.

*Figure 37—Delaminated & damaged VCT*

*Figure 38—Stained & delaminated tile at '83 bldg.*

*Figure 39—Worn down VCT tile at door '83 bldg.*

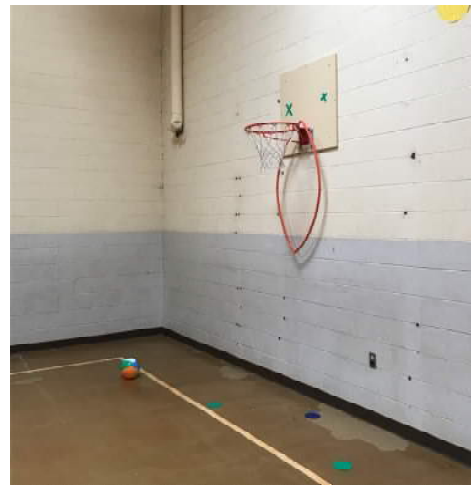
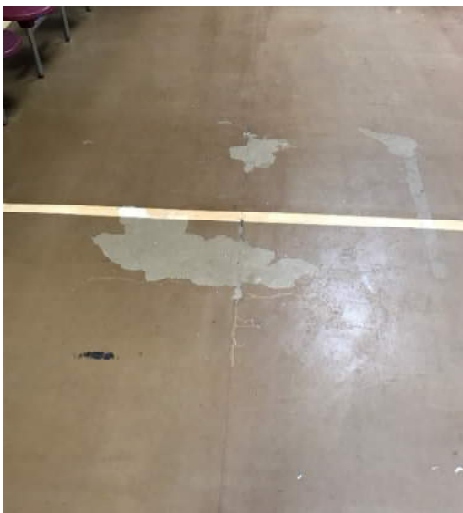
*Figure 40—Worn down paint on Gymnasium floor*

*Figure 41—Worn down paint on Gymnasium floor*

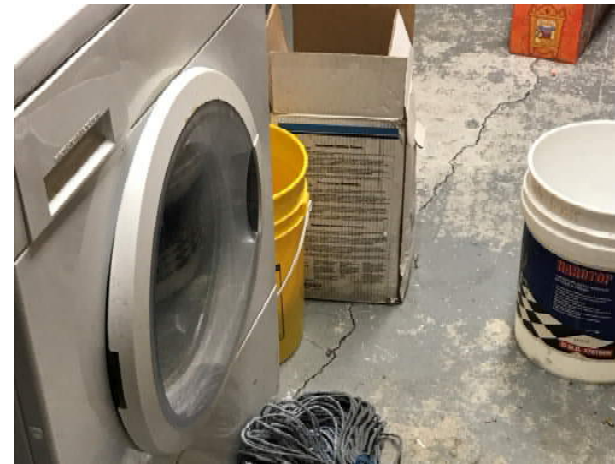
The sealed concrete floors in storage and janitorial spaces are in poor condition.

*Figure 44—Concrete floor sealer worn*

*Figure 45—Sealed concrete floor worn away typical*

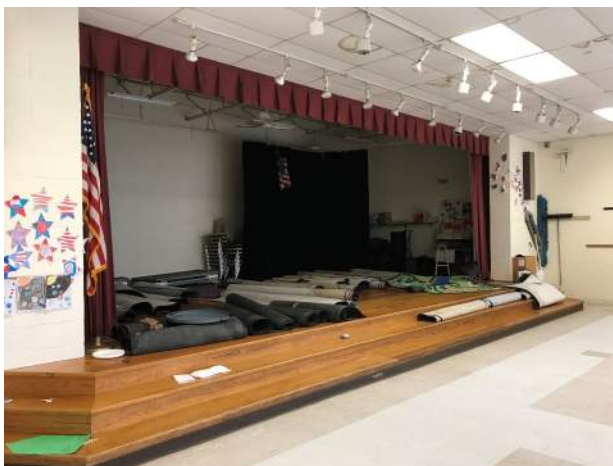
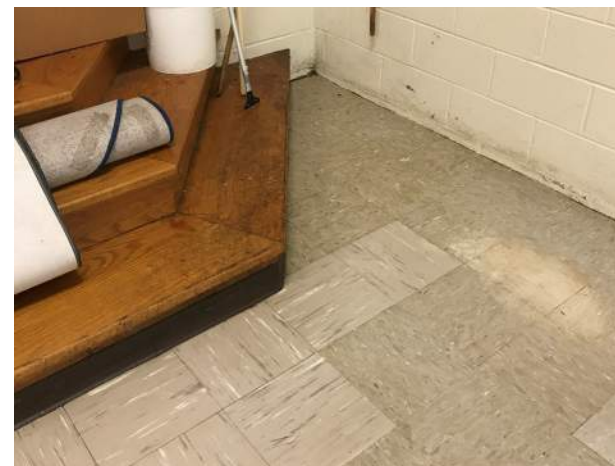
<p>The stage floor is structurally performing well, however the finish is in poor condition with scuffs, gouges, and remnants of old tape or paint lines on the floor. (Figures 46, 47).</p>	<p>Strip and refinish the wood flooring and steps to the stage. Note that some alterations of the stage front will be required to provide either a ramp or a vertical wheel chair lift to access the stage. Refer to the Accessibility portion of Regulatory Assessment for discussion.</p>
<p>Wall base in most areas is resilient base or wood. There are multiple locations of missing base in both buildings. Wood base in the original building is in poor condition with staining from years of floor cleaning, splattered paint, and surface damage.. (Figure 47)</p>	<p>Replace missing sections of base. As part of any major flooring replacement, consider replacing all damaged base throughout both buildings.</p>

*Figure 46—scuffed and gouged stage floor*

*Figure 47—Various floor and base issues*

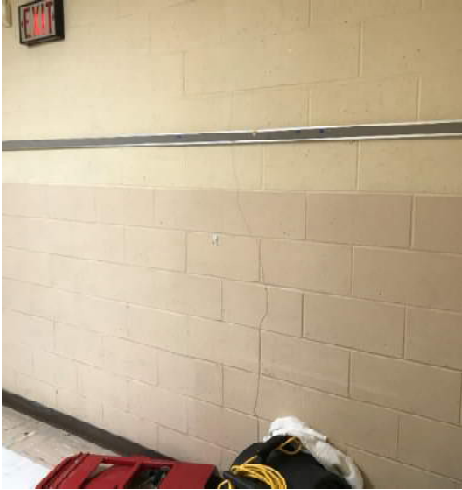
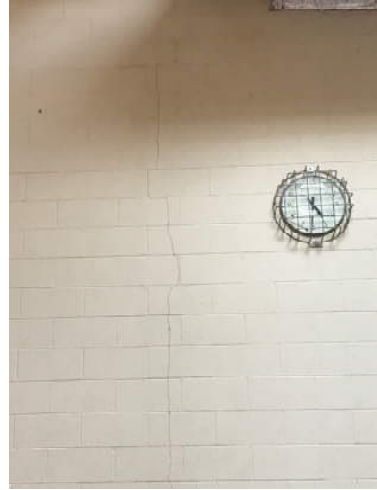
There are several superficial cracks in the CMU walls at various locations throughout the school; with multiple cracks at the gym. Most of the cracks follow the mortar joints vertically up the height of the wall, and some cracks traverse the face of some CMU blocks. (Figures 48, 49, 50).	Repair cracks with grout or sealant as part of building-wide painting program. Monitor cracks on a periodic basis to determine if cracks are worsening.
Paint finishes at walls throughout the building are in soiled and generally in need of refreshing. There are several areas where paint is peeling from the walls, apparently from lack of proper adhesion to the substrate (previously painted surface). (Figures 51, 52, 53).	Repaint walls throughout the building, removing all loose paint that is not properly adhered to the substrate.

Figure 48—Crack in corridor of '83 addition

Figure 49—Crack in Gymnasium wall

Figure 50—Crack in Gymnasium wall

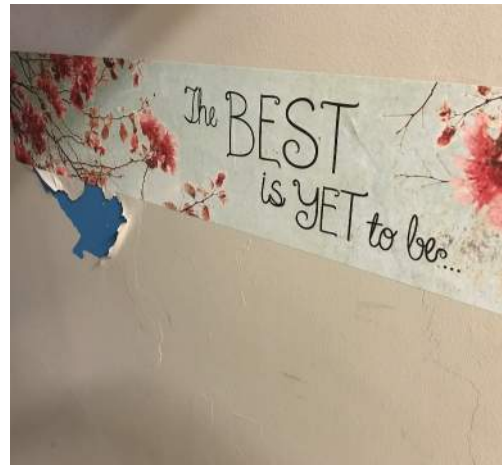
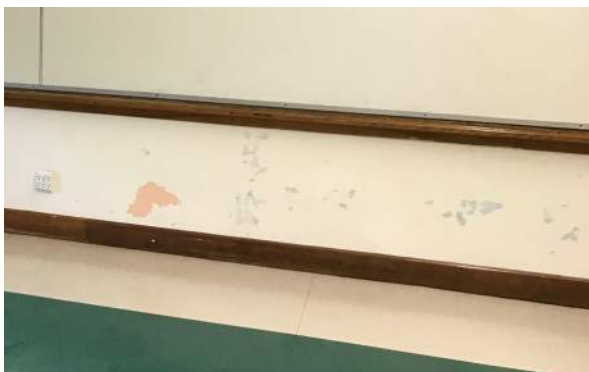
Figure 51—Paint peeling of plaster and lath wall

Figure 52—Paint peeling at plaster and lath wall

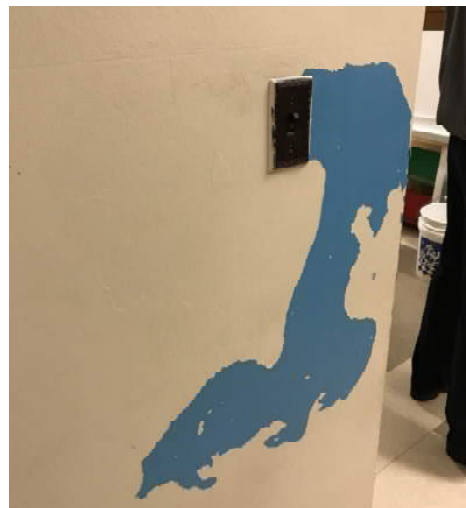
Figure 53—Paint peeling of plaster and lath wall
