# W. EDWARD BALMER ELEMENTARY SCHOOL

NORTHBRIDGE PUBLIC SCHOOLS  
TOWN OF NORTHBRIDGE, MASSACHUSETTS

## PRELIMINARY DESIGN PROGRAM, SECTION 3.1.4

### EVALUATION OF EXISTING CONDITIONS

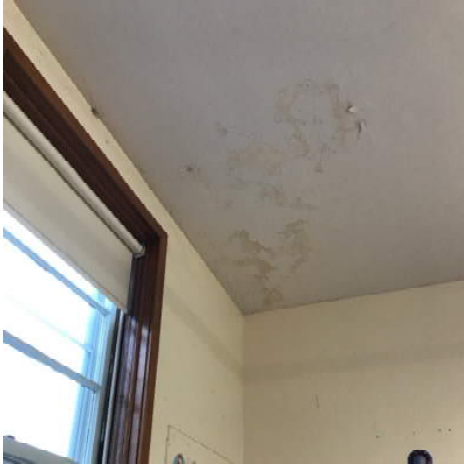
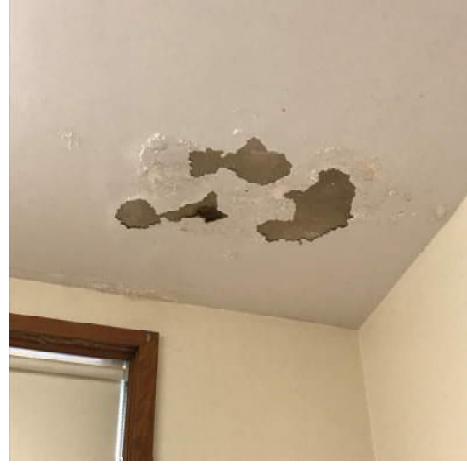
There are areas of significant water damage to the plaster in the original 1952 building. The paint is blistering, and plaster is partly dislodged and missing in sections. Adjacent wall surfaces also exhibit water damage. (Figures 53, 54, 55)	Verify that the sources of leaks are resolved. Remove all loose and damaged plaster and lath. Patch underlying materials and plaster or install new gypsum wall board patches with veneer plaster to match appearance of adjacent ceiling. Repaint ceilings in their entirety (and adjacent damaged walls) to provide a consistent “like new” appearance.
ACP ceiling panels are stained, soiled, and visibly sagging within the support framing throughout the school. In some locations, edges of tiles are not supported by the framing system, or are not laying flat in the grids. Grids are showing signs of corrosion in many locations. Ceilings have generally surpassed their expected life spans. (Figure 56, 57, 58).	Verify the sources of all leaks are resolved. Replace all acoustic panel ceiling systems in the building. Humidity-resistant ceiling panels are recommended. Utilize grid types that are compatible with existing light fixtures.

*Figure 54—Flaking ceiling paint & water damage*

*Figure 55—Flaking ceiling paint & water damage*

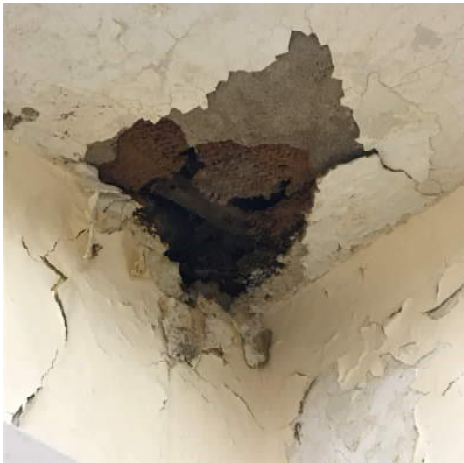
*Figure 56—Water damaged ceiling 1st floor.*

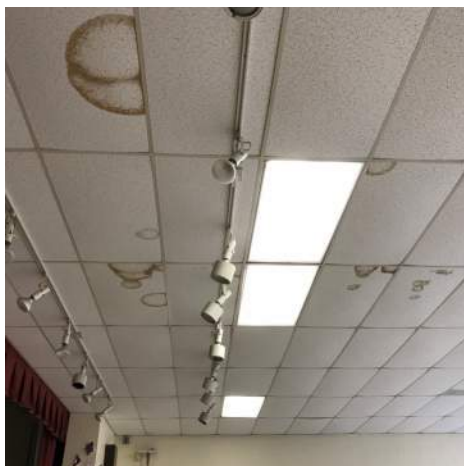
*Figure 58—Stained ceiling panels in Cafetorium*

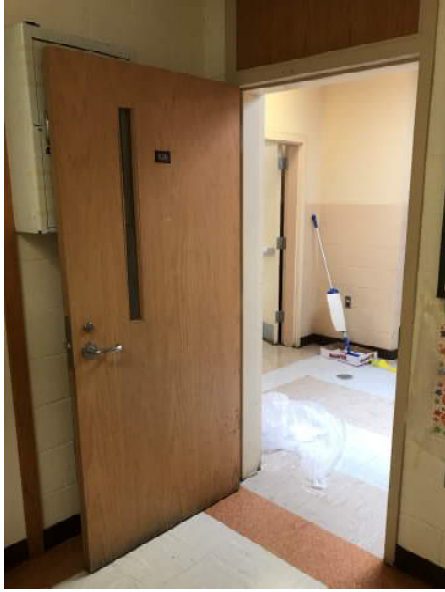
The wood doors throughout the building are in fair to good condition, however finishes are often scratched or chipped, and door faces that don't feature mop plates have stains at the floor level from floor cleaning procedures. (Figures 60, 61).	Replace visibly damaged doors. With any significant renovations, include replacement of doors and frames where fire ratings are required. See Regulatory Assessment for code discussions.
Hollow metal doors—especially those at the 1952 wing—are approaching or at the end of their service life. Some doors show visible damage and warping of the door face. Doors in the 1952 wing are of antiquated appearance. Fire rating labels could not be found on any doors. (Figure 62)	Replace visibly damaged doors. With any significant renovations, include replacement of doors and frames where fire ratings are required. See Regulatory Assessment for code discussions.
Vision panels and sidelights commonly include wired glass. Wired glass has been shown by the Consumer Products Safety Commission to represent a significant safety concern and is no longer permitted for use in pedestrian impact zones (such as vision panels and sidelights). Wired glass reduces the strength and fire performance of the glass, and if the glass is broken represents a significant cutting or finger amputation danger.. (Figure 63)	Regardless of any planned renovations, consider replacement of all vision panels and glazing in the building with tempered or laminated safety glass. Provide fire rated safety glazing in vision panels and glazed openings at corridors and stairs.

*Figure 60—Typical natural finish wood door*

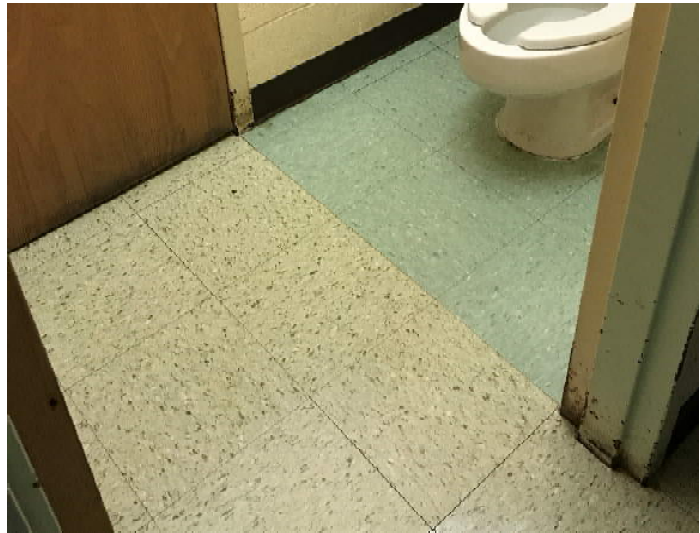
Metal frames at doors and borrowed lights often feature chipped or soiled paint finish. (Figures 61, 62).	Glazing needs to be replaced in the borrowed lite systems to tempered glazing.

*Figure 61—Soiled bottom edge of door and frame*

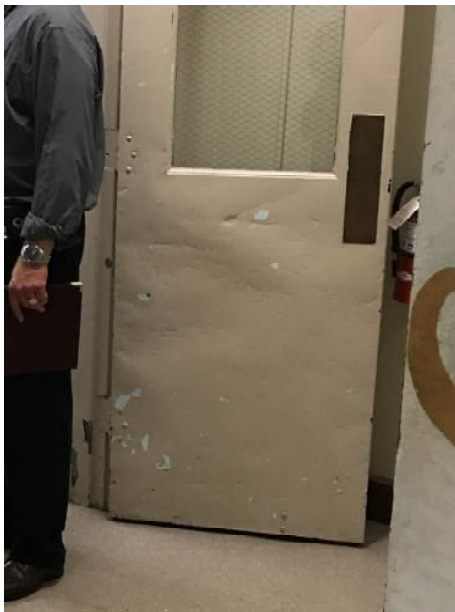
*Figure 62—Damaged face of HM door*

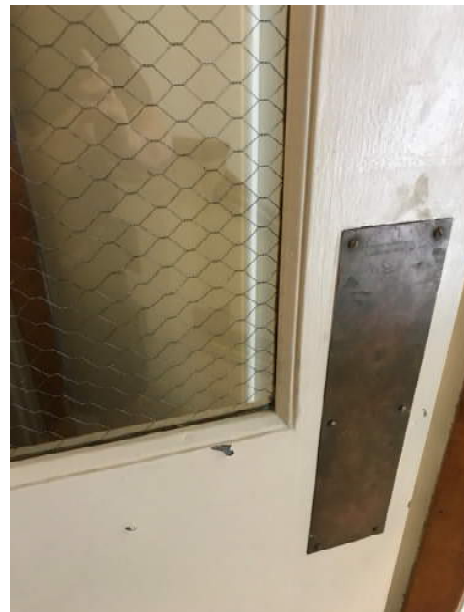
Vision panels and sidelight glazing generally include wired glass. Wired glass has been shown to represent a significant life safety hazard, as the presence of the wire within the glazing has been shown to reduce the fire and impact performance of the glass, and to represent a significant cutting hazard if located in pedestrian impact areas when the glass is broken.

*Figure 63—Wired glass vision panel*

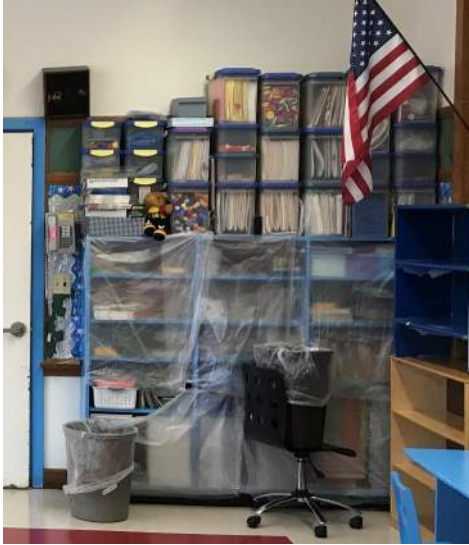
Storage in the building appears to be inadequate for current needs. Classroom storage is piled high and densely on shelving; existing storage accommodations may not be efficient for current needs. (Figures 64, 65)	Undertake a storage needs study for classrooms, to identify the types of storage needed for typical classrooms. Replace storage casework in classrooms with modern storage cabinets that better meet classroom needs.
Classroom casework is nearing or at the end of its useful life. In many places, laminates are chipped or delaminating from substrate, countertop edges are delaminating, some drawer glides no longer operate smoothly. Sink cabinets do not meet accessibility requirements. (Figure 66)	. Undertake a casework replacement program to provide a consistent approach and appearance school-wide.
Classroom wall surfaces commonly feature chalk boards that are no longer used and create inefficient surfaces that are not compatible with modern teaching methods. The area of marker board surfaces is limited, and the current boards are mounted too high for smaller children to use effectively, which is limited by the existing chalk board trim (Figure 67).	Remove existing chalk and cork boards and related trim from walls; provide new marker and tack boards following repair of scars at wall surfaces. Assume two new 8’ marker boards and two new 6’ tack boards per classroom. Mount marker boards in grades PK thru3 at 24” AFF to bottom of board.

*Figure 64—High piled classroom storage*

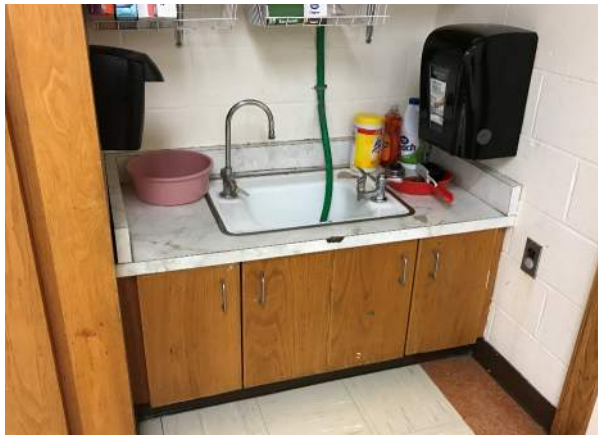
*Figure 66—Classroom casework sink base*

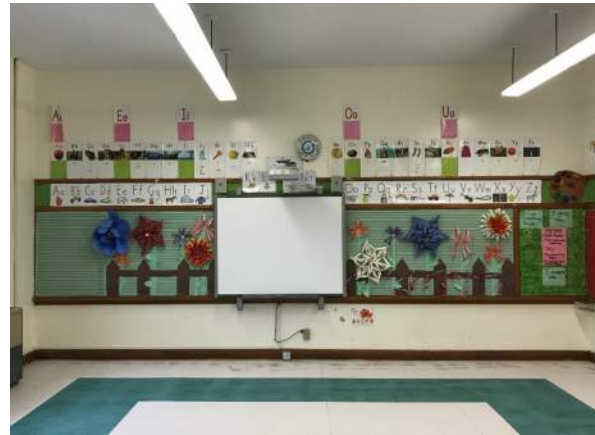
*Figure 67—Inefficient use of teaching walls*

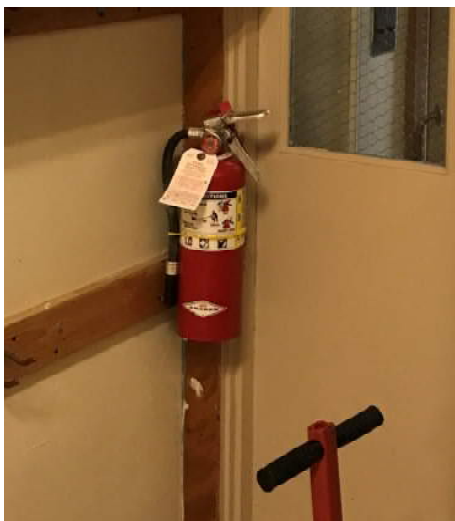
*Figure 68—Fire Extinguisher*

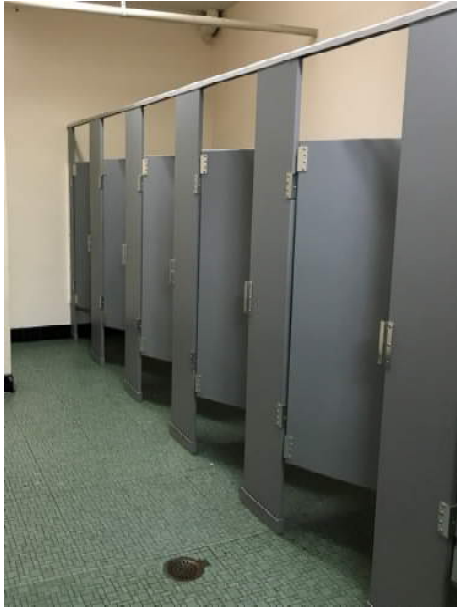
Toilet partitions appear to have been replaced in the recent past, with solid plastic partitions. Not all partitions appear to be in compliance with ADA/MAAB accessibility rules. Partitions are in good condition, however require some cleaning and maintenance. (Figure 69).	Perform maintenance on all toilet partitions; perform cleaning of surfaces, and replace missing and damaged components such as shoes, wall anchors, etc., to keep partitions in peak operating condition. Refer to Accessibility portion of Regulatory Compliance section of this report.
In the Gymnasium, there is no wall padding present. It appears at one time there was padding on the walls at one time because the mounting hardware and Velcro tape are still visible on the walls, but the padding has been removed. (Figure 70)	Provide new wall padding from 4" above floor to approximately 6 feet above floor at each wall of the gymnasium to increase the safety of all users.

*Figure 69—Toilet Partitions*

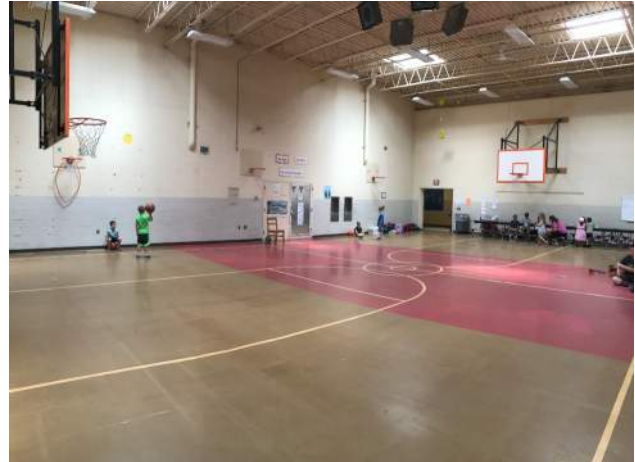
*Figure 70—Lack of wall pads at gymnasium*

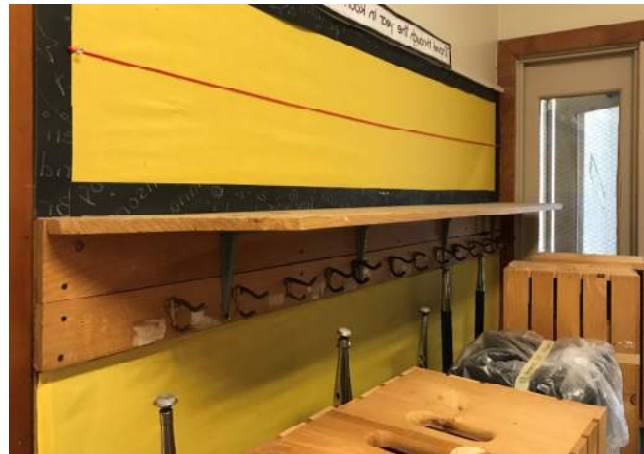
In the corridors of the second and third floor of the 1952 building there are rows of storage shelves and coat hooks. The coat hooks create a potential hazard if no coats are on them, as the sides are open and young children can easily run into them. These shelves and hooks are in poor condition. (Figure 71)	Remove old shelf and coat hook system in their entirety, and patch the walls. Install new casework "cubby" units that include enclosed coat hanging spaces.
At the Stage / Platform, portions of the performance lighting appears to have been replaced with general flood lighting bulbs. Curtains include one traveling main curtain at the proscenium, and a traveler at the back, upstage. The lighting batten is permanently attached to the roof joists making maintenance more difficult. There is no provision for projection surfaces on the stage. (Figure 72)	Replace flood lights with theatrical fixtures, or replace all stage lighting with up-to-date energy efficient theatrical fixtures with matching controls, suitable for elementary school use. Consider mounting the lighting on a batten to allow for manual lowering to facilitate aiming and maintenance of fixtures. Professionally clean and re-hang stage curtains, and adjust travelers for smooth operation. Consider providing a large-format motorized projection screen near the front of the stage.

*Figure 71—Shelves and coat hooks at corridor*

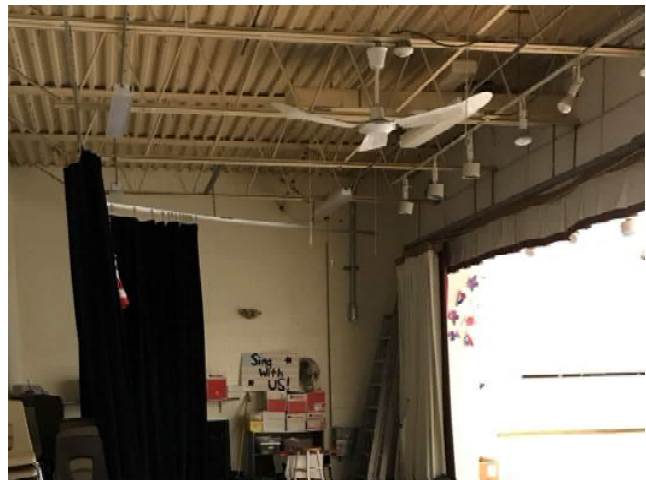
*Figure 72—Stage / Platform rigging*

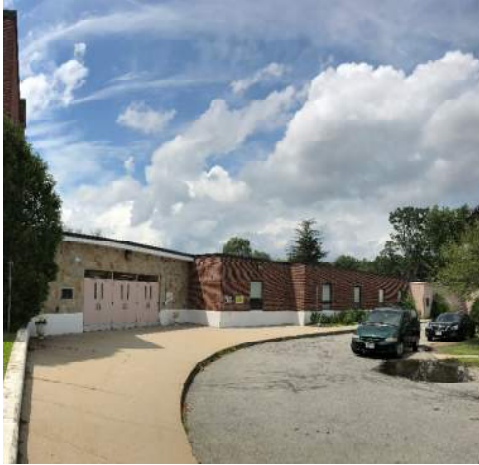
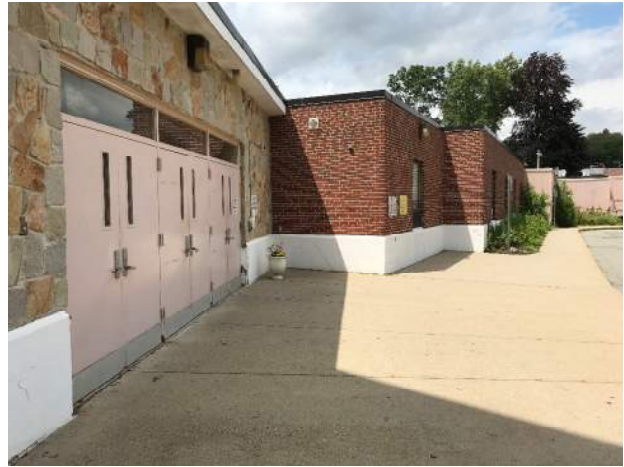
There is no accessible route provided from the vehicular drop-off zone to the main entrance; there are no curb ramps to allow wheel chair access to the main doors. (Figures 1, 2).	A curb cut ramp should be created at the main drop off loop in front of the main entry doors.
There are 36 parking spaces on the property, 21 of which serve the school building. There are no handicapped designated parking spaces serving the school, and there is no accessible route from the parking area to a building entrance.	Restripe the parking lot to create a van accessible parking space with required signage to comply with ADA. Provide a concrete walkway from the parking lot to connect to the sidewalk at the drop-off area.
The main entrance includes three pairs of doors, each with 36" wide leaves. A call button/ intercom is provided at accessible height, however no motorized operators are provided on any exterior door (Figure 3). All secondary entrance doors also have two 36" wide leaves (Figure 4). Concrete walks are in good condition.	Provide a motorized operator on one of the doors at the main entry to guarantee that the door will comply with opening force requirements.

*Figure 1—Non-accessible entrance no curb cut ramp*

*Figure 2—Non-accessible entrance no curb cut ramp*

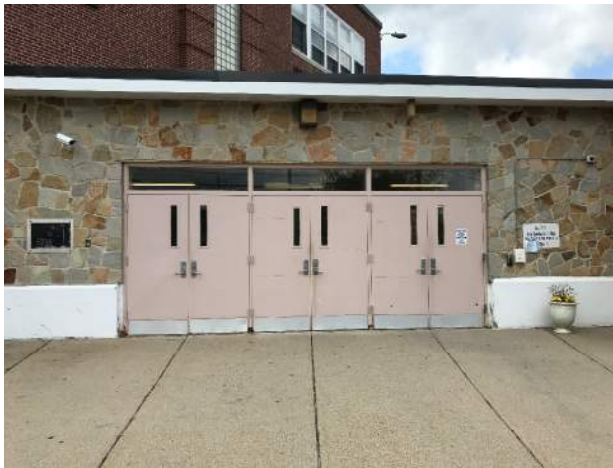
*Figure 3—Main entry doors*

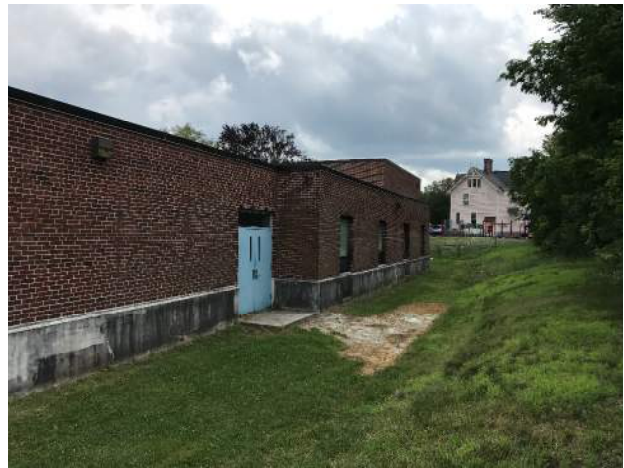
*Figure 4—Typical non-accessible side door*

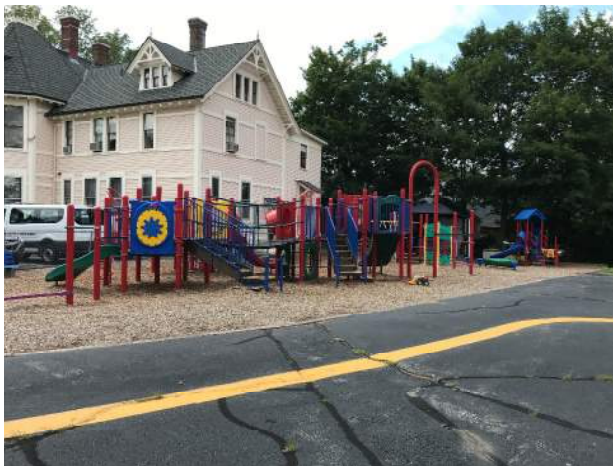
*Figure 5—Playground surface and equipment issues*

There is a playground in between the school and the district offices. The play surface under the equipment is wood chips, which does not comply with MAAB accessible path requirements, (Figure 5, previous page).	Refer to Site Assessment section of this report for discussion of replacing playground surfacing.
Nearly all of the required egress doors feature a frost pad with a step down to grade. All doors intended to be used as entrances should be accessible from the exterior. A percentage of doors are required to provide an accessible means of egress from the building to a public way. (Figure 6).	Adjust grading of sidewalks and adjacent landscaped areas leading up to exterior frost pads at doors to provide an accessible path. Ideally, slopes should be maintained at less than 1:20. See Site Assessment section for additional discussion
There is no elevator to provide access to the second and third floor of the original classroom wing. There are no other means to reach the upper levels except stairs.	Install an elevator in a hoistway constructed exterior to the existing building to provide access to the second floor classroom wing.

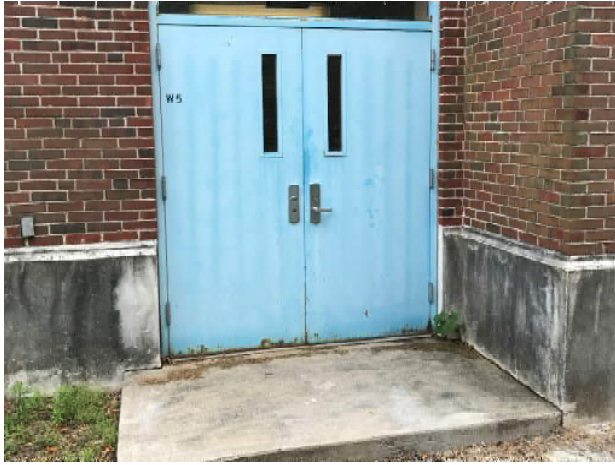
*Figure 6—Exit stair discharge door with step*

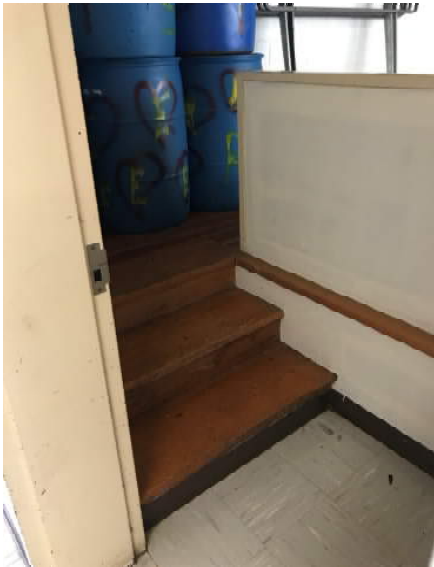
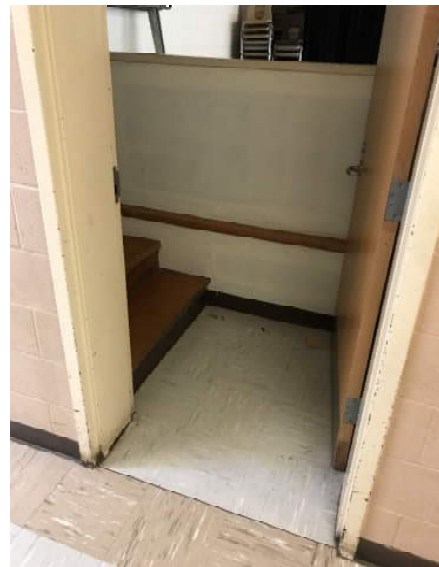
The vestibule for the connector corridor at the modular classrooms has ample room 27'-0" +/- there is also one classroom door entering / exiting into this vestibule. This configuration is acceptable per current IBC code requirements (Figure 7).	None.
There is no accessible path from the Cafetorium floor to the stage platform. The only way to access the stage is by the stairs at the front of the stage or the stairway accessed from outside the Cafetorium space. (Figure 8, 9,10).	Install an enclosed vertical wheelchair lift to access the platform stage.

*Figure 8—Stair at side of stage / platform*

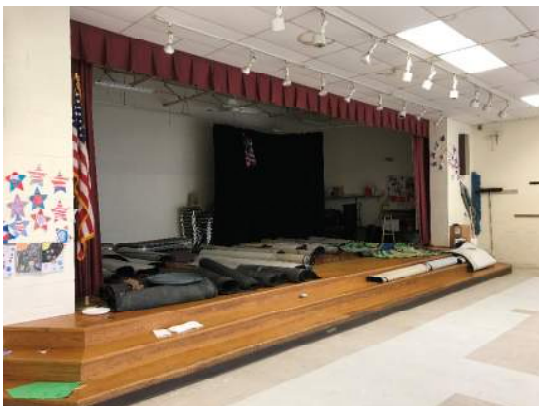
*Figure 9—Stairs at the front of cafeteria stage*

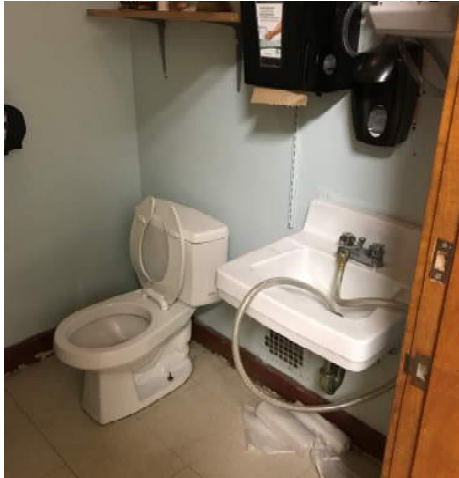
*Figure 10—Non accessible toilet room.*

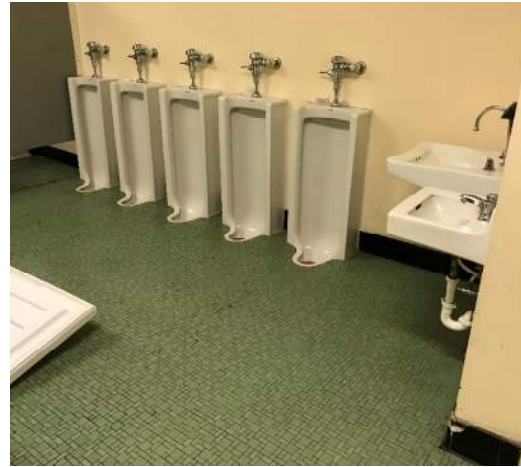
*Figure 11—Non accessible gang bathroom typical*

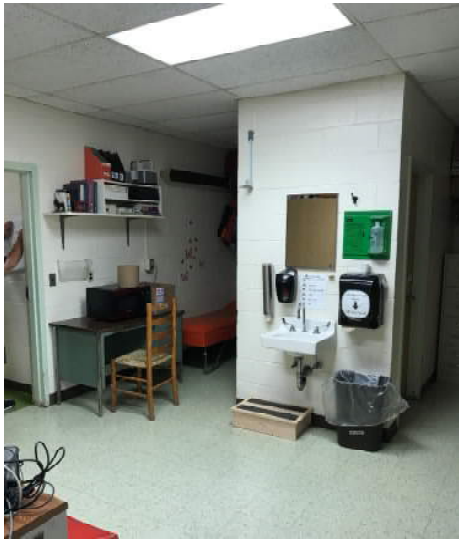
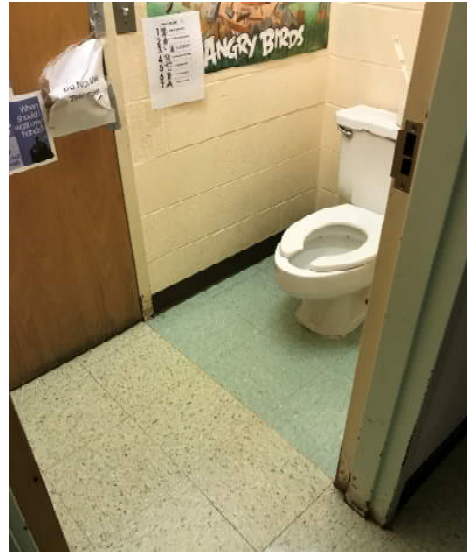
The faculty toilet rooms and the toilet in the Nurse's suite is not accessible; the configuration of walls does not provide the required floor clearance for any fixture or door openings. At the nurse's office the sink is located outside of the toilet room. (Figures 12, 13).	Demolish inaccessible toilet room in its entirety including doors, frames, and cmu walls. Provide new toilet room layout that is in compliance with current MAAB regulations.
Drinking fountains in the building are not the high/ low configuration required by ADA, and do not provide knee space for forward approach. Also in some cases there are electrical panels mounted above the drinking fountains (Figure 15).	Remove all non compliant drinking fountains and replace them with the high / low configuration that is compliant with the current MAAB regulations. Refer to Electrical Assessment for discussion of replacement and relocation of electrical panels.

*Figure 12—Non-accessible toilet in nurses suite*

*Figure 13—Non-accessible toilet in nurses suite*

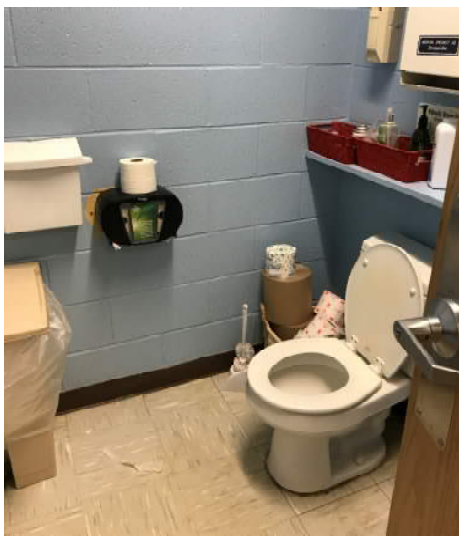
*Figure 14—Typ. non accessible single user toilet room.*

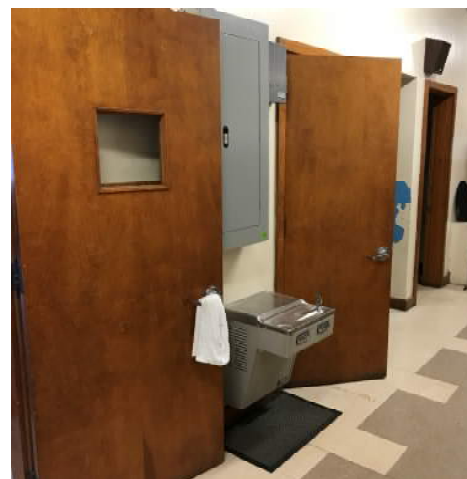
*Figure 15—Non-accessible drinking fountains*

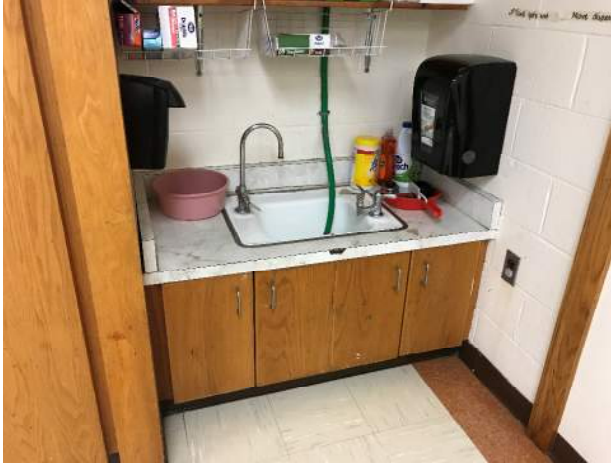
None of the casework at the sinks in the classrooms is accessible; there is no knee-space provided for forward approach. (Figure 16).	Refer to the Architectural assessment for discussion of replacement of casework. Provide sinks with compliant kneespace and piping insulation as appropriate to the age of the intended users..
The toilet room at a Pre-K or Kindergarten classroom is not compliant. A child size toilet is provided, however the side clearance to the adjacent wall exceeds the limit for children of this age. Side clearance to the sink is not provided. Makeshift grab bars are included, however they do not meet dimensional requirements. The toilet paper dispenser is mounted above the grab bar, and is not within reach ranges; MAAB does not permit installation of accessories above grab bars.. Piping below the sink is not insulated or guarded, and the faucets on the sink are not compliant. There was an attempt made to make it accessible by adding grab bars at the toilet. However it still does not meet MAAB current regulations. It is our interpretation that the occupants in these classrooms are not covered by accessible gang facilities on the floor; if these facilities are provided for a specific use such as pre-K or Kindergarten-only, in-class use, they should be accessible. (Figure 17).	Demolish inaccessible toilet room in its entirety and provide an accessible toilet room meeting the reach ranges and dimensional requirements for the age of the intended users..

*Figure 16—Typical non-accessible sink in classroom*

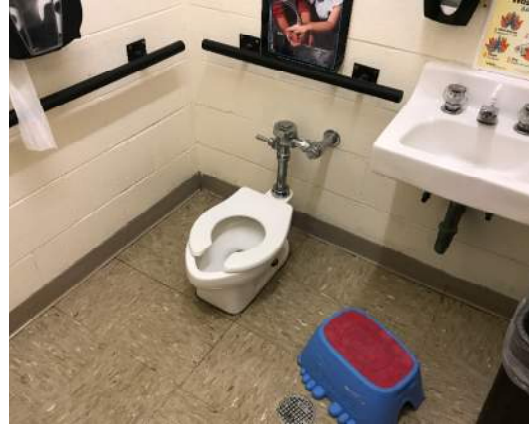
*Figure 17—Non-accessible classroom toilet*

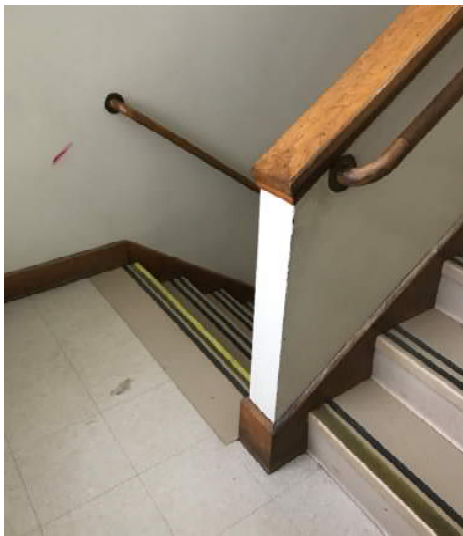
Handrails at stairs in the 1953 building do not feature required top or bottom extensions, especially at side-wall handrails. (Figure 18).	Replace handrails with types that include top and bottom extensions at walls. Provide handrails at kneewall between flights that are continuous around the end of the kneewall guard and between flights.
Some doors are located in narrow recesses and do not provide the required 18" pull side clearance. The doors do feature lever-type door hardware and closers in the '52 building & '83 addition (Figure 19).	Conduct a building-wide survey to identify accessible route to each space. Confirm that all doors required to be accessible comply with floor approach clearance requirements. At non-compliant doors, renovate adjacent walls to provide required clearances at each side of doors.
Some doors in the building feature round knob hardware trim, which is not compliant. Lever trim is required. (Figure 20)	Conduct a building-wide survey and replace all knob-type hardware with latch or locksets that feature lever style trim.

*Figure 18—Typical egress stairwell handrails*

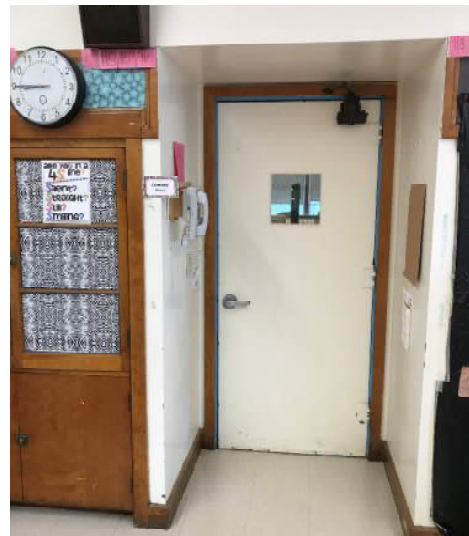
*Figure 19—C.R. door lacking pull side clearance*

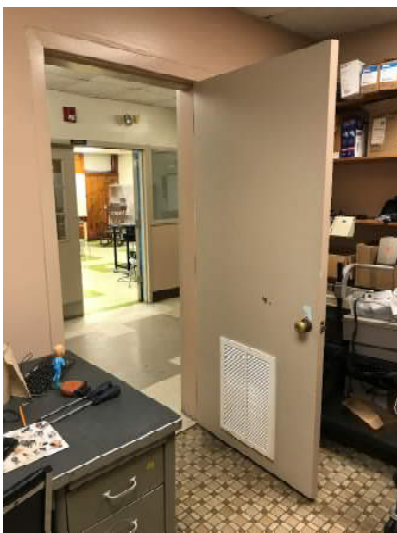
*Figure 20 —Knob type door handles*

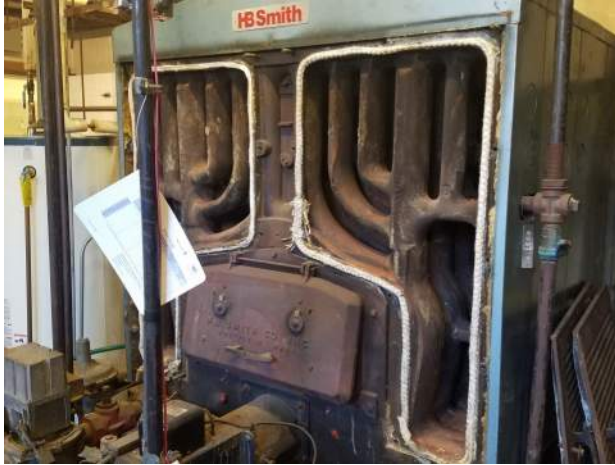
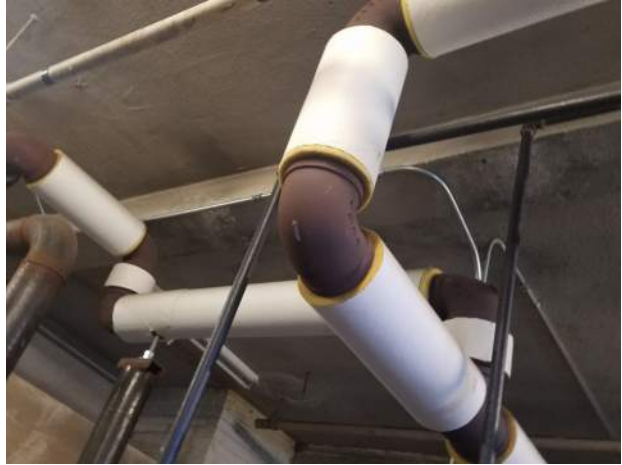
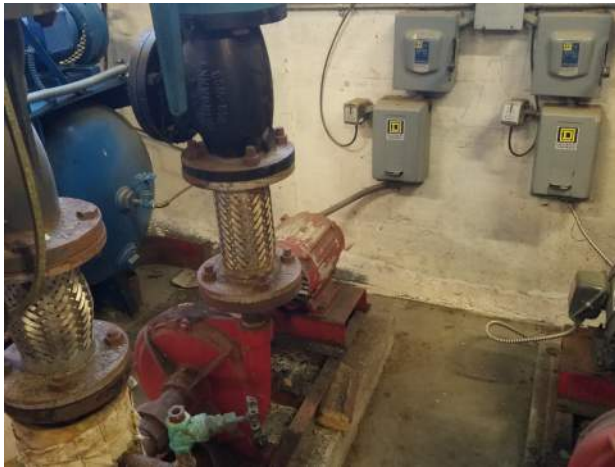
*Figure 1*

Insulation associated with the Heating Plant breeching system may contain asbestos.	Test and abate all insulation as required for removal of toxins within the educational environment.
Abandoned fuel-oil system may be a cause for pollution concerns beneath the ground.	Remove/ test fuel-oil system as required to alleviate all pollution concerns.
Damaged and missing hot water and steam piping insulation within boiler room and likely throughout building.	Add and replace with new insulation as required for complete system coverage.

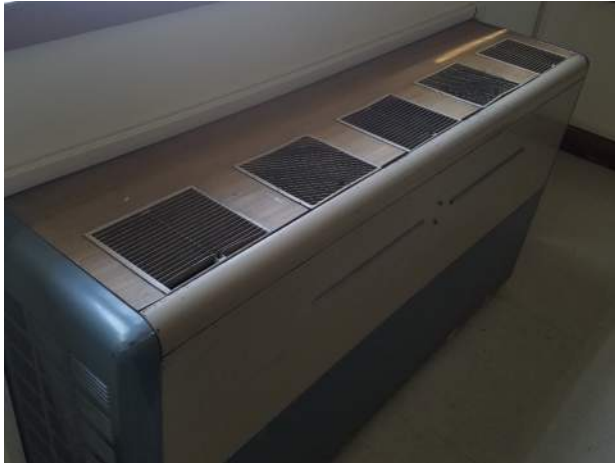
Figure 4

Existing systems do not utilize demand control ventilation to limit the amount of Outdoor Air introduced based on space CO2 levels for energy conservation and current code compliance.	Replace existing air-handling and control systems with current technologies for compliance with the current building code and general energy efficiency.
No supplemental hot water heating units are installed for maintenance of unoccupied heating space temperature set-points to avoid running the unit ventilators when unnecessary.	Provide supplemental hot water heating terminal units within the space as the primary occupied and unoccupied heating source.

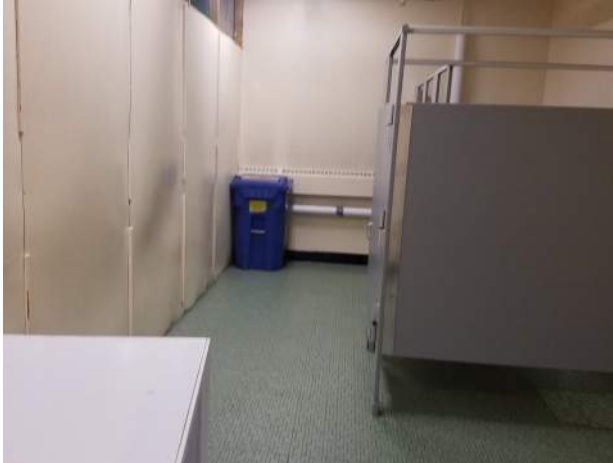
*Figure 8*

All toilet rooms within the building are provided with hot water or steam terminal heating unit for space heating. All toilet rooms are also provided with general exhaust systems connected to roof-mounted exhaust fans. All systems have surpassed their expected service lives. (Figure 8)

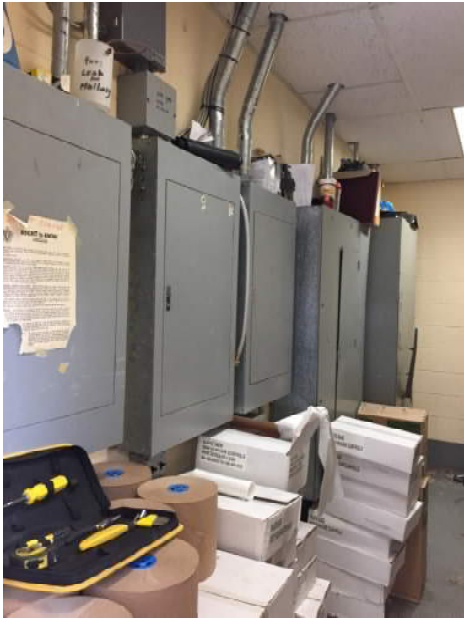
*Figure 1*

Main building switchgear is beyond its serviceable life, and in poor condition.	Upgrade service equipment and provide with transient voltage surge suppression and replace all panelboards with exception to the modular classrooms throughout the facility. Extend and reconnect existing branch circuits to new panelboards.
GFI protection is non-compliant.	Add GFI outlets/breakers for devices within 6' of a water source and protect all 15A and 20A devices in the kitchen.
Lack of receptacles.	Add receptacles for computer equipment and A/V that has been added over the years.

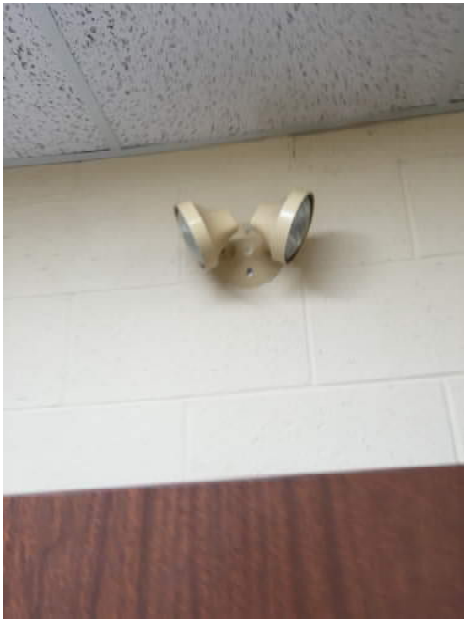
*Figure 3*

The facility does not contain an emergency stand-by generator. Emergency lighting is accomplished using battery units with either integral heads or remote heads. (Figure 3) Existing signs are provided with integral batteries and self diagnostics. (Figure 4) The condition of the emergency lighting varies from poor to good condition. The lack of generator means there is no ability to provide freeze protection in the case of a power outage, leaving the facility vulnerable to freezing pipes and potential water damage.

Battery units and exit sign condition vary and require maintenance on each unit. There is no generator at the facility.	Provide a new emergency stand-by generator and a normal/emergency distribution system that will serve emergency lighting, life safety loads, and optional stand-by loads. The existing battery units can be eliminated and maintenance will be limited to the generator and transfer equipment only.
---	--

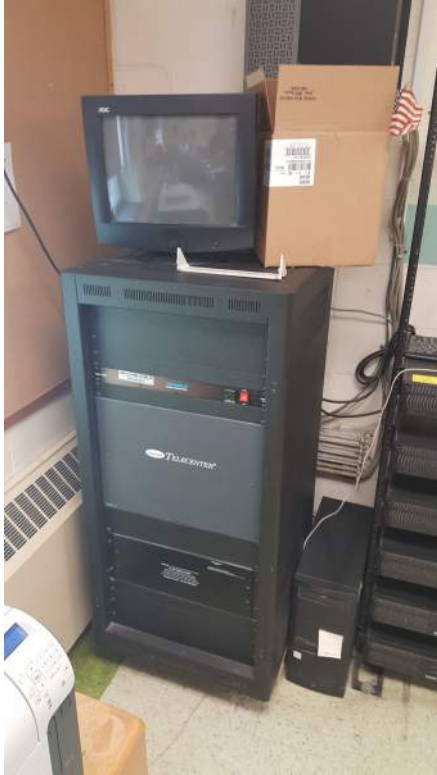
Figure 4 - Public Address System

The Distributed Communication System, (public address system) including the master clock system is in poor condition, and is based on an older version of the Rauland Telecenter system (Figure 4). Not all of the secondary analog clocks in classrooms (Figure 5) are synchronized with the master clock. Announcements are not heard in all spaces or rooms. Classroom telephone handsets are dedicated to the public address system and not part of the schools telephone system.

Public address system cabling and speakers are original and in poor condition. The system's main equipment is older and outdated.	Replace with a new public address system, with new main equipment and speakers throughout. Move main equipment to the MDF room.
Master and secondary analog clock system is not working properly in all areas.	Replace existing clock system with new equipment that provides for synchronized secondary clocks throughout the school.
Public address system handsets (Figure 5) in all rooms tie back to the main office, but do not provide outside dialing capability.	Utilize telephone handsets that connect to the public address system to provide both internal and external communications. Add call switches to the rooms for separate independent calling capability.
Main System Equipment is located in main office area	Move main equipment and connections to the MDF.

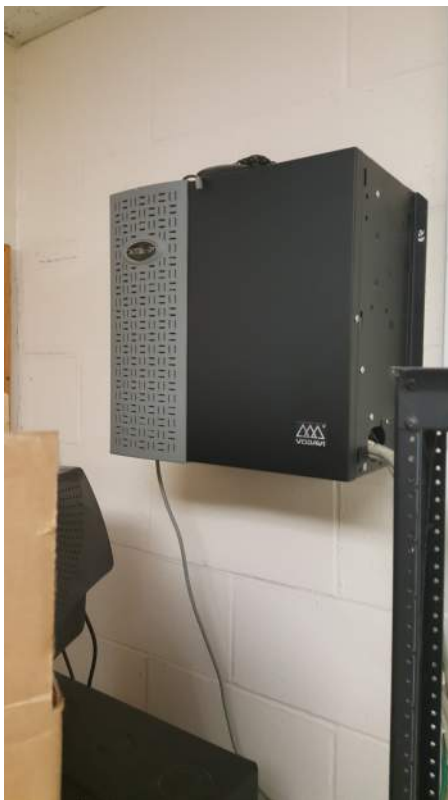
Figure 6 - Telephone System

Older system provides only administrative offices with telephone capability. It is linked to the Public Address system so that announcements can be initiated at any administrative telephone handset.	Telephone system should be expanded or upgraded to provide telephone handsets that are distributed throughout the school with voicemail capability provided for all teachers and staff in addition to administrators. Voicemail should also be integrated with email, so that messages are received through both the telephone system and the district's email system.
--	--

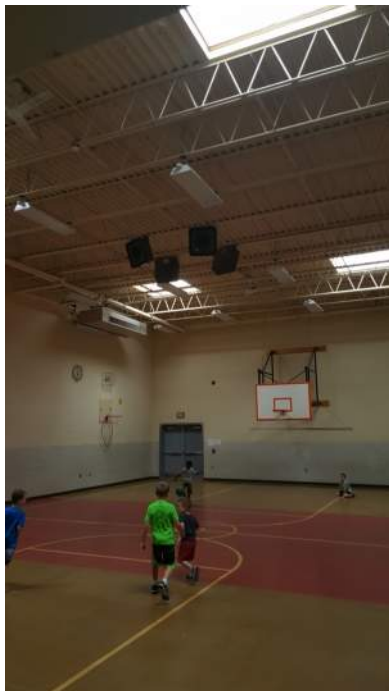
*Figure 11-Gym Sound System*

The Gymnasium has poor quality audio system speakers and no real permanent audio system.

<i>Specific Issues</i>	<i>Recommendations</i>
Audio system in the primary assembly area was not working.	Install new permeant sound equipment.
There is a portable projection cart with a low lumen projector used in Cafeteria.	Install a permanent mounted high lumen projector with connections to new audio system and inputs at the state for presentations. Upgrade screen.
Gymnasium is without permanent AV equipment	Install new audio system and projection screen on the wall. Upgrade portable cart with high lumen projector for use in the Gym.

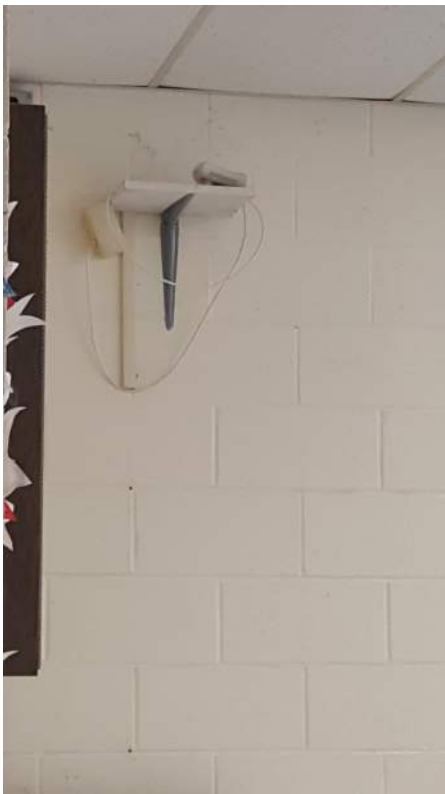
*Figure 16—Wireless Access Point*

Ensure that there is an adequate concentration of wireless access points to meet existing and future wireless connection needs.	Increase the number of wireless access points to at least one per classroom and provide multiple access points in larger assembly spaces like the cafeteria, library, gymnasium, etc. Cover all administrative areas. Perform a heat map and deploy wireless access points for optimum coverage to support a one-to-one deployment of user devices.
Aruba is legacy wireless technology in the district.	Upgrade the Aruba wireless access point network to the District Aerohive wireless network standard.

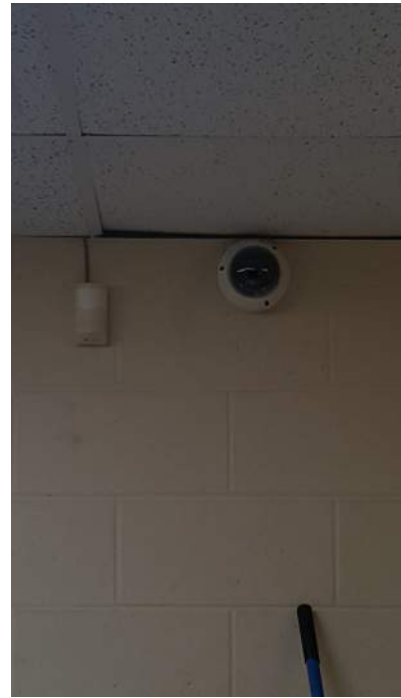
*Figure 19 -Motion Detector  
Inside Dome Camera*

Possible lack of coverage by surveillance system cameras and alarm system motion sensors.	Increase the number of cameras and areas of coverage as required or needed. Adjust and modify with additional motion sensors for greater intrusion detection. Maintain system software assurance for best return on investment.
---	---

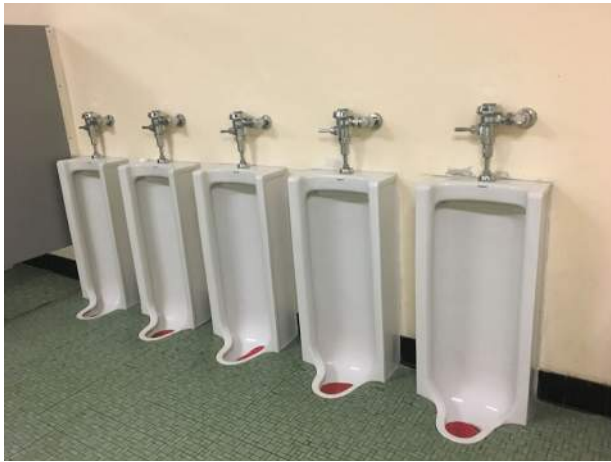
Toilets are a combination of tank and flush valve types, and are not water conserving types. (Figures 2, 4)	Consider replacing all toilets with consistent type throughout building, and featuring low-flow (1.28 gpm) flush valves.
Urinals are floor mounted and 1gallon per flush. Floor mounted urinals do not meet current accessibility codes. Urinals are not shielded for privacy, which is a violation of the plumbing code. (Figure 1).	Replace all urinals with code compliant wall mount types, and replace all flush valves with low-flow (1/8 gpf) types.
Toilet room has been adapted for use as a janitor's closet, (Figure 3).	Determine appropriate use of room; if for storage, remove and cap off toilet.
A lavatory has a chemical dispenser connected to it (Figure 4.)	This is a plumbing code violation and should be removed.
Supply and waste piping at sinks is not typically insulated in conformance with accessibility rules.	Insulate all piping at sinks that could be used by disabled persons.

*Figure 1— Urinals*

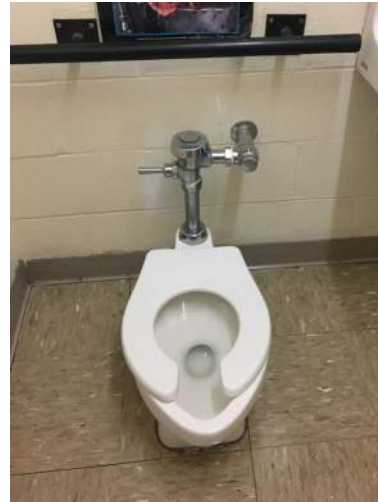
*Figure 2— Small pre-k toilet*

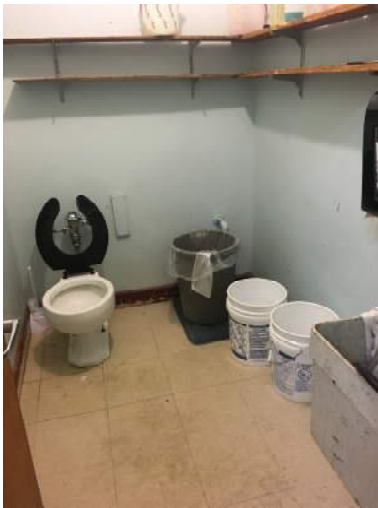
*Figure 3 — Toilet and Janitor's Sink*

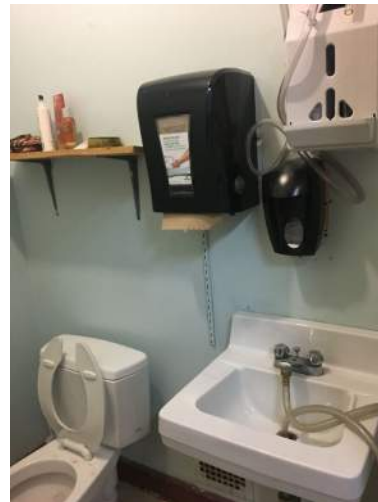
*Figure 4—Tank type toilet and chemical dispenser*

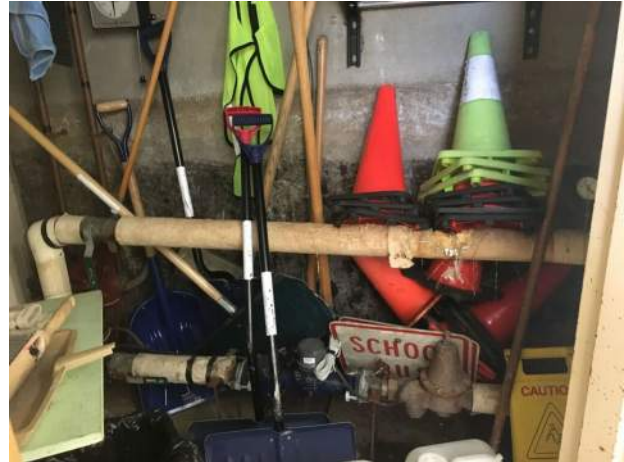
The backflow preventer and pressure reducing valve for the HVAC supply system are in fair to good condition. (Figure 5)	None
Incoming water service is congested by stored materials, which are capable of damaging the piping. Some insulation is slightly damaged and incomplete. (Figure 6)	Remove stored material from the vicinity of the water service piping.
The gas meter is obstructed with vegetation. The concrete pad under the meter appears to be insufficient. (Figure 7)	Remove vegetation from in front of the gas meter. Replace the concrete paver below the meter with a more substantial concrete slab.
The existing gas fired hot water heater is approaching the end of its service life. (Figure 8).	Consider replacing it with a new, high-efficiency gas fired hot water heater.

Figure 6— Water Service

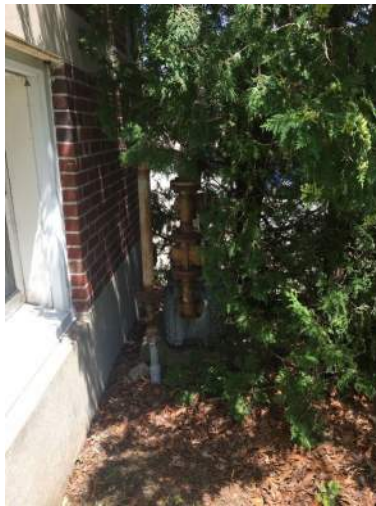
Figure 7— Gas service and meter

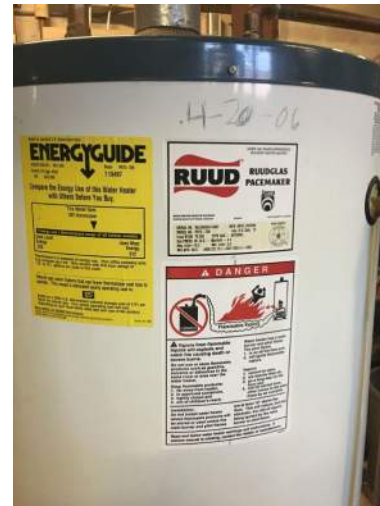
Figure 8— 75 gallon domestic hot water heater

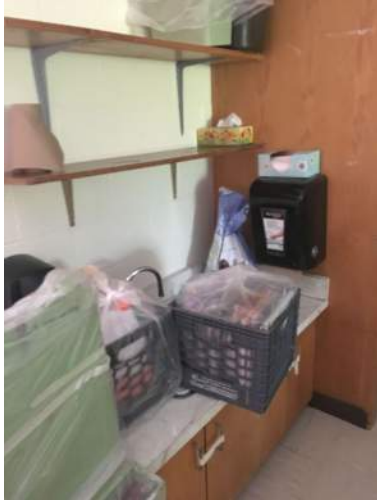
Classroom sinks are generally not accessible. (Figure 9)	Refer to the Regulatory Assessment and Architectural Assessment sections of this report for further discussion.
Janitor's sink has a chemical dispenser. However, there is no backflow preventer installed to prevent cross-contamination (Figure 10).	Backflow preventers are required and will need to be installed per plumbing code.
A classroom sink in the modular classroom building does not have piped plumbing. The clean water is sourced from the container in the left side of the cabinet, and the dirty water is drained into the right container in the cabinet. As a result the sink is also not accessible. (Figure 11)	Provide piped potable hot and cold water supply and sanitary drainage piping to all fixtures.

*Figure 9 — Classroom sink*

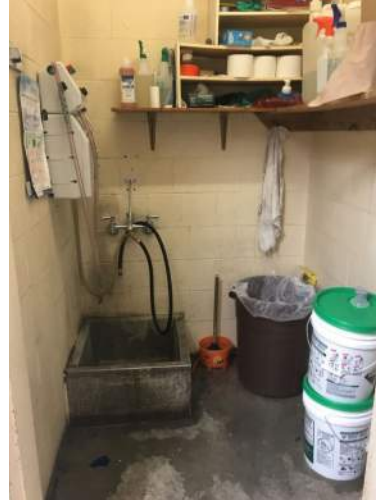
*Figure 10 — Janitor's sink*

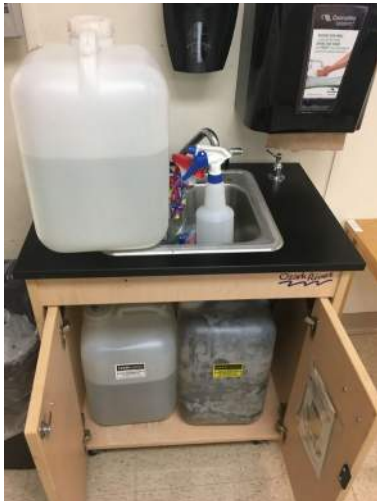
*Figure 11 — Classroom sink*

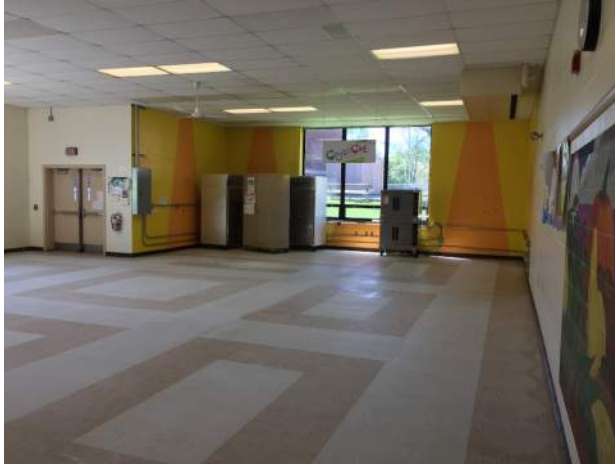
The space where the kitchen serving equipment is located is not able to be secured when not in use. Additionally the space was not designed to be a kitchen space. The floor and ceiling finishes are not appropriate for a kitchen environment. (Figure 1).	A full commercial kitchen, complete with modern equipment, sanitation, and storage facilities is needed.
The three bay sink is a self contained portable unit. The bowls are too small for anything more than washing serving utensils. (Figure 2).	See recommendation for Figure 1
The hand sink is a self contained portable unit. It meets the requirements of the health codes, but a plumbed-in hand sink would offer unlimited water volume and consistent wash temperatures. (Figure 3).	See the recommendation for figure 1.
The cold food serving counter is ice cooled. Ice is a less consistent cooling medium than a mechanically chilled serving pan. (Figure 4).	Replace with a modern mechanically cooled unit.

*Figure 1—The kitchen space at the rear*
