# W. EDWARD BALMER ELEMENTARY SCHOOL

NORTHBRIDGE PUBLIC SCHOOLS  
TOWN OF NORTHBRIDGE, MASSACHUSETTS

## PRELIMINARY DESIGN PROGRAM, SECTION 3.1.4

### EVALUATION OF EXISTING CONDITIONS

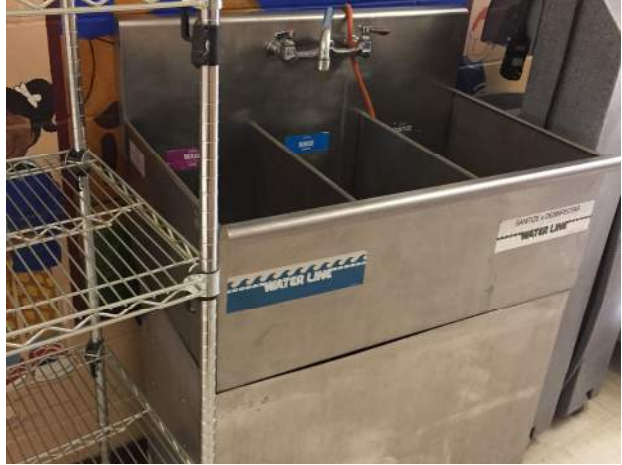
*Figure 2—Three bay sink*

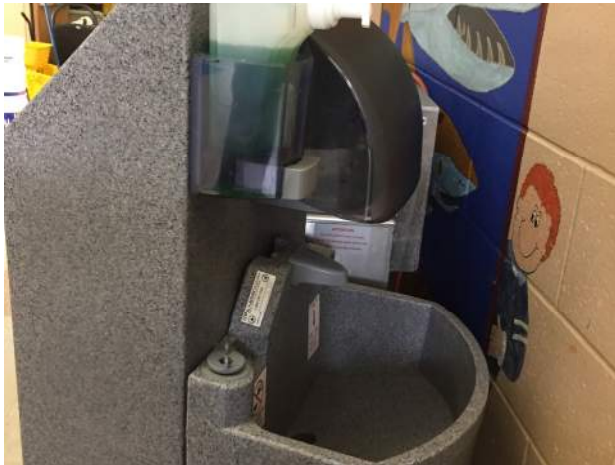
*Figure 3—The hand washing station*

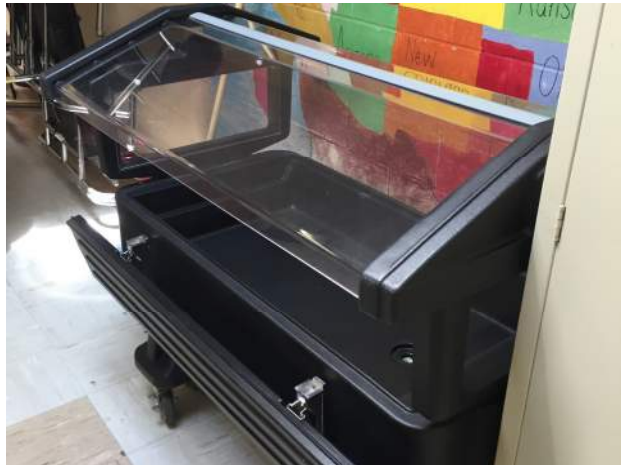
The space where the kitchen serving equipment is located is not able to be secured when not in use. Additionally the space was not designed to be a kitchen space. The floor and ceiling finishes are not appropriate for a kitchen environment. (Figure 1).	A full commercial kitchen, complete with modern equipment, sanitation, and storage facilities is needed.
The three bay sink is a self contained portable unit. The bowls are too small for anything more than washing serving utensils. (Figure 2).	See recommendation for Figure 1
The hand sink is a self contained portable unit. It meets the requirements of the health codes, but a plumbed-in hand sink would offer unlimited water volume and consistent wash temperatures. (Figure 3).	See the recommendation for figure 1.
The cold food serving counter is ice cooled. Ice is a less consistent cooling medium than a mechanically chilled serving pan. (Figure 4).	Replace with a modern mechanically cooled unit.

*Figure 4—The cold food serving counter*
